Westward Drive Arterial Qualitative Assessment Report

PROJECT: Westward Drive Arterial Qualitative Assessment Report

LOCATION: City of Miami Springs, Florida

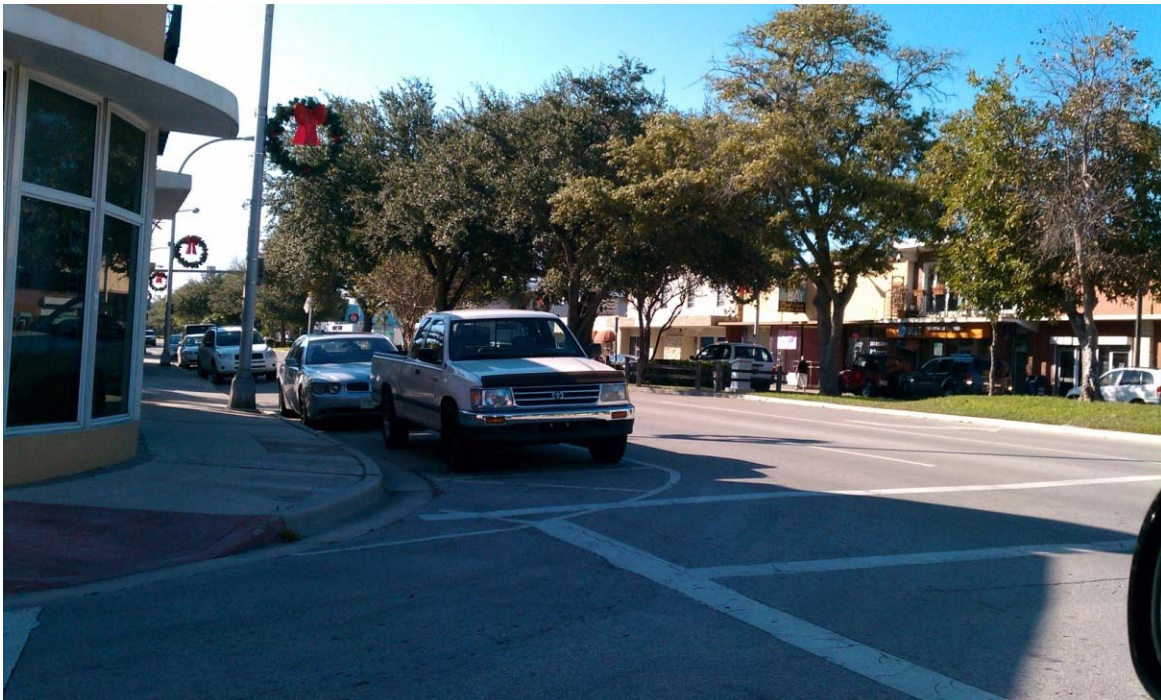
PHOTO 1

Northbound at Cross Street – Notice that vehicles obstruct view of opposing traffic.

- iii. Perform individual intersection safety analysis at each of the side street locations to address sight distance obstructions and make safety recommendations. This task would include a historical crash analysis with collision diagrams.

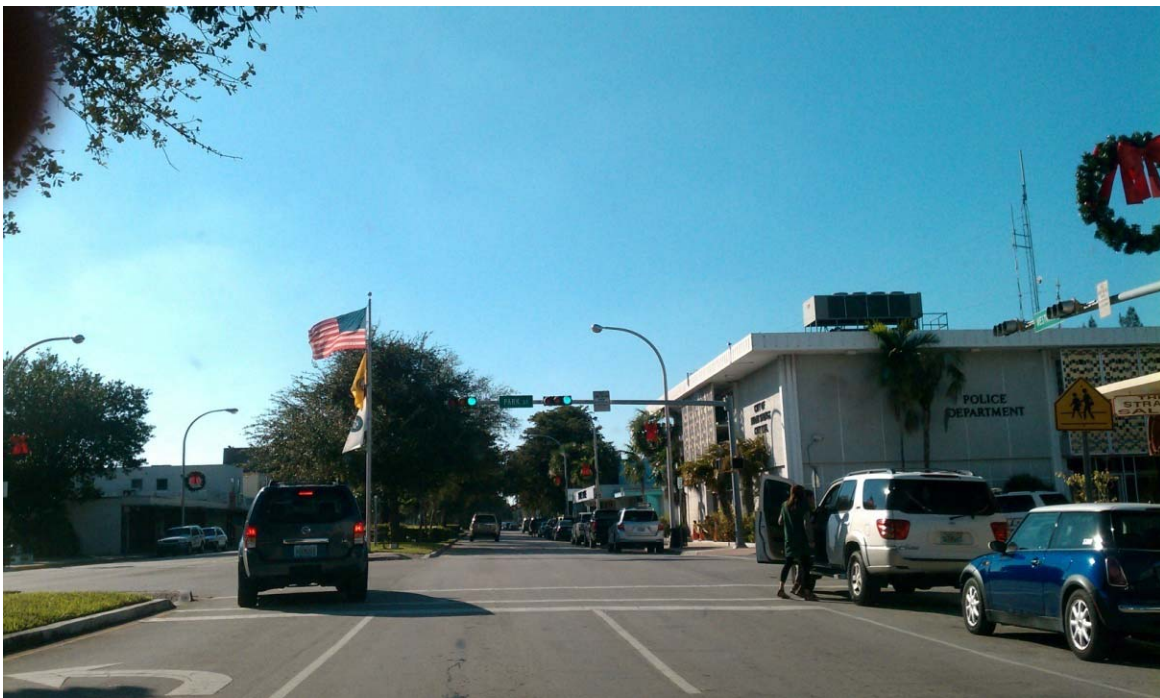
PHOTO 2

Westbound on Westward Drive at Park Street – Notice vehicle parked blocking crosswalk.

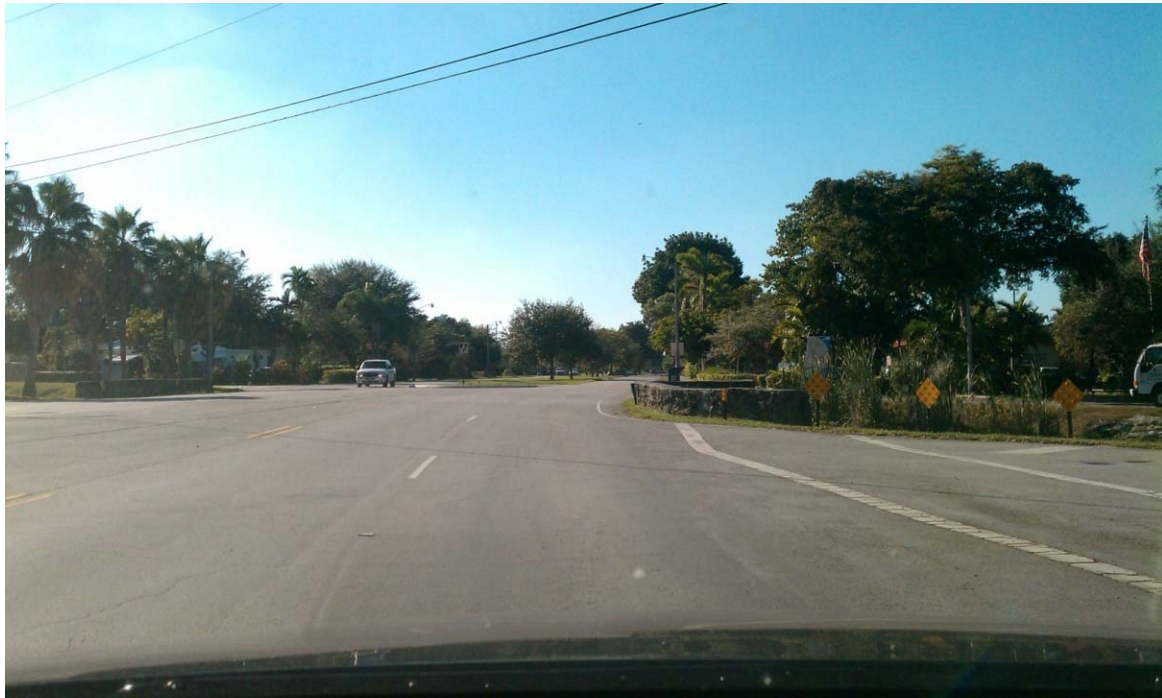
PHOTO 3

Westbound on Westward Drive at Esplanade Drive – Crosswalk lacks connectivity to sidewalk across the canal on north side of roadway.

- ii. Redesign the bridge over the canal located between Esplanade Drive and Flamingo Circle to accommodate a pedestrian crosswalk in the east/west direction.

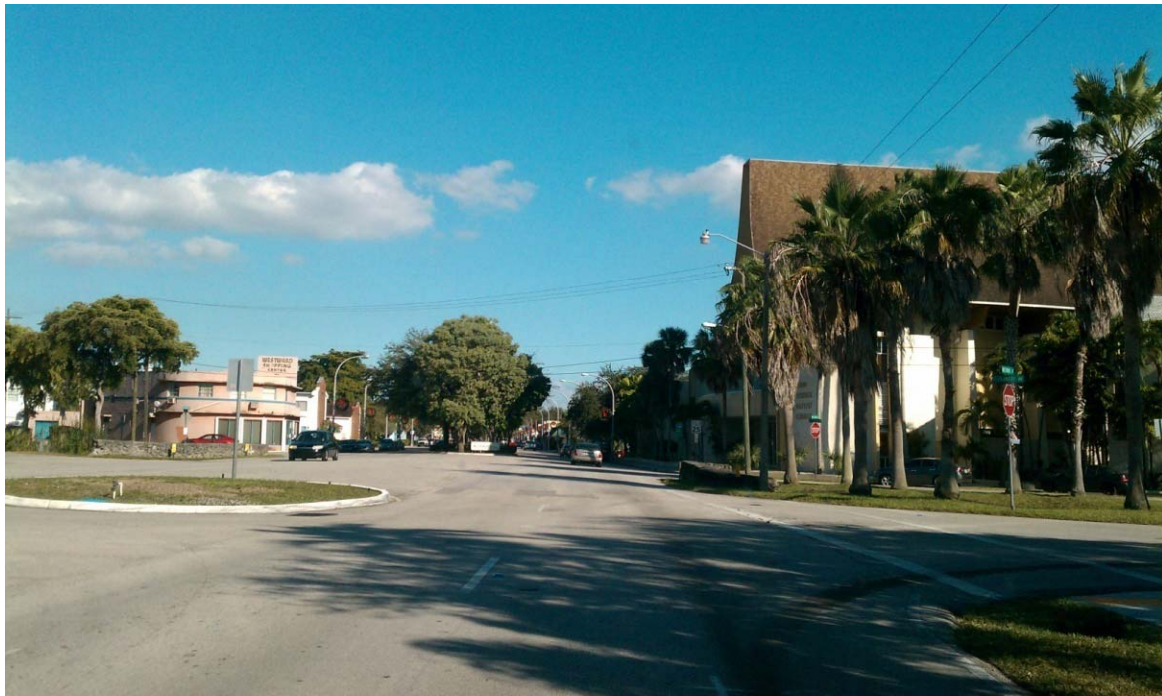
PHOTO 4

Eastbound on Westward Drive at Flamingo Circle – Crosswalk lacks connectivity to sidewalk across the canal on south side of roadway.

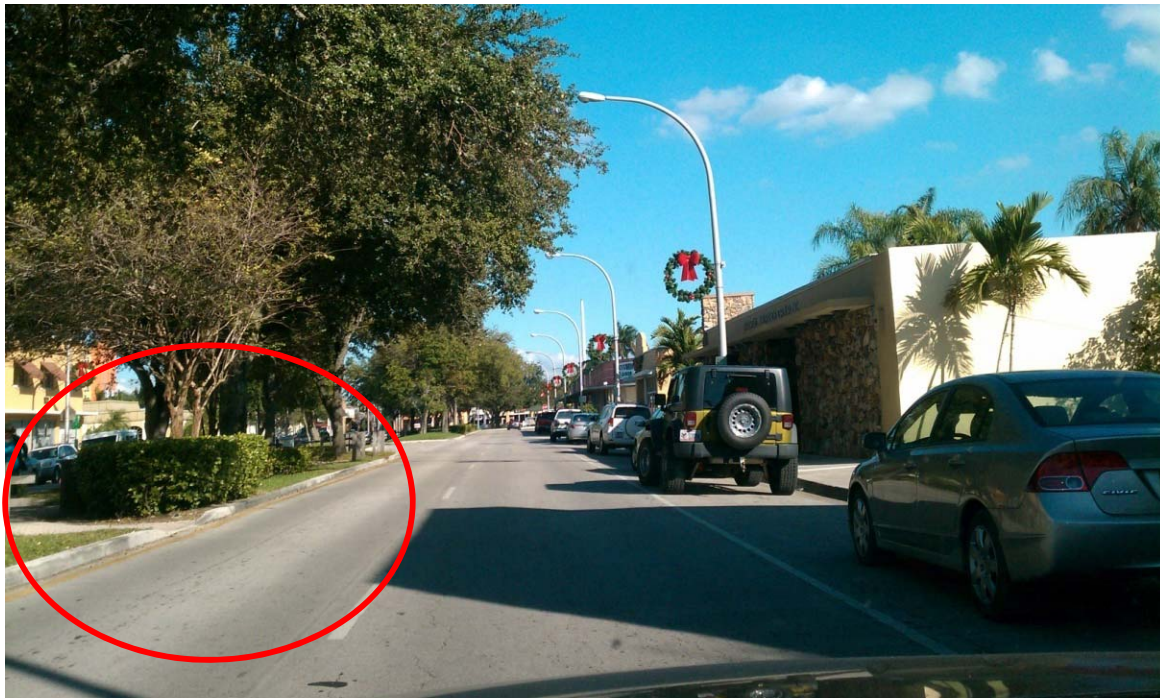
PHOTO 5

Eastbound on Westward Drive, just east of Park Street – Notice the pedestrian pathway in the center median that lacks connectivity to crosswalks at the intersection.

- iv. Redesign the landscaped center island pedestrian pathways to create connectivity to the designated crosswalks at the intersections.
 - v. Prepare an access management plan to address full median openings located at each side streets. These median openings are currently spaced well below minimum FDOT access management standard guidelines of 660 feet for Access Class 7.

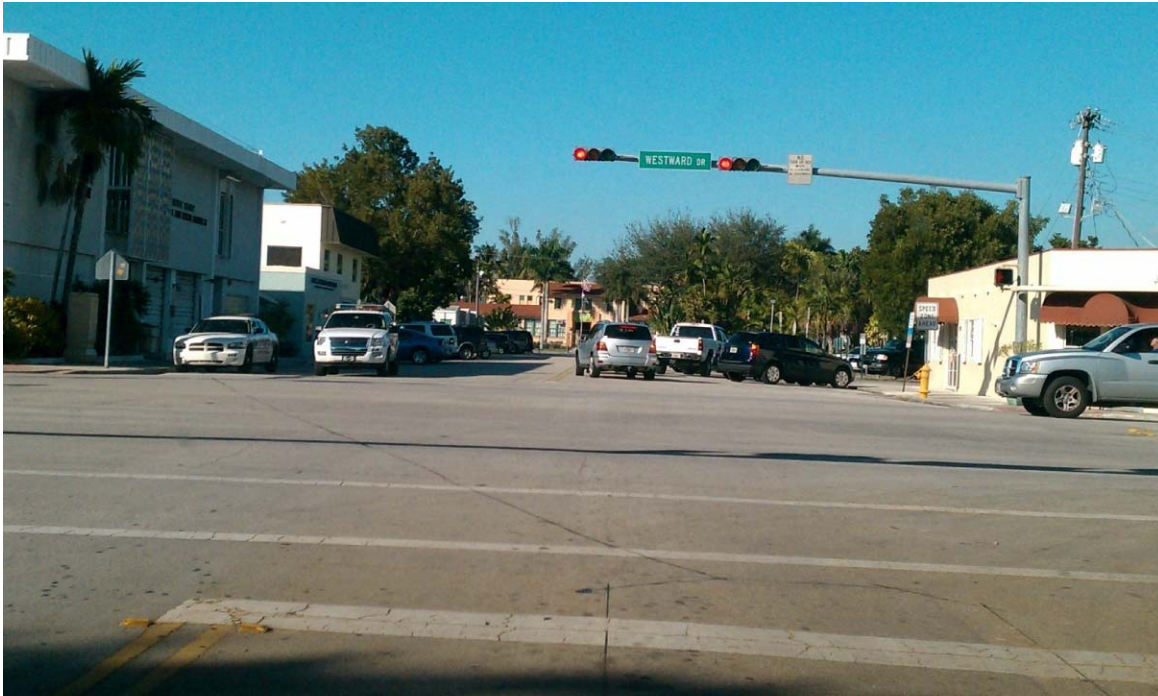
PHOTO 7

There was light traffic on the northbound and southbound approaches with minimal (1 to 2 vehicles) queue observed during most of the day, with the exception of school dismissal time (approximately 3 PM) where northbound queues on the north leg of the intersection entering the school nearly extended back 400 feet to the Westward Drive at Park Street intersection. Traffic in the eastbound and westbound directions was moderate, with average queues observed of 3 to vehicles per lane with very few left turn movements. No cycle failures were observed during the AM or PM peak periods.

Northbound on Park Street at Westward Drive – Notice queue nearly extends to Westward Drive at school dismissal.

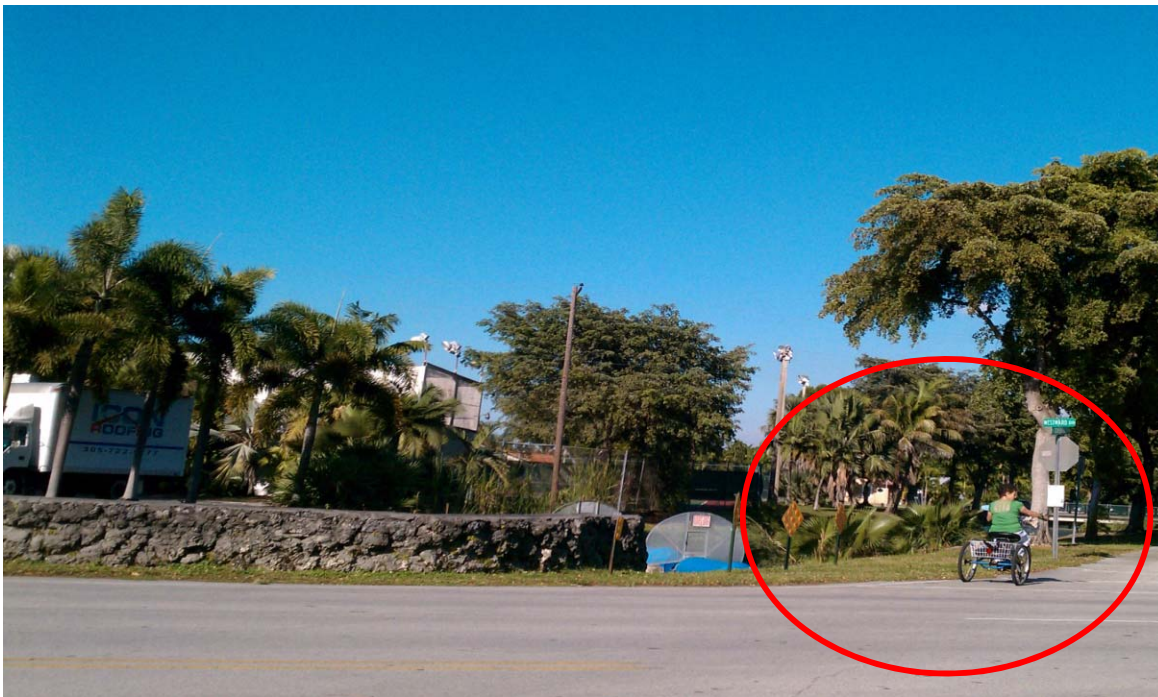
PHOTO 8

Esplanade Drive is a 2-lane stop-controlled undivided roadway on both the north and south legs of the intersection. Esplanade Drive runs parallel to a canal which exists on the west side of the roadway. There is no on street parking on the north or south leg of the intersection. However, illegal parking was observed in the grass swale on the east side of the roadway on both the north and south legs of the intersection. The Miami Springs Baptist Church exists on the southeast corner of the intersection. There was little to no pedestrian activity observed at this intersection, but that which was observed in the east/west direction was forced to cross without a pedestrian crosswalk over the canal, west of this intersection.

Northbound on Esplanade Drive at Westward Drive – Notice eastbound bicycle forced to enter roadway to cross canal.

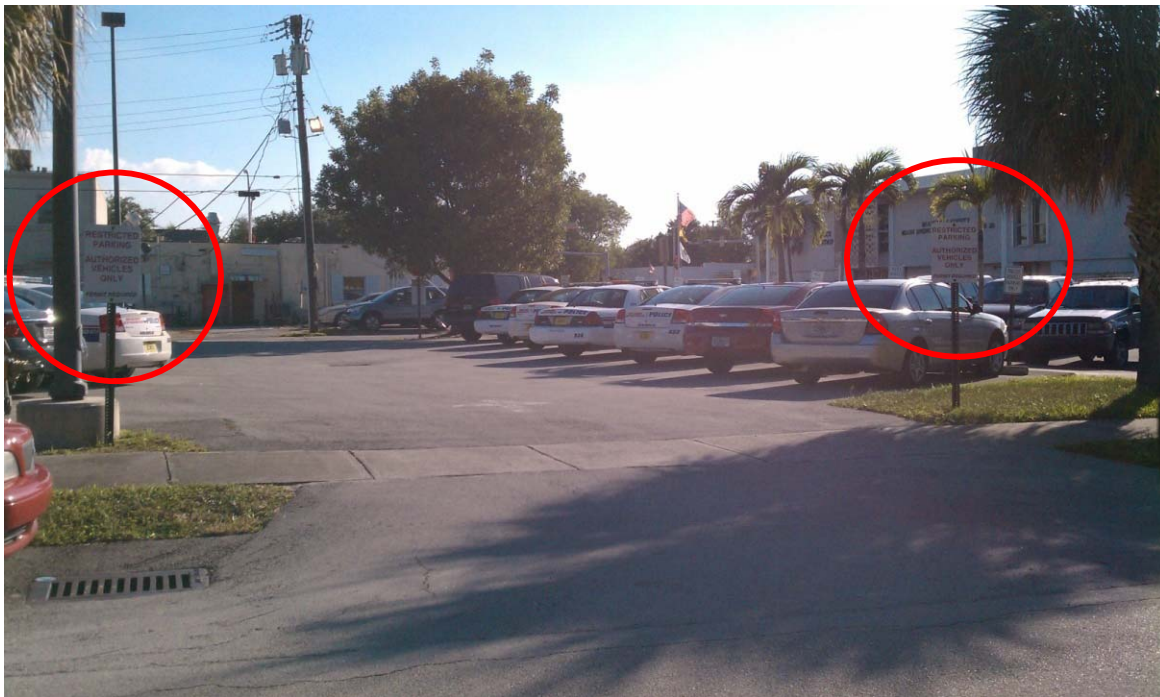
PHOTO 10

View of Public Parking lot on the north side of Westward Drive, between Park Street and Cross Street – Notice parking restrictions.

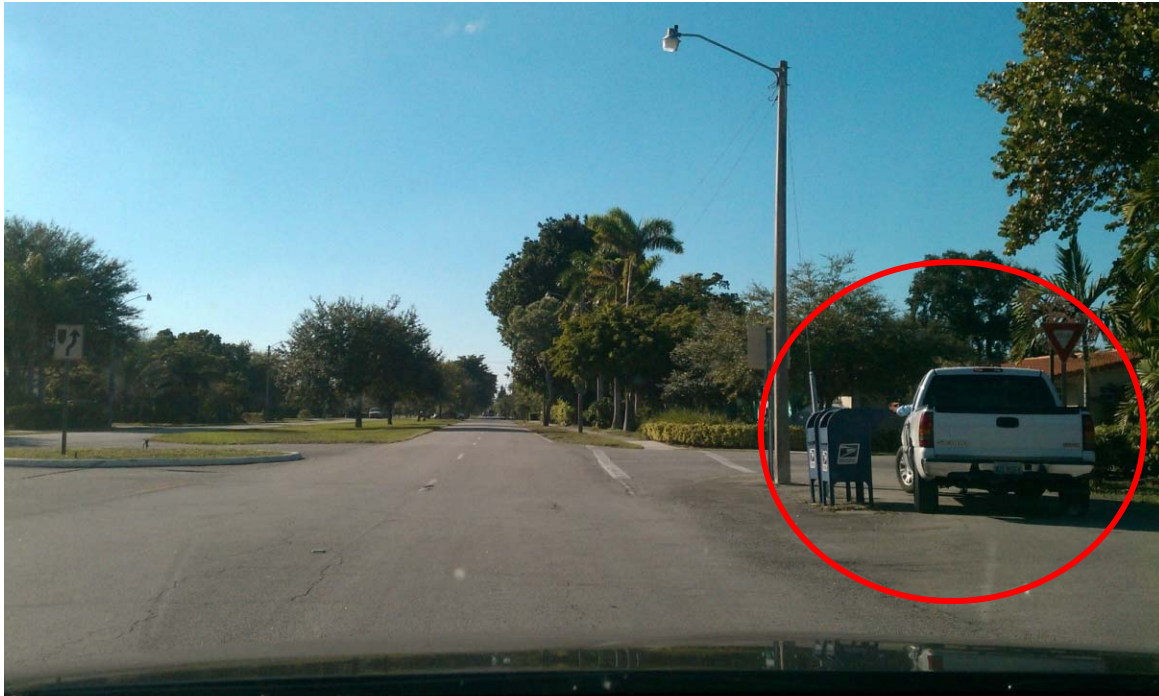
PHOTO 11

There were also twenty-seven “Angle” crashes along the study corridor. Eleven of the twenty-seven “Angle” crashes occurred near Flamingo Circle. These crashes are consistent with conflicts observed during the field review which occurred due to the substandard configuration of the USPS driveway to the “Drop Box”.

Westbound on Westward Drive, just east of Flamingo Circle – Notice substandard driveway that services USPS Drop Box.

- A. Perform a comprehensive arterial analysis study to perform the following task, as follows:
- i. Reconfigure the substandard driveway parallel to Westward Drive at the Flamingo Circle intersection for the United States Postal Service (USPS) “Drop Box” located in front of the Miami Springs Branch Public Library.

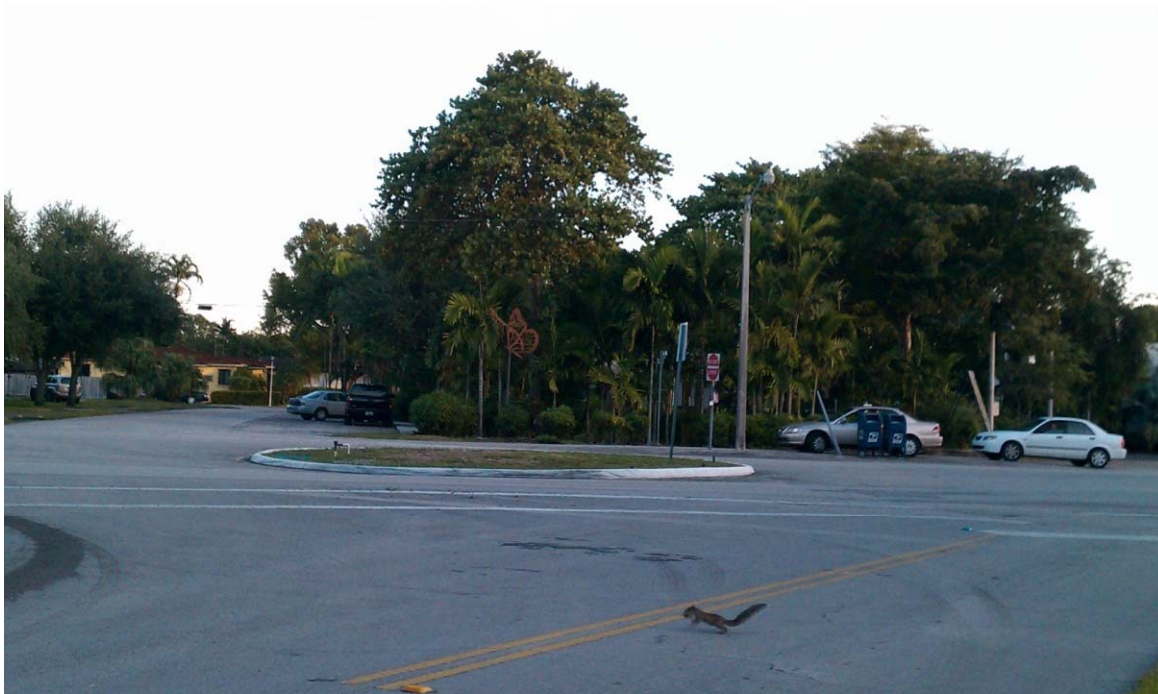
PHOTO 12

Northbound on Flamingo Circle at Westward Drive – Notice vehicles queued at substandard driveway that services USPS Drop Box.
