# SENIOR LIVING FACILITIES ROAD SAFETY AUDIT

## WORK ORDER # GPC VII-02

OCTOBER  
2019

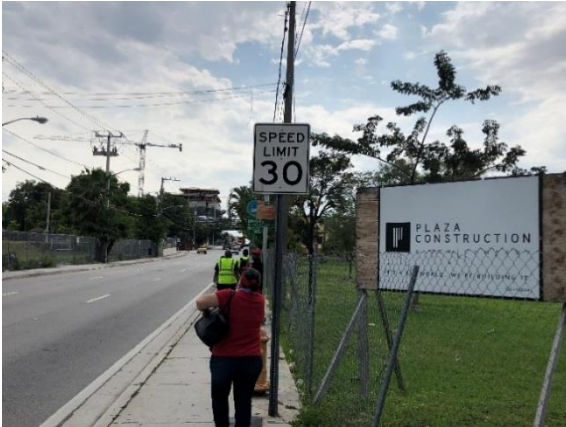
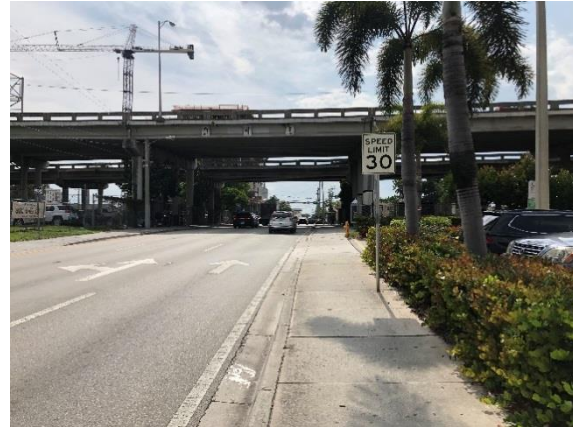
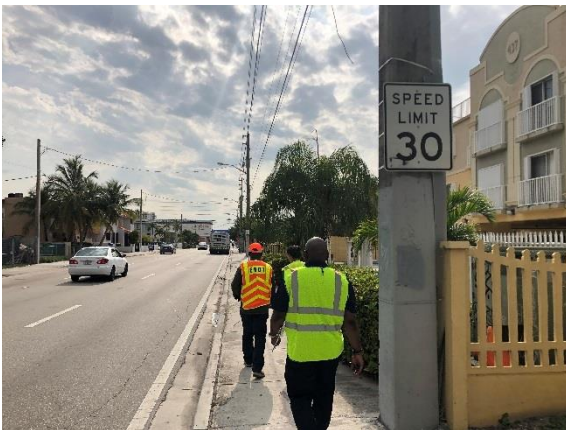
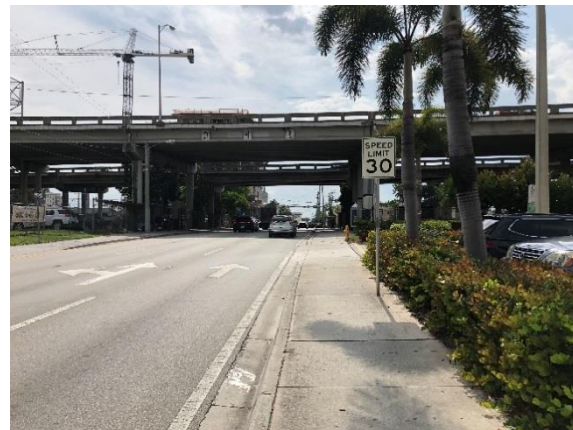
#### Issue #1: Vehicular Speed

Posted speeds are 30 MPH for the study area. Based on visual observation, speeds appear to routinely exceed 30 MPH on SW 7<sup>th</sup> Street.

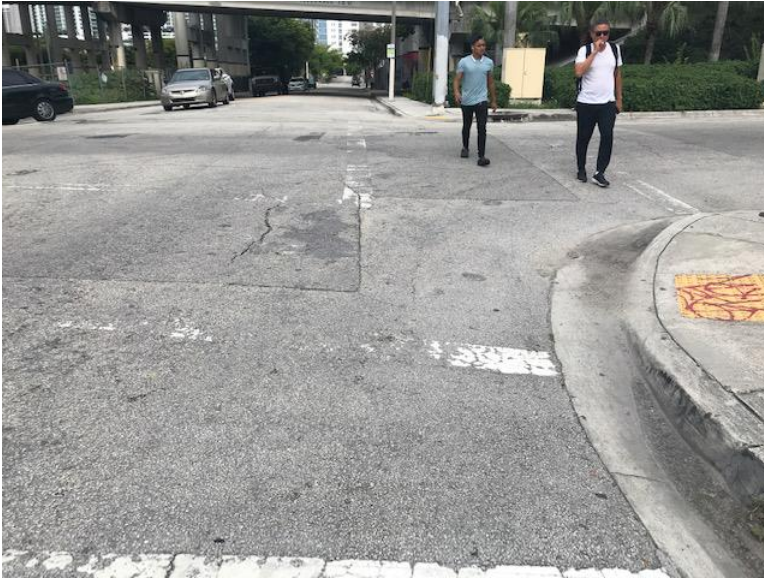
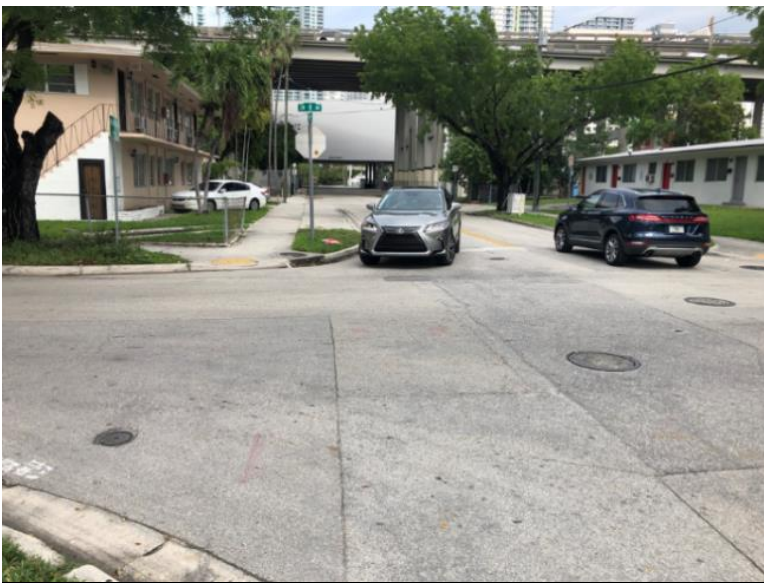
**Issue #2: Pedestrian Crossings**

Crosswalk pavement markings on major and minor streets throughout the study area are missing or faded.

- Short-Term or Maintenance Project – Restripe intersection crosswalks where faded.
- Near-Term Project – Add crosswalks at signalized and stop controlled intersection approaches where they are currently missing. These crosswalks are intended to improve pedestrian safety by facilitating pedestrian crossings at designated locations.

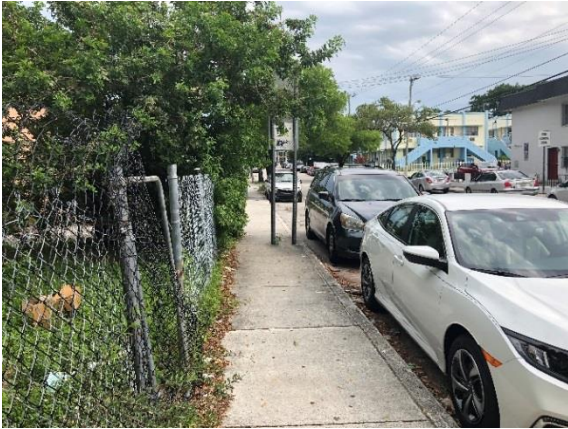
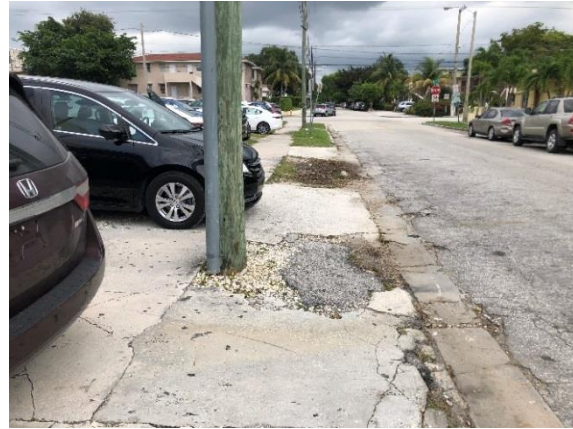
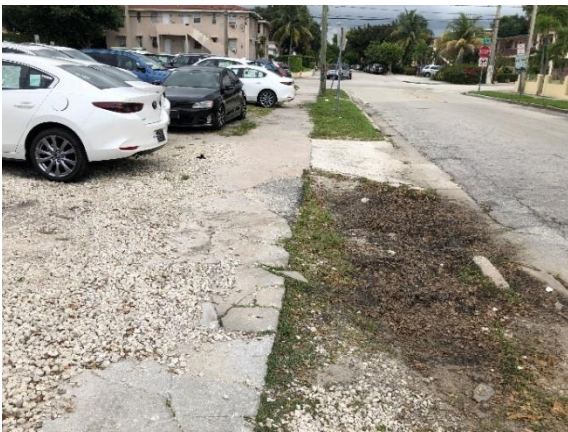
**Issue #3: Narrow and Partially Obstructed Sidewalks**

The sidewalks, particularly on local roads, were observed to be narrow and in some circumstances obstructed by utilities, sign poles, and vegetation.

- Short-Term or Maintenance Project –  
Vegetation adjacent to sidewalks throughout the corridor should be properly maintained; this improvement may require code enforcement on private property.
- Long-Term Project –  
Recommend further study to determine if alternative sidewalk alignment and/or additional right-of-way is necessary to allow for wider sidewalk where obstructions are present.

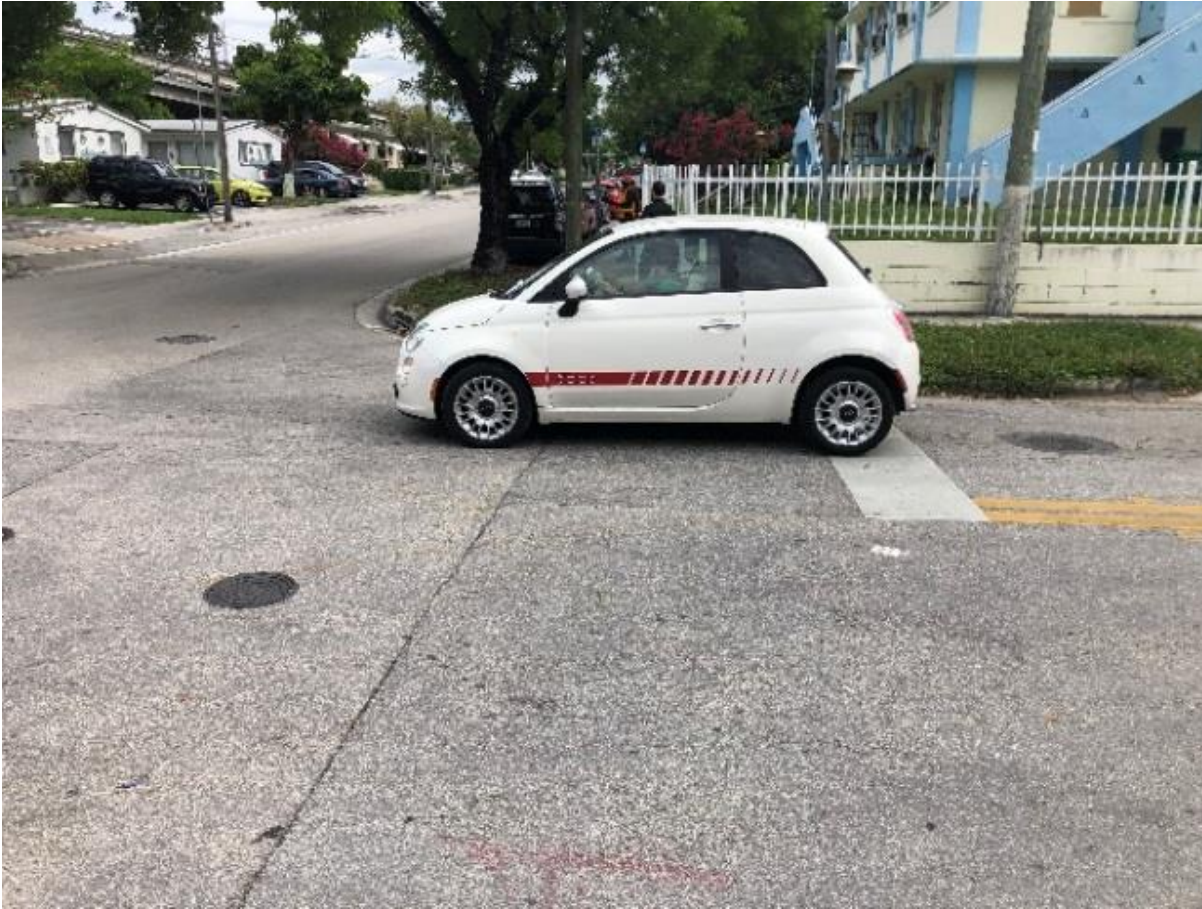
**Issue #4: Poor Sight Distance at Intersections**

Due to on street parking and other objects such as structures, walls/fences, and trees, many intersections have sight distance for vehicles. This leads to vehicles pulling into crosswalk areas as shown in the picture above.

- Short-Term or Maintenance Project –  
Recommend further study to determine if removing sight obstructions and reducing on street parking near intersections to increase sight distance is needed.

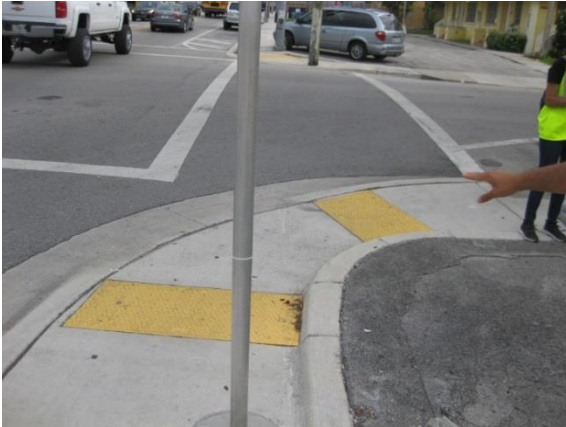
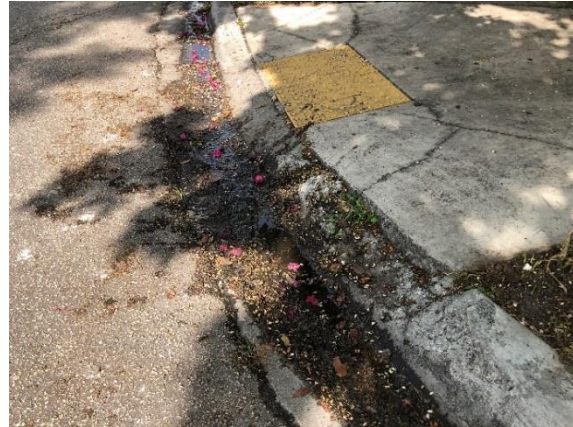
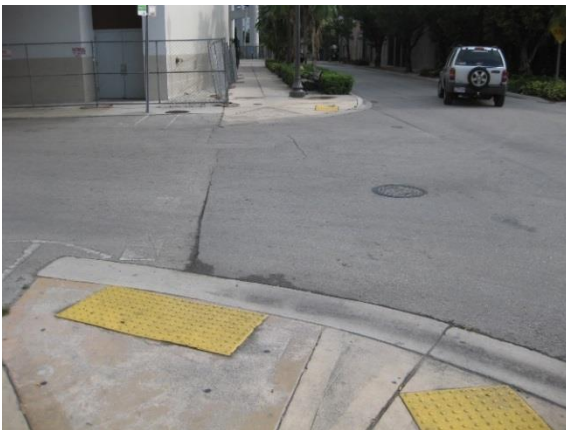
**Issue #6: Improper Truncated Domes**

Marked crosswalks and truncated dome surfaces do not properly align at some intersections. For example, some crosswalks were observed to direct pedestrians away from the curb ramps while some truncated dome surfaces are oriented at 45-degree angles to crosswalks. These pedestrian features could misdirect a visually impaired pedestrian. It should be noted that blind pedestrians are active within the study area, particularly near Miami Lighthouse for the Blind (601 SW 8<sup>th</sup> Avenue).

- Short-Term or Maintenance Project –  
Replace deteriorated or misaligned truncated dome surfaces. Specific locations are discussed later in the report.
- Near-Term/Long-Term Project –  
Align crosswalks and curb ramps/truncated domes for future construction projects.

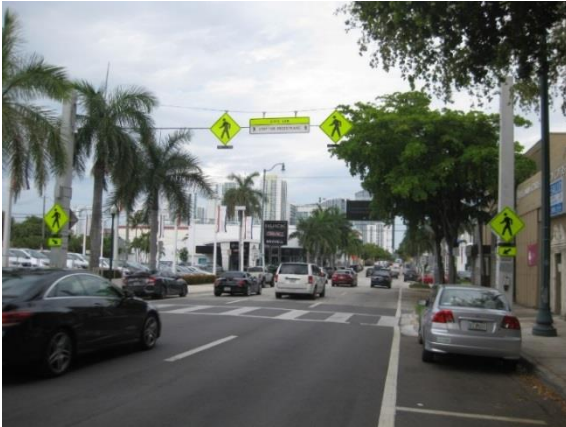
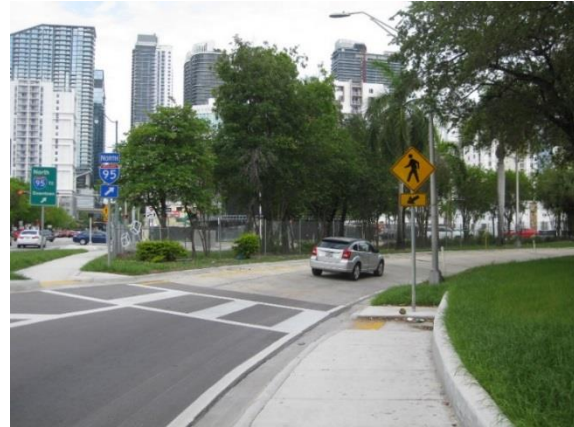
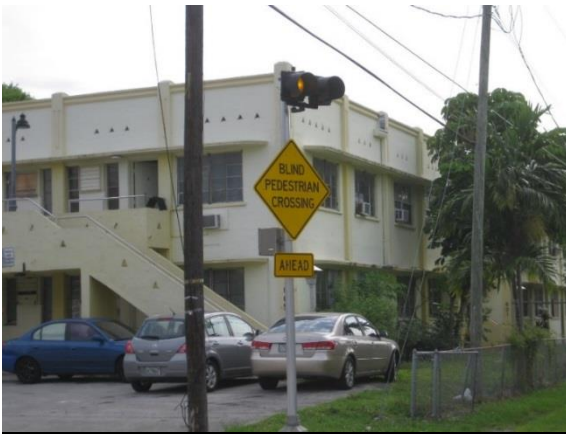
**Issue #7: Sign Visibility**

The pedestrian warning signs throughout the study area have inconsistent color of sign sheeting. Some have traditional engineering grade reflective yellow sheeting while others have high intensity fluorescent yellow-green sign sheeting. The latter are more visible to the road users and are the standard for warning signs associated with schools according to the MUTCD Section 2C.03.

- Near-Term Project –  
Replace traditional engineering grade reflective yellow pedestrian warning signs with high intensity fluorescent yellow-green sign sheeting for conspicuity and consistency in the area.

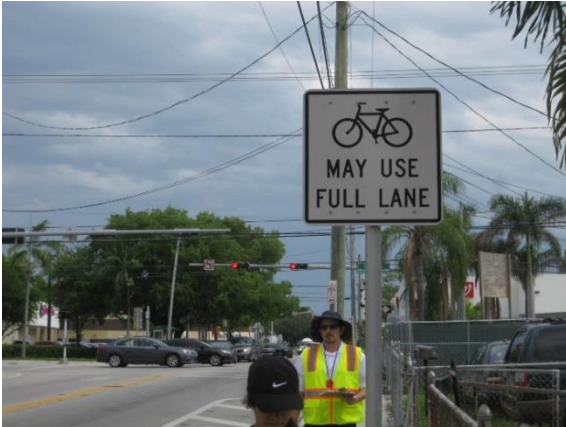
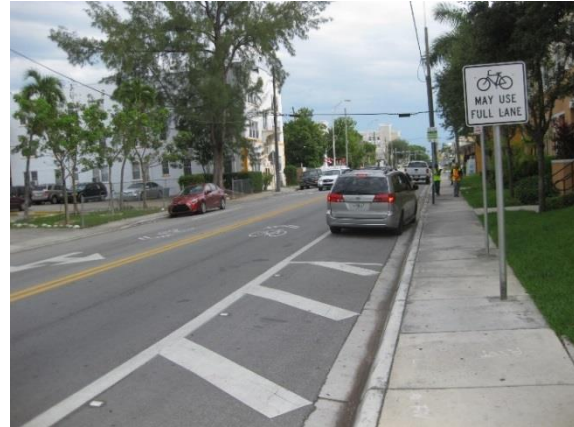
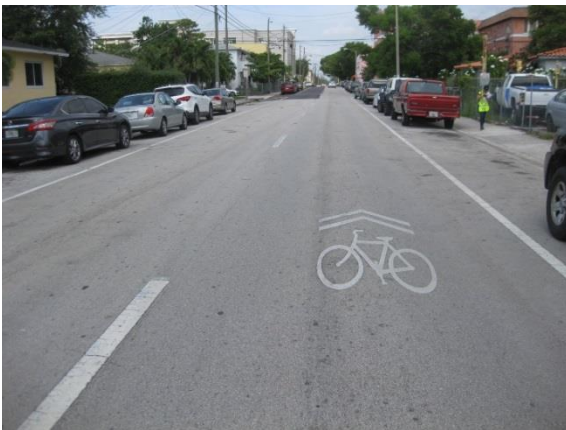
**Issue #8: Bicycle Facilities**

Sharrows are provided along SW 6<sup>th</sup> Street and SW 8<sup>th</sup> Avenue within the study area. Bicycles were observed making unsafe maneuvers, such as riding the wrong direction and riding on the sidewalk against traffic. Bicyclists were generally not observed riding in the roadway using sharrows.

- Near-Term or Maintenance Project –  
Conduct an educational campaign on bicycle safety and best practices on sharing the road.  
Consider adding signage for stop-controlled approaches at unsignalized intersections to alert drivers to look both ways for bicyclists.
- Long-Term Project –  
Conduct a study to evaluate the feasibility of lane repurposing (reducing the number of through lanes) to provide bike lanes.

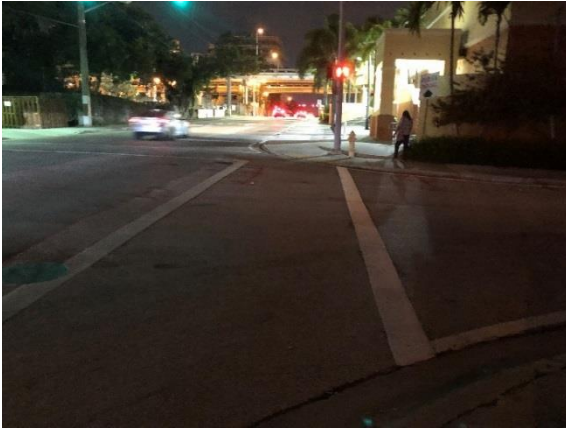
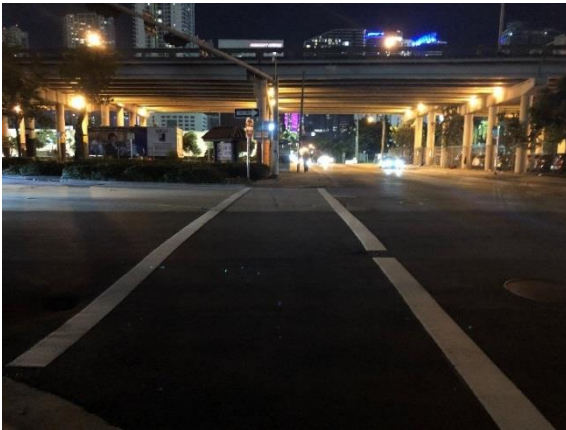
**Issue #9: Roadway Lighting**

Lighting levels were inconsistent throughout the study area and low along some corridors and intersections. Large overhanging trees adjacent to the roadway partially block the roadway lighting, resulting in dark spots.

- Near-Term or Maintenance Project –  
Conduct maintenance work on the existing landscape and prevent lighting poles being blocked by tree branches.
- Long-Term Project –  
Lighting assessment studies are needed throughout the study area. Lighting alternatives with lower level light poles or pedestrian level lighting should be considered. When modifying intersections, upgrade lighting at intersections to match current FDOT intersection lighting standards.

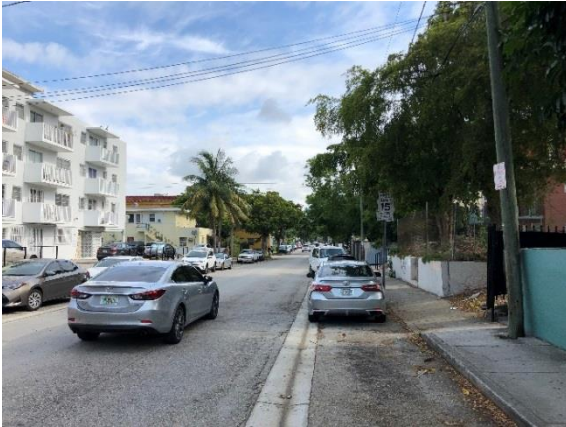
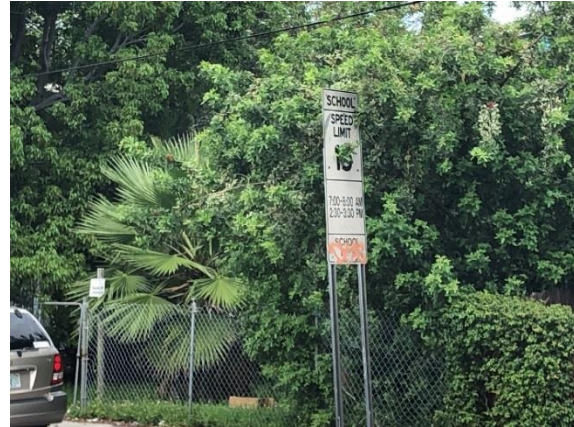
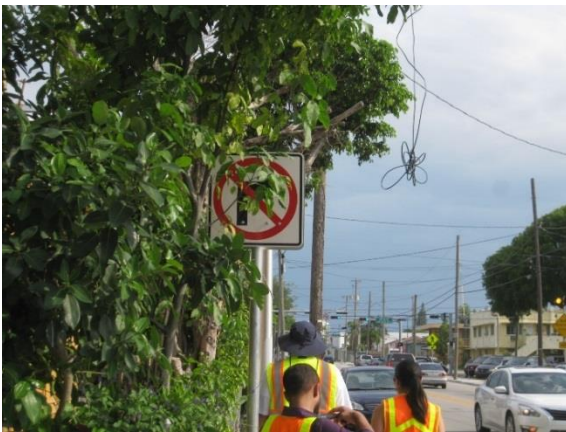
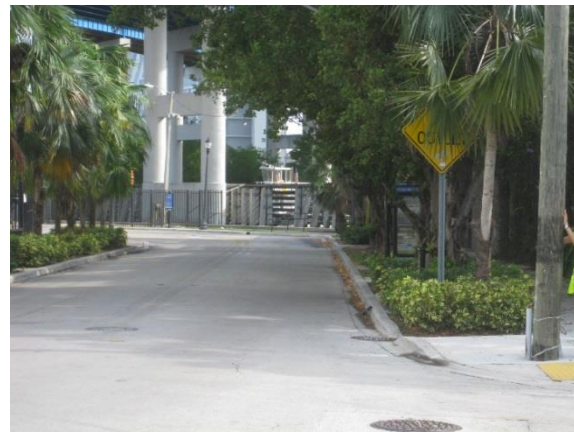
**Issue #10: Roadway Signs Blocked**

Some roadway signs were blocked by vegetation in the study area. This prevents the driver from reading regulatory, directional and warning information.

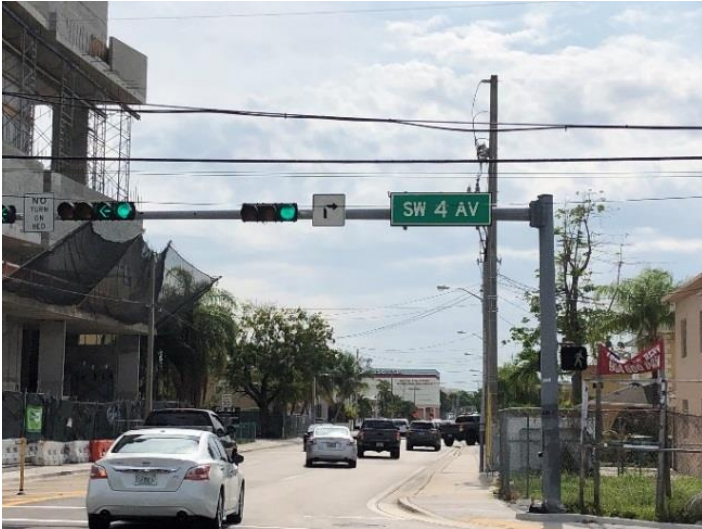
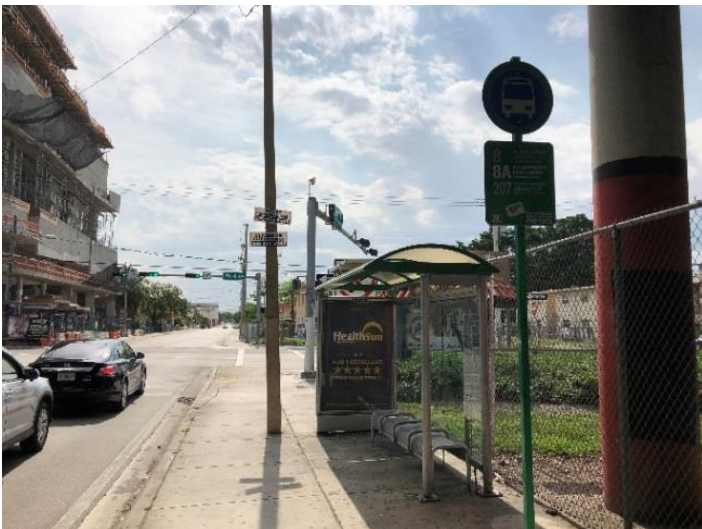
##### Issue #12: Worn/Faded No-Right Turn Sign

The No Right Turn sign is faded, it is no longer retroreflective and is blocked by bus stop shelter on the westbound approach. When the RSA Team drove by this intersection at night, the sign was not visible.

- Short-Term or Maintenance Project –  
Replace the No Right Turn sign.  
The post-mounted sign should be relocated to increase visibility.

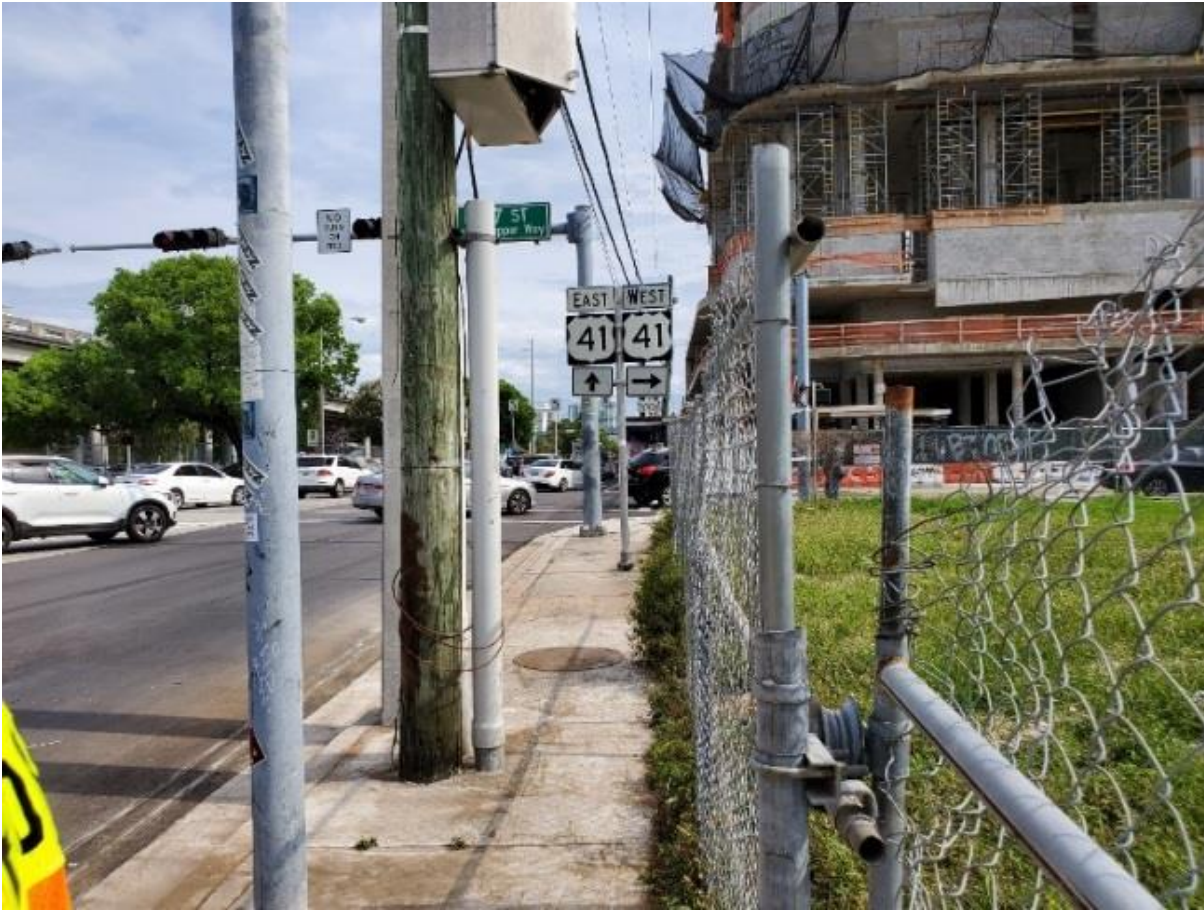
**Location: SW 4<sup>TH</sup> AVENUE AND SW 7<sup>TH</sup> STREET INTERSECTION****Issue #13: Obstructed Sidewalk**

The sidewalk on the southbound approach to SW 4<sup>th</sup> Avenue and SW 7<sup>th</sup> Street is obstructed.

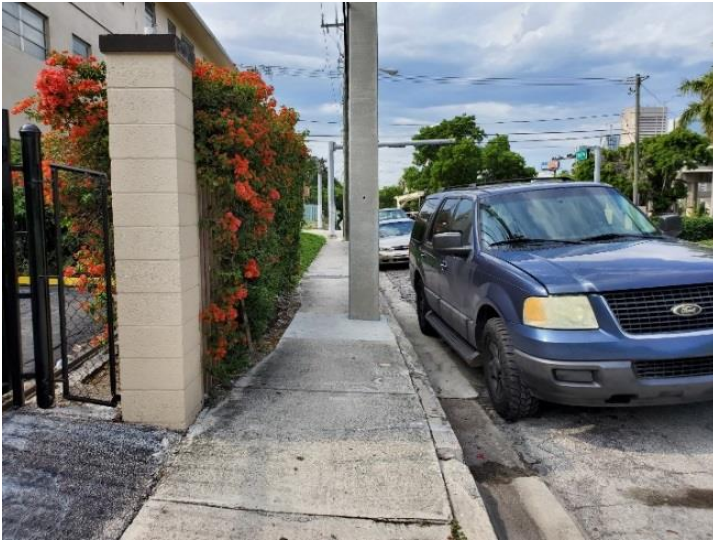
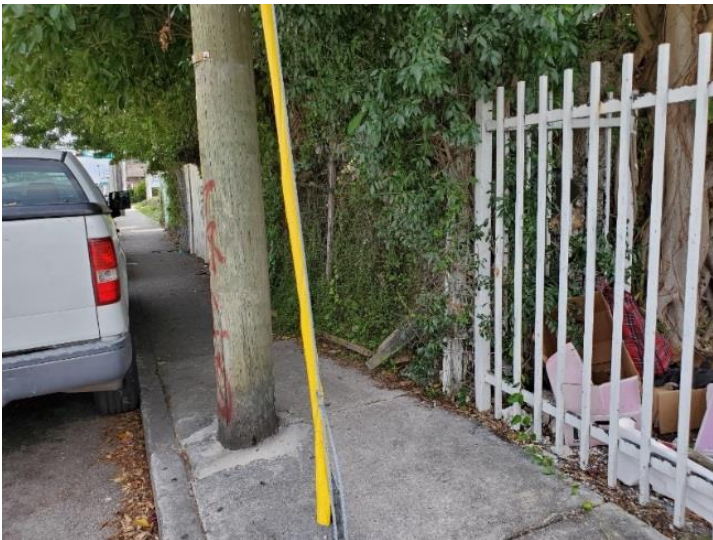
**Location: SW 4<sup>TH</sup> AVENUE AND SW 6<sup>TH</sup> STREET INTERSECTION****Issue #14: Obstructed Sidewalk**

The sidewalk on the west side of SW 4<sup>th</sup> Avenue is obstructed by overgrown vegetation. In addition, a concrete pole on the west side of SW 4<sup>th</sup> Avenue on the south leg is also obstructing the sidewalk.

- Short-Term or Maintenance Project –  
Vegetation adjacent to the sidewalk should be properly maintained; may require code enforcement on private property.
- Long-Term Project –  
Conduct a study to determine if relocating the utility pole would be feasible and/or if widening the sidewalk is possible. Additional right-of-way may be required.

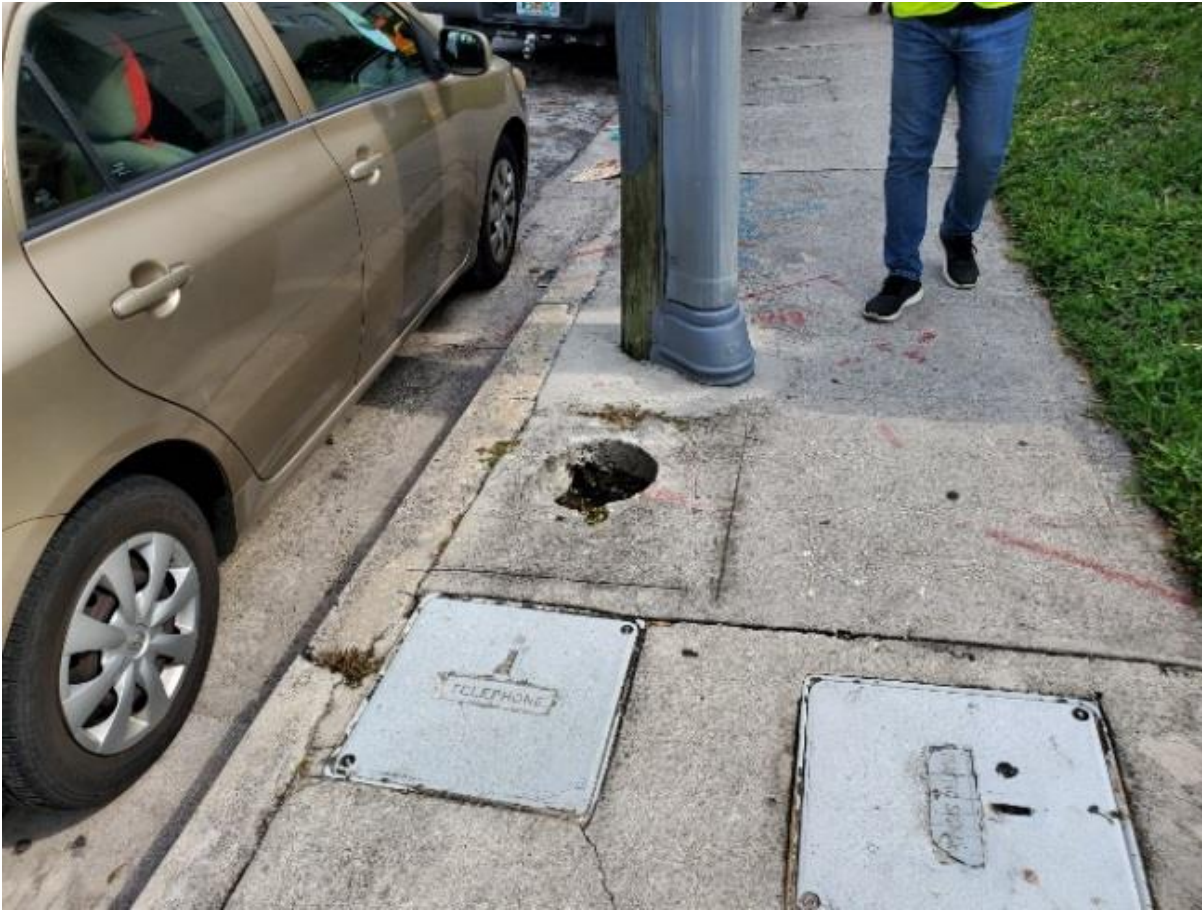
**Location: SW 4<sup>TH</sup> AVENUE AND SW 6<sup>TH</sup> STREET INTERSECTION****Issue #15: Utility Hole in Sidewalk**

There is an uncovered utility access hole in the sidewalk on the southwest corner of the intersection.

- Short-Term or Maintenance Project – Consider covering the utility hole.

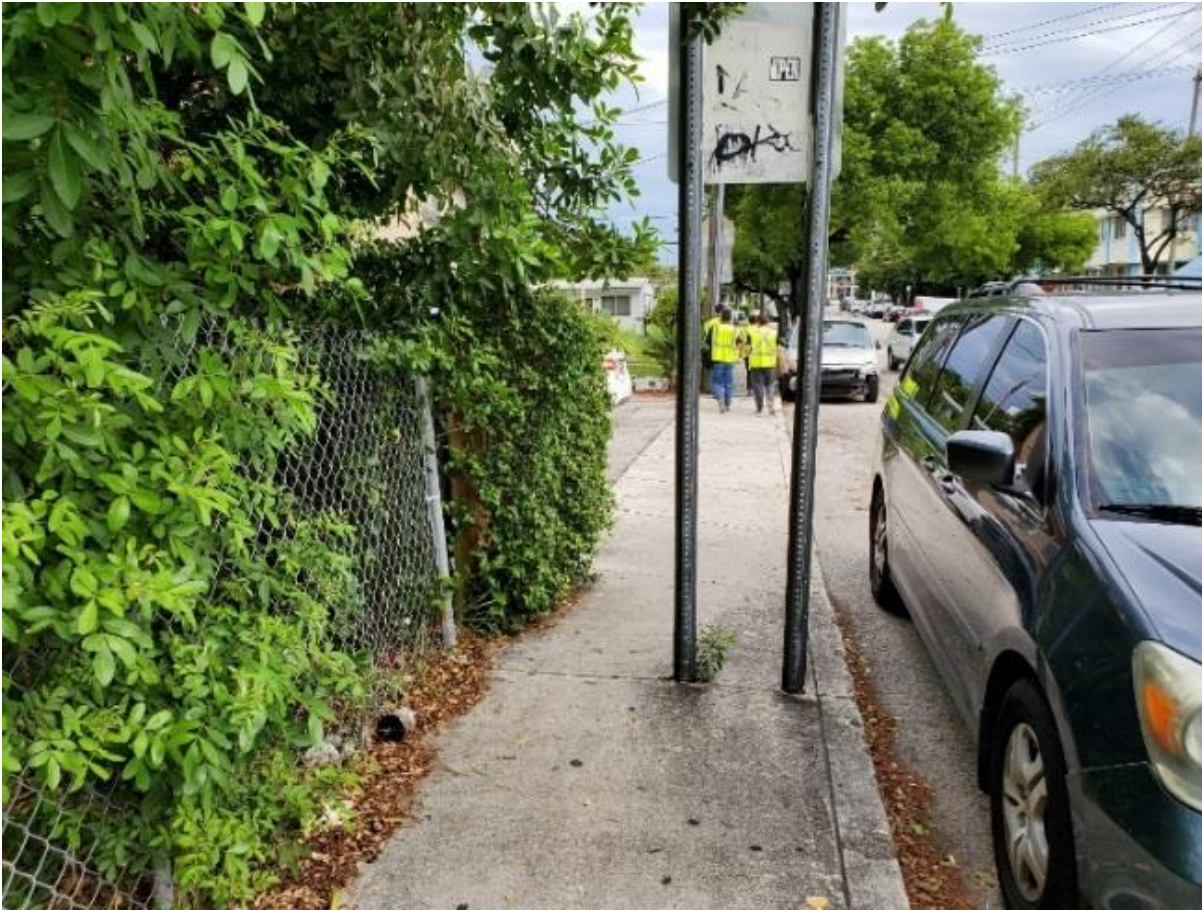
**Location: SW 4<sup>TH</sup> AVENUE AND SW 5<sup>TH</sup> STREET INTERSECTION****Issue #16: Obstructed Sidewalk**

The sidewalk is obstructed by overgrown vegetation and a School Zone speed limit sign.

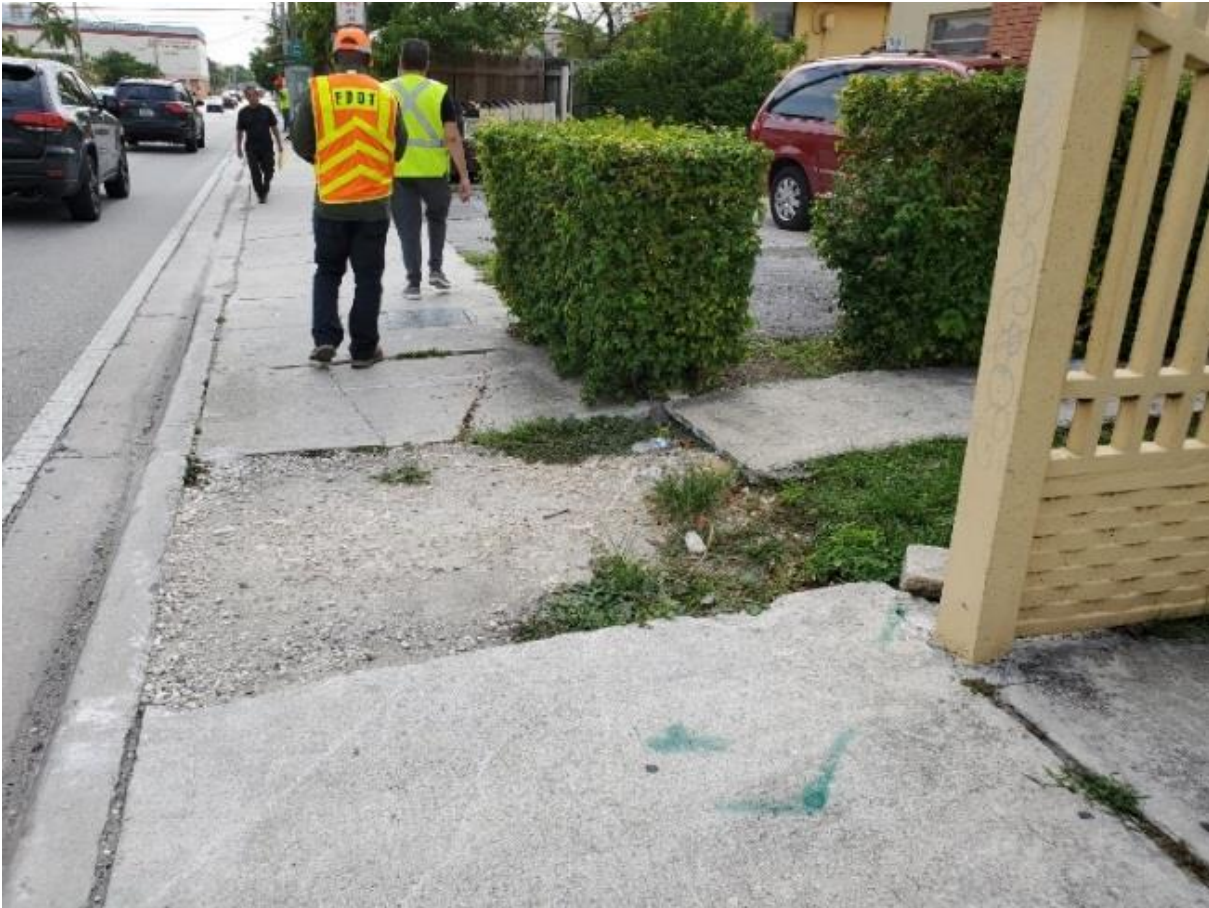
**Location: SW 7<sup>TH</sup> STREET AND SW 5<sup>TH</sup> AVENUE INTERSECTION****Issue #17: Damaged Sidewalk**

The north side sidewalk of SW 7<sup>th</sup> Street on the east leg of the intersection is damaged and affects the connecting walkway to the multi-family residences in the area. The damaged sidewalk is located near 437 SW 7<sup>th</sup> Street.

- Short-Term or Maintenance Project – Repair the sidewalk.

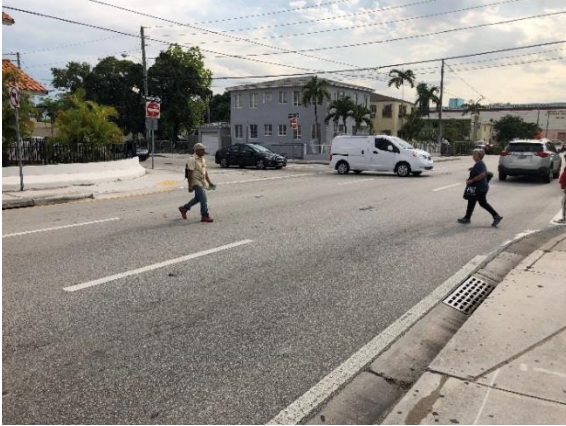
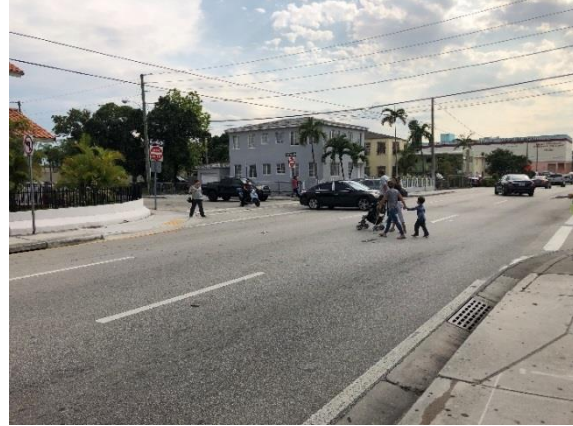
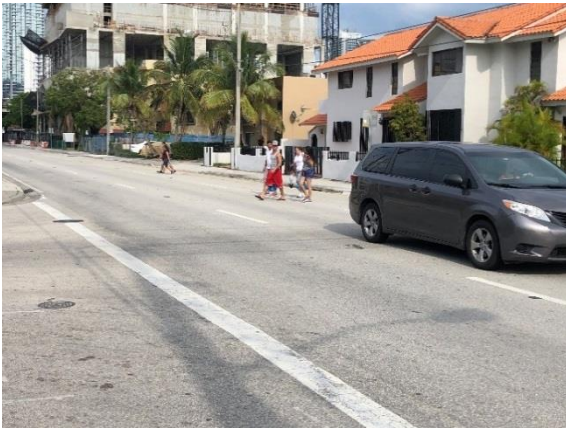
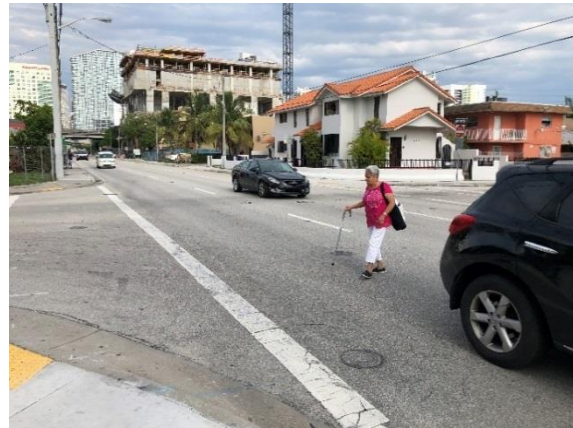
**Location: SW 7<sup>TH</sup> STREET AND SW 5<sup>TH</sup> AVENUE INTERSECTION****Issue #18: North/South Pedestrian Crossings on SW 7<sup>th</sup> Street from SW 4<sup>th</sup> Avenue to SW 8<sup>th</sup> Avenue**

Pedestrians were observed crossing SW 7<sup>th</sup> Street, particularly near transit stops. There are no marked north/south pedestrian crossings across SW 7<sup>th</sup> Street between SW 4<sup>th</sup> Avenue and SW 8<sup>th</sup> Avenue.

- Long-Term Project –  
Conduct a study to evaluate the need for a designated mid-block pedestrian crossing within the study area.

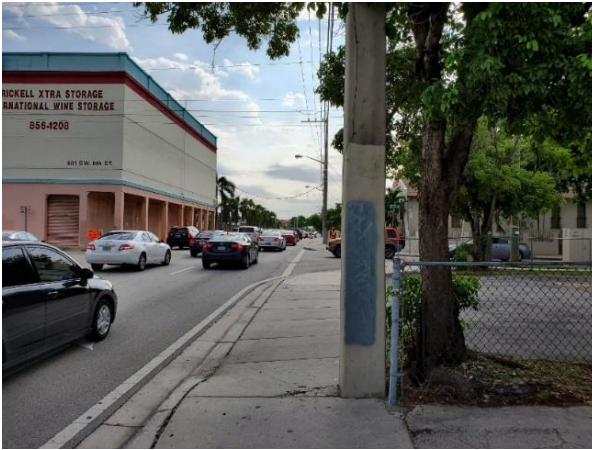
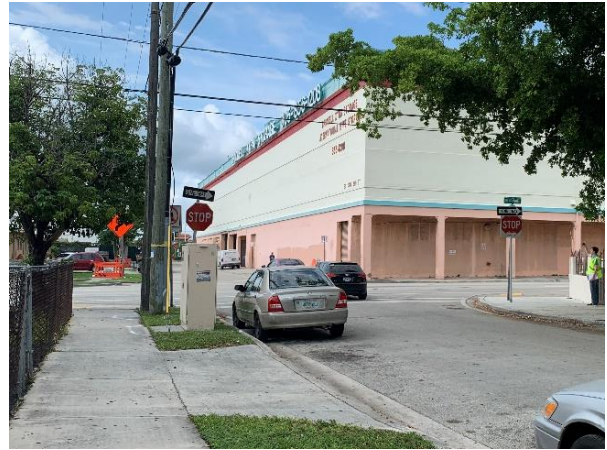
**Location: SW 7<sup>TH</sup> STREET AND SW 6<sup>TH</sup> AVENUE INTERSECTION****Issue #19: Regulatory signs for one-way street streets**

It was observed that a limited number of regulatory signs were provided at the unsignalized intersection of SW 7<sup>th</sup> Street and SW 6<sup>th</sup> Avenue to alert drivers of one-way roadway conditions. SW 7<sup>th</sup> Street is a one-way roadway with westbound traffic and SW 6<sup>th</sup> Avenue is a one-way roadway with southbound traffic. SW 7<sup>th</sup> Street is a high volume and higher speed roadway based on field observations. There are no signs on SW 7<sup>th</sup> Street to indicate SW 6<sup>th</sup> Avenue is a one-way street.

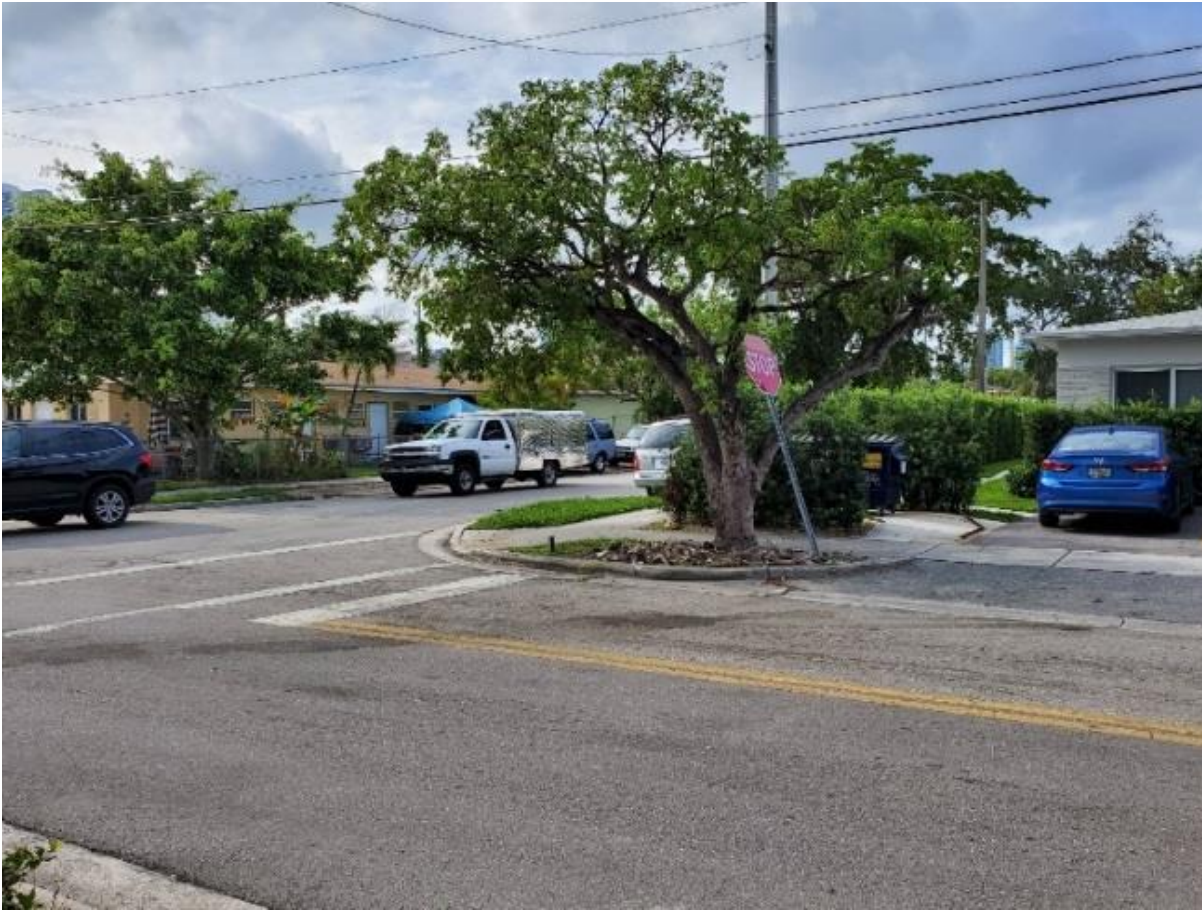
**Location: SW 9<sup>TH</sup> STREET AND SW 5<sup>TH</sup> AVENUE INTERSECTION****Issue #20: Damaged Sign**

Stop sign on the southwest corner of the intersection has been hit and is bent in the direction away from oncoming motorists on SW 9<sup>th</sup> Street.

- Short-Term or Maintenance Project – Replace sign pole.

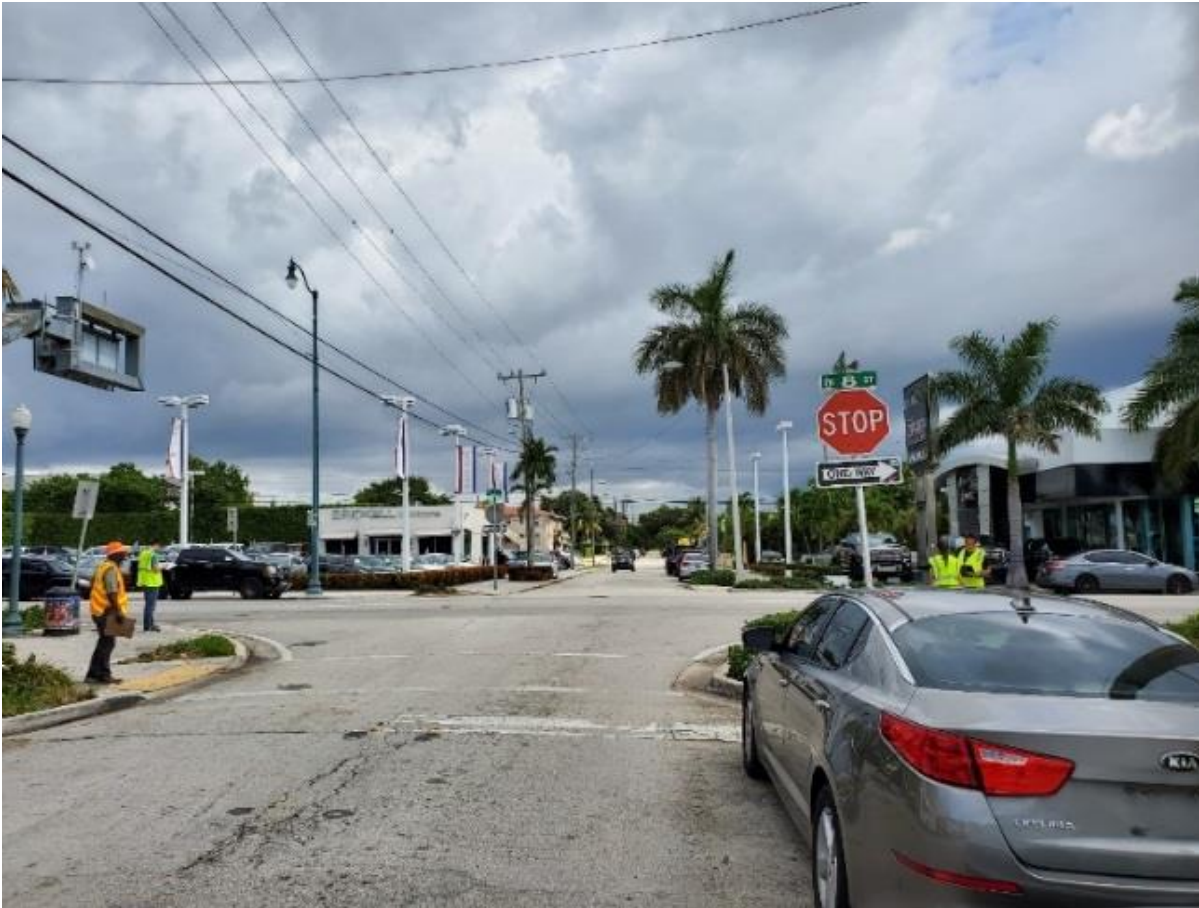
**Location: SW 8<sup>TH</sup> STREET AND SW 7<sup>TH</sup> AVENUE INTERSECTION****Issue #21: Regulatory signs for one-way street streets**

It was observed that a limited number of regulatory signs were provided at the unsignalized intersection SW 7<sup>th</sup> Avenue and SW 8<sup>th</sup> Street to alert drivers of one-way roadway conditions. SW 8<sup>th</sup> Street is a one-way roadway with eastbound traffic.

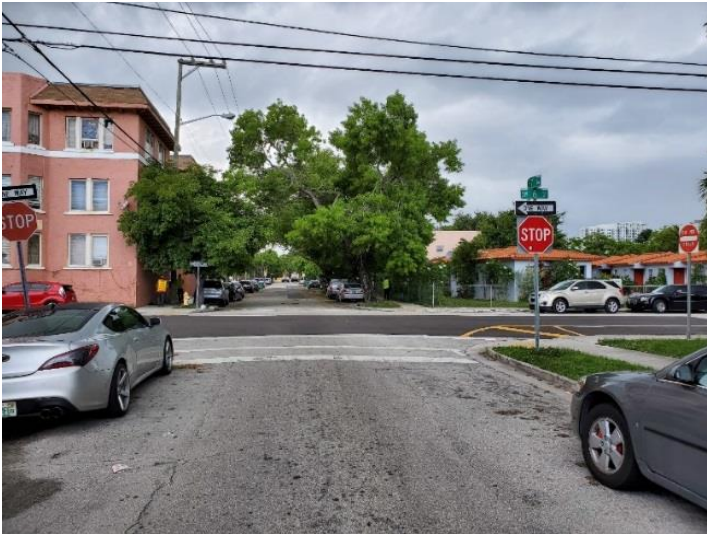
**Location: SW 6<sup>TH</sup> STREET AND SW 7<sup>TH</sup> AVENUE INTERSECTION****Issue #22: Regulatory signs for one-way street streets**

It was observed that a limited number of regulatory signs were provided at the unsignalized intersection of SW 6<sup>th</sup> Street and SW 7<sup>th</sup> Avenue to alert drivers of one-way roadway conditions. SW 6<sup>th</sup> Street is a one-way roadway with westbound traffic and SW 7<sup>th</sup> Avenue is a one-way roadway with northbound traffic.

- Short-Term or Maintenance Project –  
Install No Right Turn sign (R3-1) facing northbound traffic on SW 7<sup>th</sup> Avenue in conjunction with the Stop sign located on the near right-hand corner according to MUTCD Section 2B.18.03.  
Install One-Way signs (R6-1) on the far-left corner of the intersection facing northbound traffic on SW 7<sup>th</sup> Avenue according to the MUTCD Section 2B.40.07. The existing sign on the far-left corner or northwest corner of the intersection is facing the wrong way or southbound traffic.

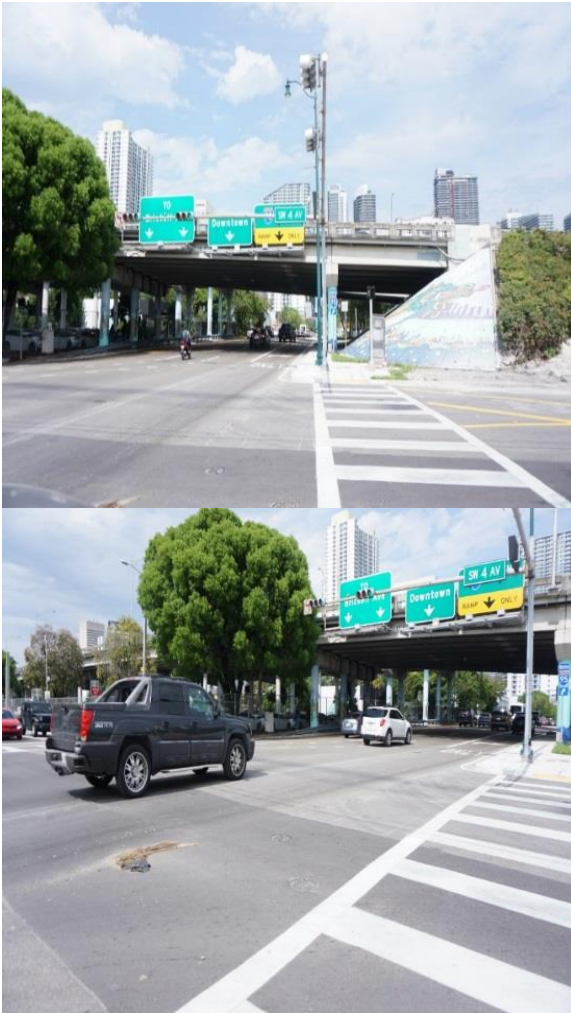
**Location: SW 4<sup>TH</sup> AVENUE AND SW 8<sup>TH</sup> STREET INTERSECTION****Issue #23: Traffic Conflict**

The north leg lane configuration at SW 4<sup>th</sup> Avenue and SW 8<sup>th</sup> Street includes three exclusive left-turn lanes and a single through lane. Some southbound drivers on the exclusive left-turn lanes driving on this intersection leg (from the I-95 southbound off-ramp) were observed to forcefully merge with the southbound through traffic. About half of the receiving area on the south leg of the intersection has chevron pavement markings restricting southbound vehicle travel path. Southbound traffic in the exclusive left-turn lane adjacent to the through lane was observed continuing southbound through the intersection and traversing through the chevron pavement markings.

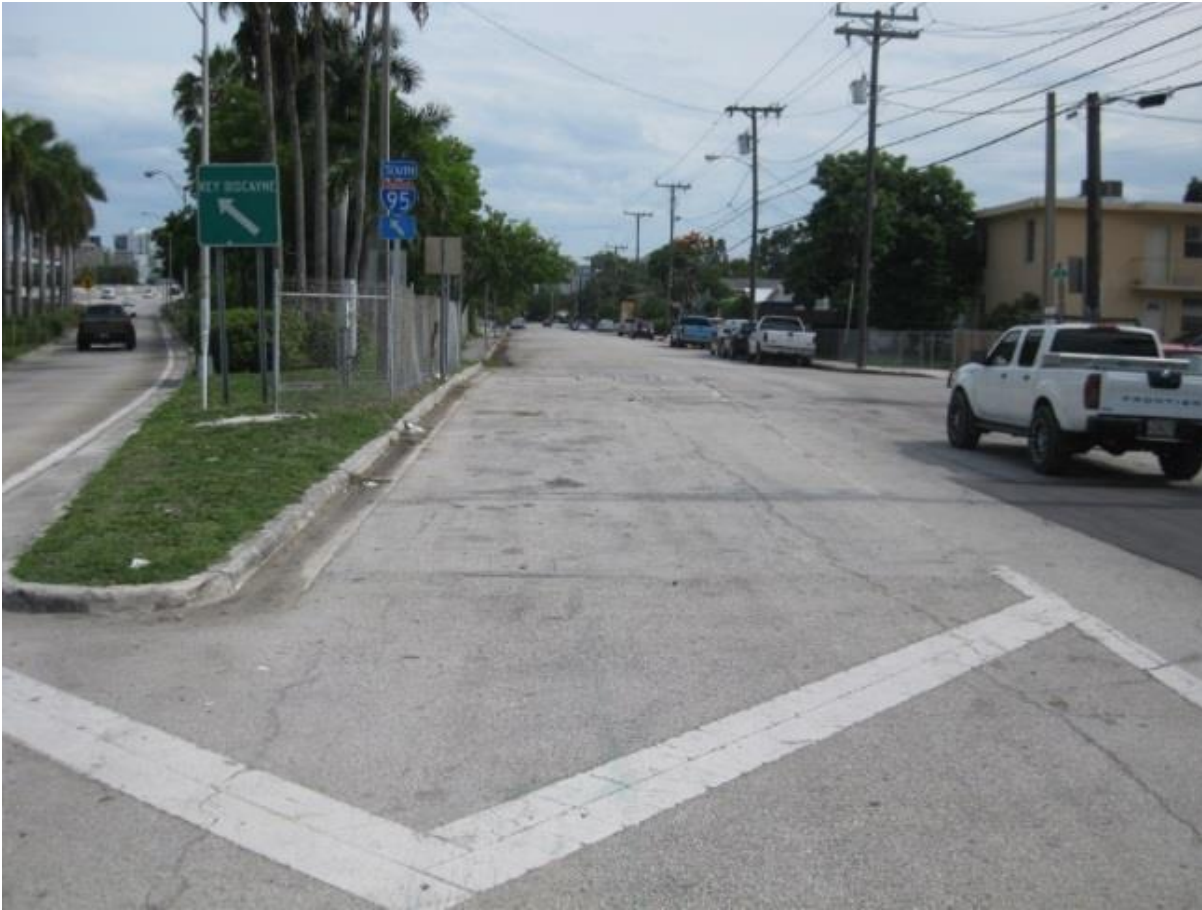
**Location: SW 4<sup>TH</sup> AVENUE AND I-95 SOUTHBOUND ON-RAMP****Issue #24: Roadway Improvement**

The painted gore chevron markings and lane markings do not extend beyond the physical gore by the I-95 on-ramp just south of SW 4<sup>th</sup> Avenue.
