# SENIOR LIVING FACILITIES ROAD SAFETY AUDIT

## WORK ORDER # GPC VII-02

OCTOBER  
2019

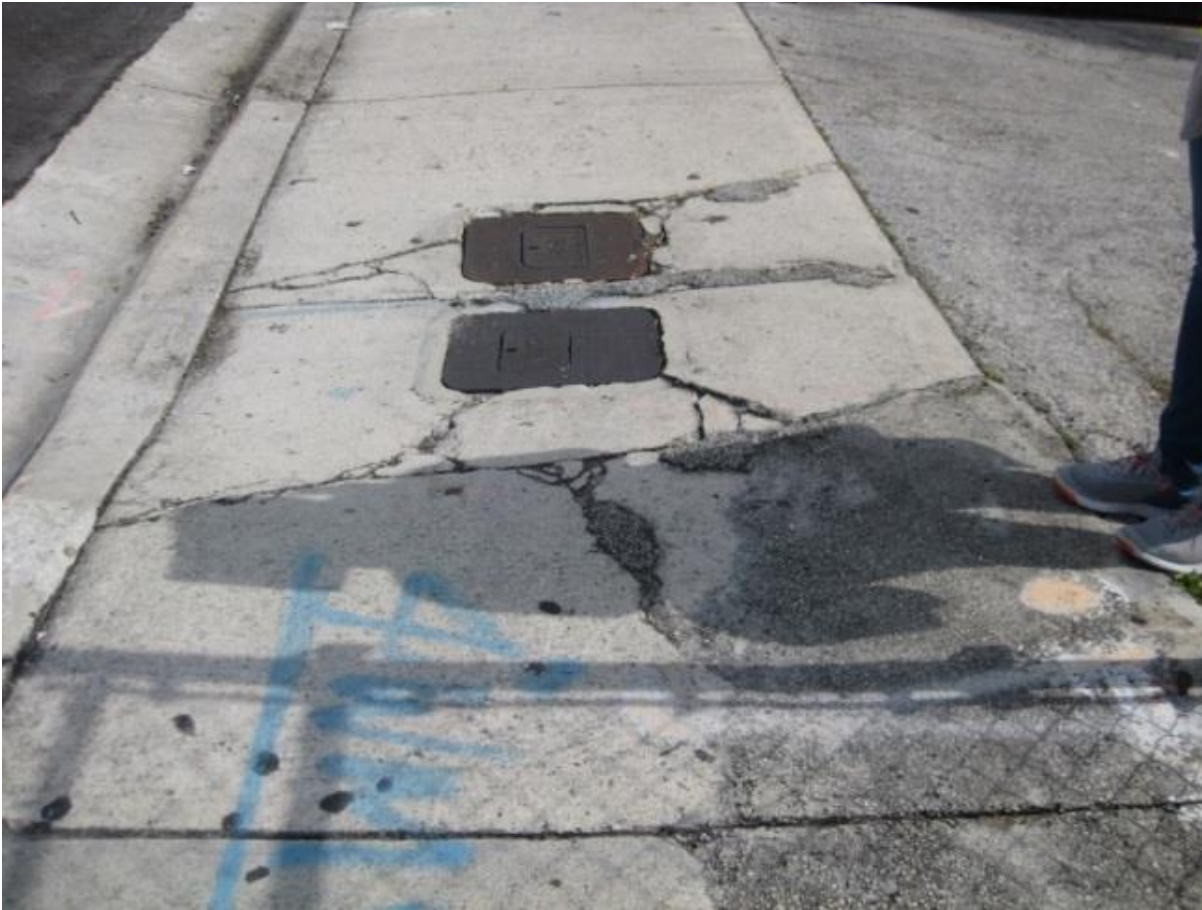
**Issue #25: Pedestrian Facility**

The sidewalk is cracked and depressed utility lids are present.

- Short-Term or Maintenance Project –  
Repair the sidewalk and replace the utility lids.

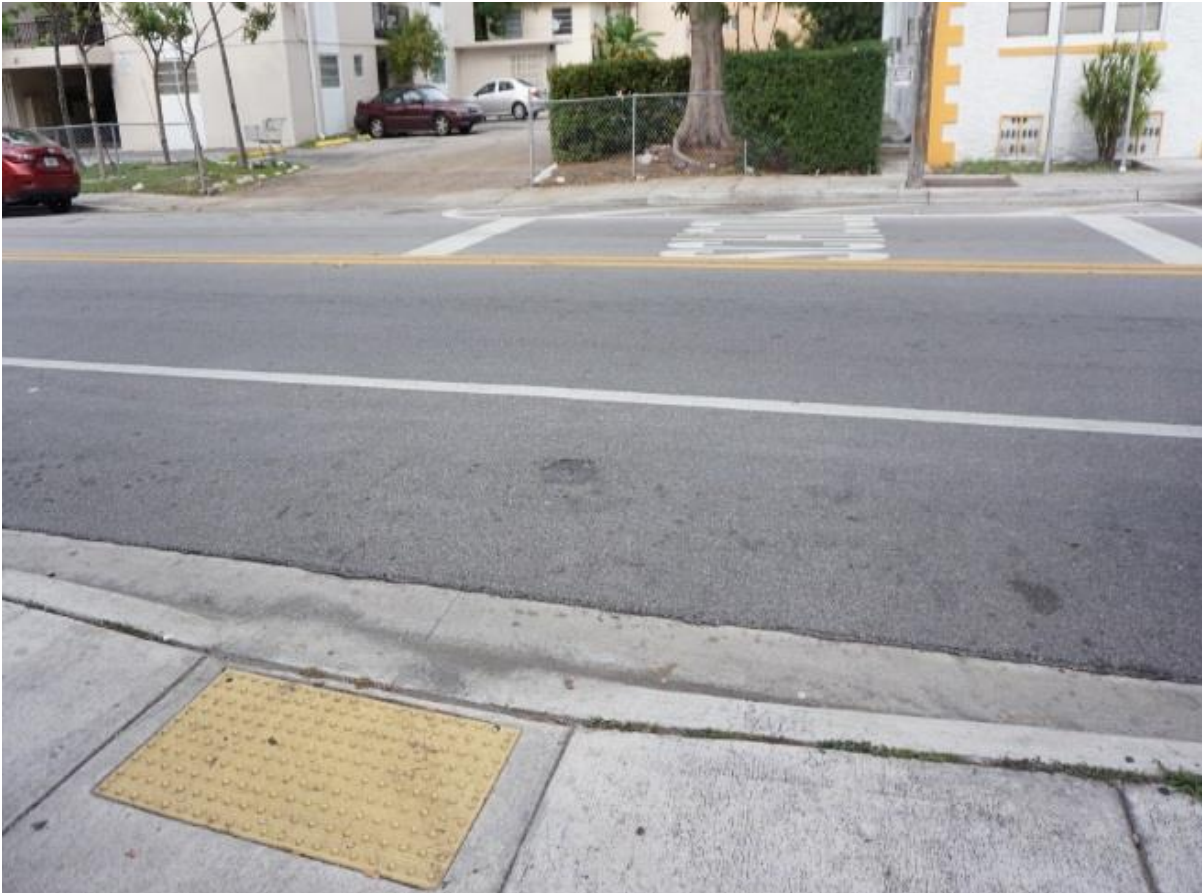
**Issue #26: Curb Ramp**

There is a curb ramp on the west side of SW 8<sup>th</sup> Avenue, south of SW 4<sup>th</sup> Street that does not lead to a crosswalk.

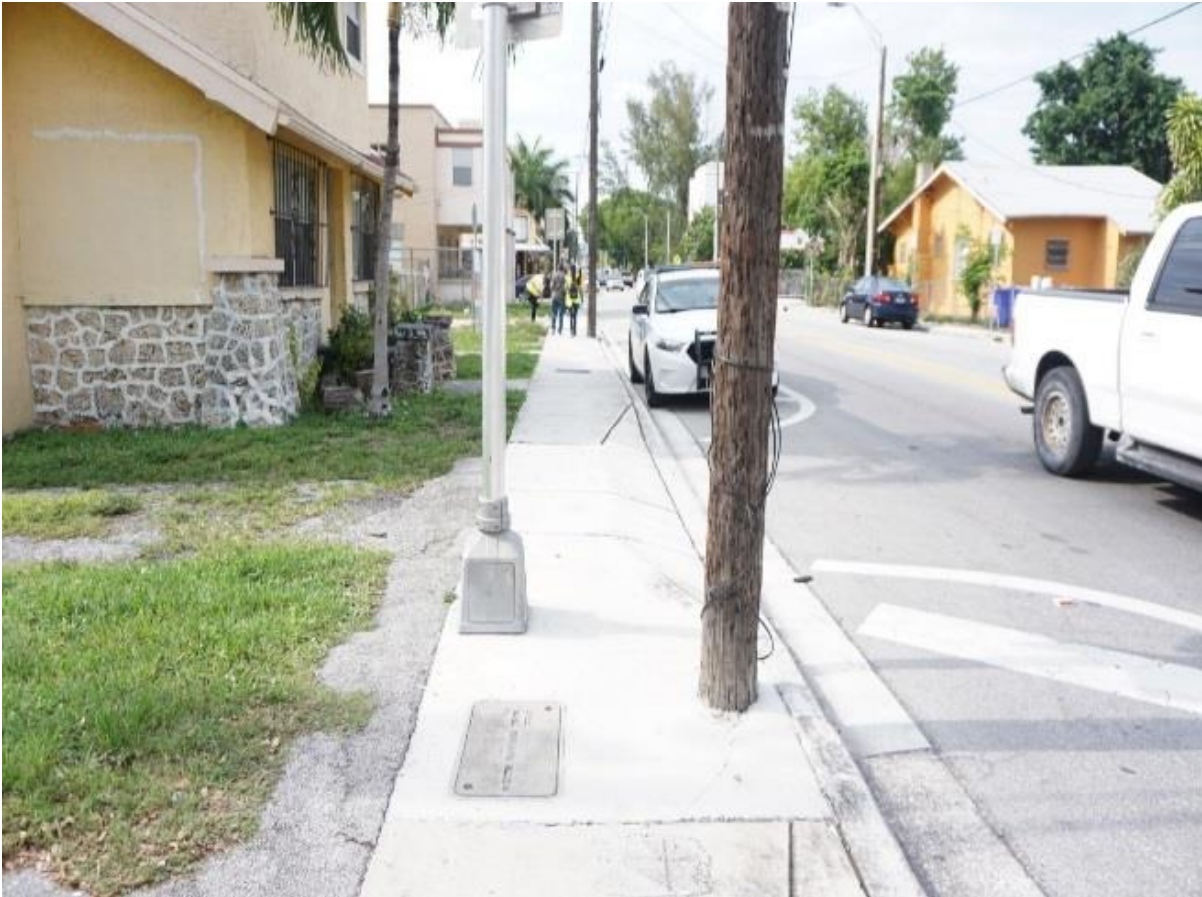
**Issue #27: Obstructed Sidewalk**

The west side sidewalk on SW 8<sup>th</sup> Avenue between SW 5<sup>th</sup> Street and 6<sup>th</sup> Street is obstructed by a utility pole and warning sign pole with flashing beacons.

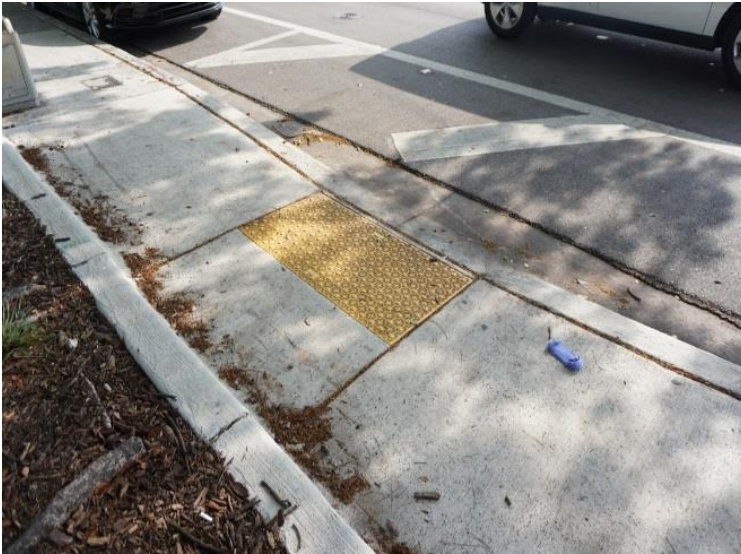
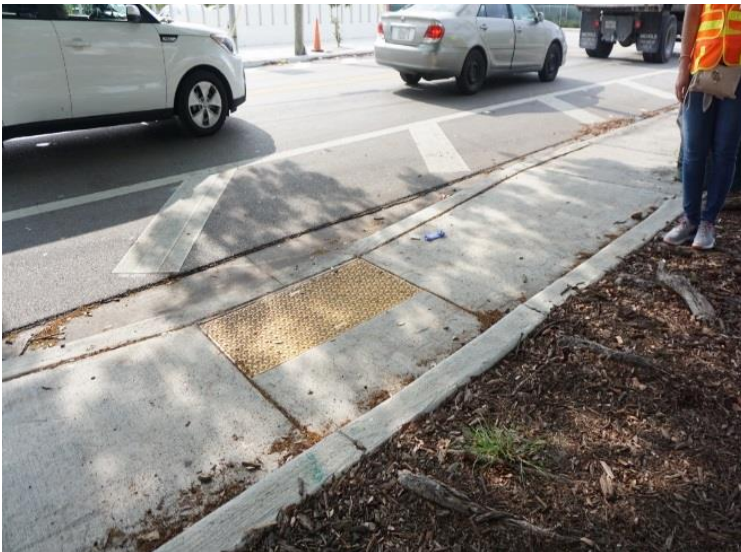
**Issue #28: Curb Ramp**

There is a curb ramp on the east side of SW 8<sup>th</sup> Avenue, south of SW 7<sup>th</sup> Street that does not lead to a crosswalk.

- Near-Term Project –  
Remove curb ramp or conduct study to determine if the crossing should be installed.

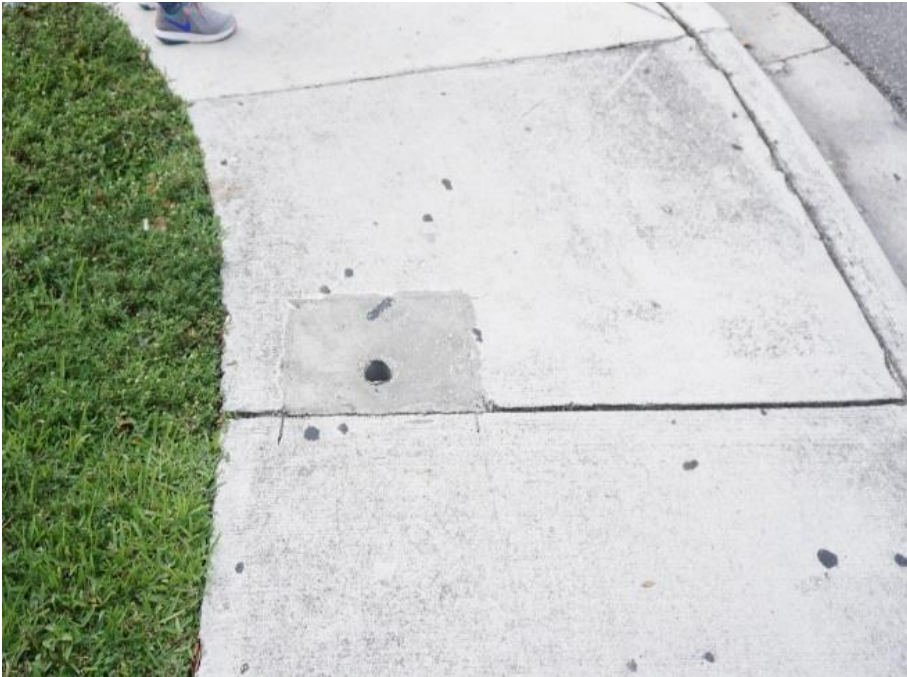
**Location: SW 8<sup>TH</sup> AVENUE AND SW 5<sup>TH</sup> STREET INTERSECTION****Issue #29: Hole in Sidewalk**

There is an exposed sign pole hole in ground on the southwest corner of the intersection.

- Short-Term or Maintenance Project –  
Coordinate with the maintenance agency to determine if a sign is missing. Otherwise, consider filling if the hole in the sidewalk.

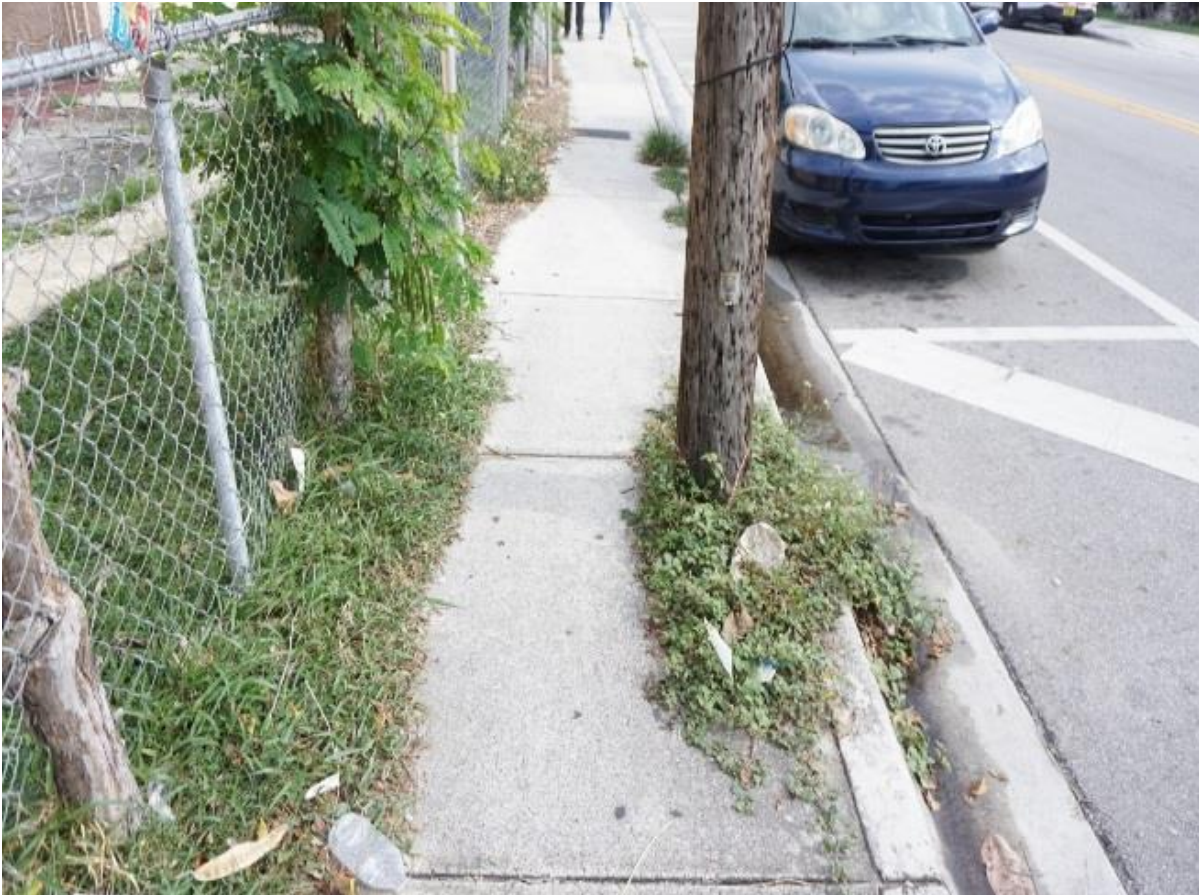
**Location: SW 8<sup>TH</sup> AVENUE AND SW 5<sup>TH</sup> STREET INTERSECTION****Issue #30: Sidewalk Access**

The sidewalk on the southeast corner of the intersection is obstructed by overgrown vegetation and a utility pole.

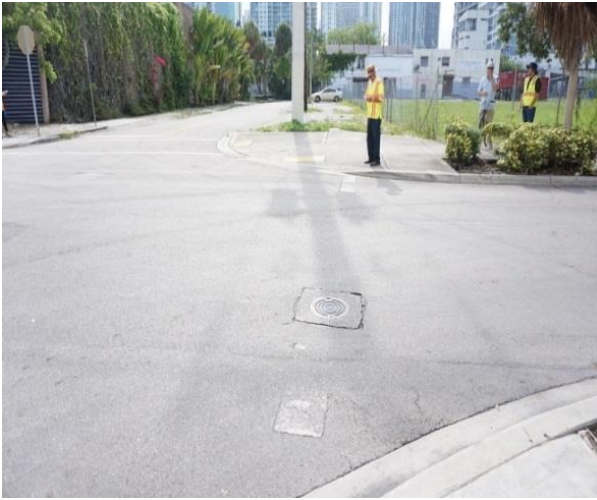
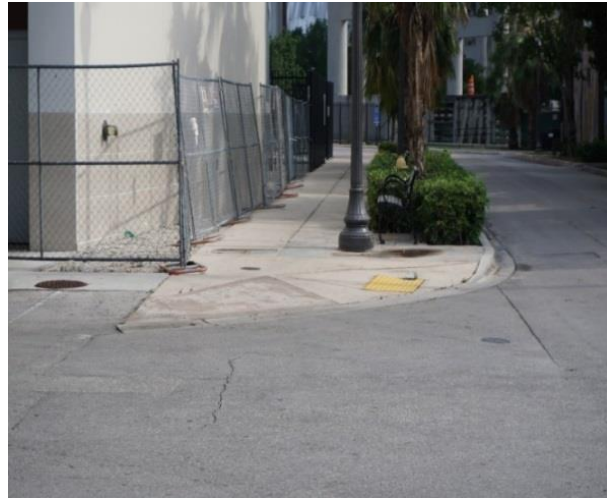
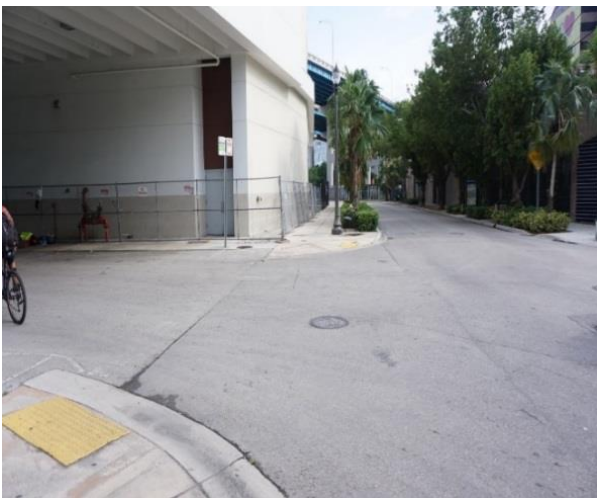
**Location: SW 3<sup>RD</sup> AVENUE AND SW 5<sup>TH</sup> STREET INTERSECTION****Issue #31: Pedestrian Crossing**

Faded crosswalk striping on the west leg of the intersection. The intersection is missing a truncated dome surface on the northwest corner of the intersection – north/south crosswalk.

- Short-Term or Maintenance Project – Restripe crosswalk and install truncated dome surface to the northwest corner.

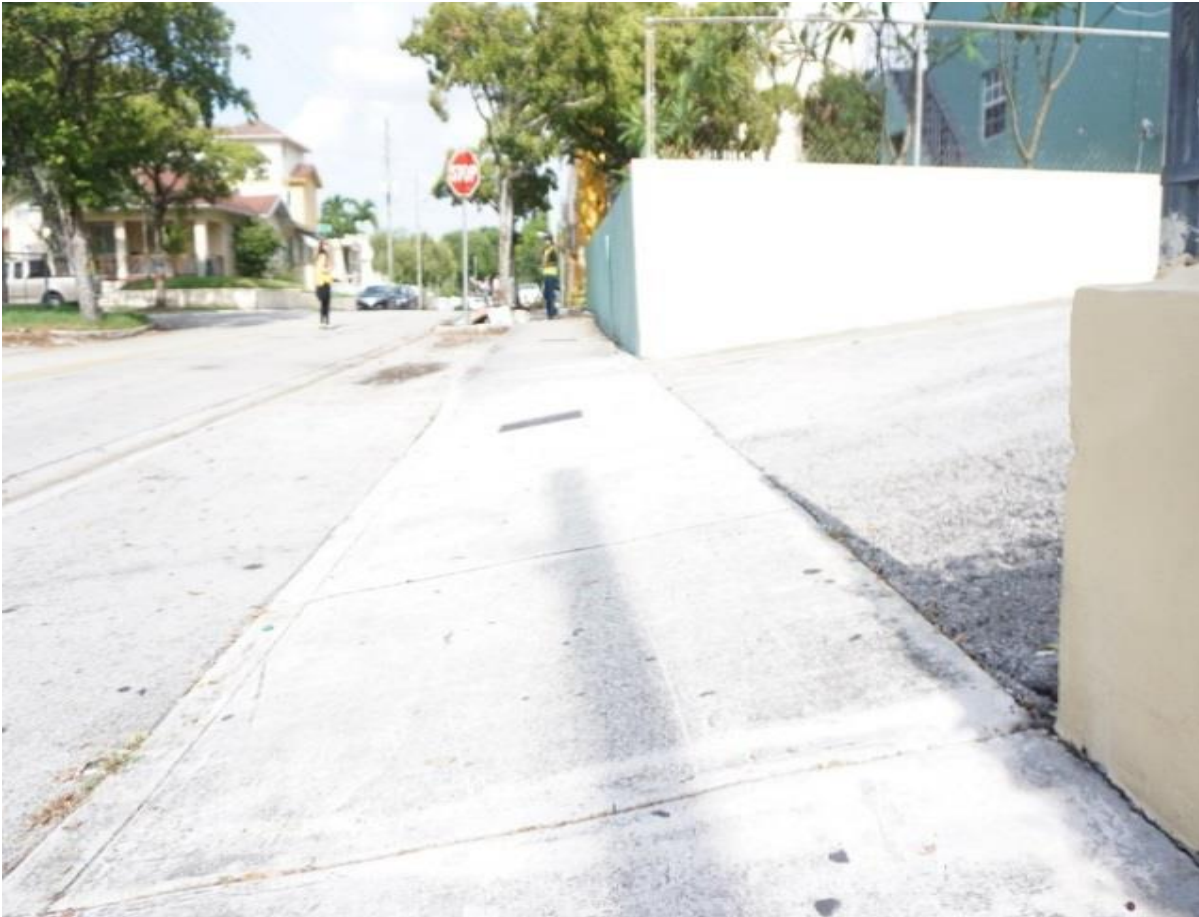
**Location: SW 5<sup>TH</sup> AVENUE AND SW 5<sup>TH</sup> STREET INTERSECTION****Issue #32: Sloped Sidewalk**

The cross slope of the sidewalks across the driveway is steep. Shown in the picture above is the north side of SW 5<sup>th</sup> Avenue just east on SW 5<sup>th</sup> Street as an example of the issue in the area.

- Near-Term/Long-Term Project –  
Conduct a study to determine if driveway/sidewalk slope issues may be improved by reconstruction or relocation of the driveway. If driveways cannot be relocated on private property, it may be necessary to provide an easement or purchase right of way to provide a flat surface sidewalk between driveways and private property.

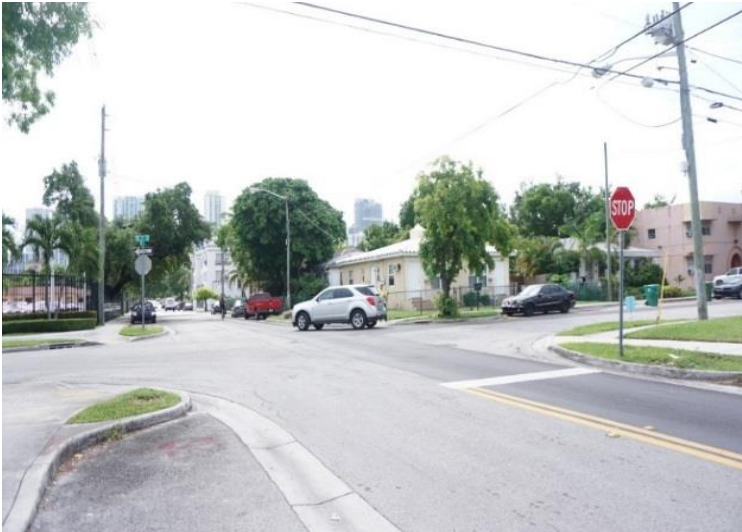
**Location: SW 7<sup>TH</sup> AVENUE AND SW 5<sup>TH</sup> STREET INTERSECTION****Issue #33: One-Way Sign**

It was observed that a limited number of regulatory signs were provided at the unsignalized intersection SW 7<sup>th</sup> Avenue and SW 5<sup>th</sup> Street to alert drivers of one-way roadway conditions. SW 7<sup>th</sup> Avenue is a one-way roadway with northbound traffic.

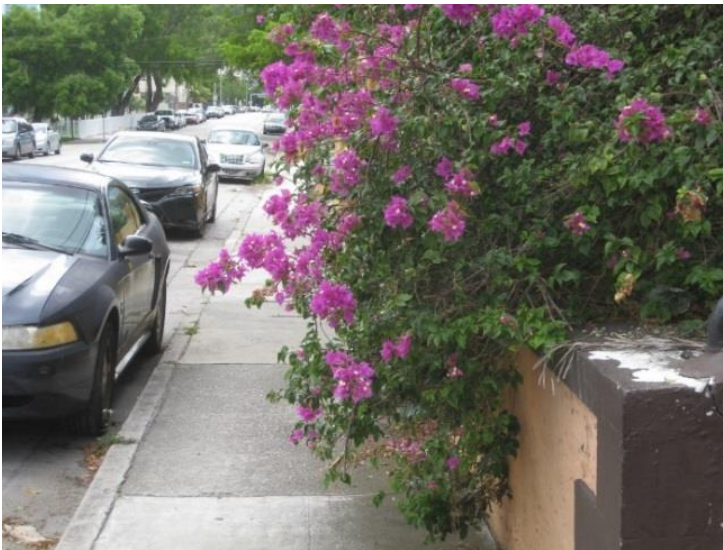
**Location: SW 6<sup>TH</sup> COURT AND SW 6<sup>TH</sup> STREET****Issue #34: Obstructed Sidewalk**

The sidewalk is obstructed by overgrown vegetation (thorny bougainvillea) on the south side of SW 6<sup>th</sup> Street.

- Short-Term or Maintenance Project –  
Vegetation adjacent to the sidewalk on the south side of SW 6<sup>th</sup> Street should be properly maintained; may require code enforcement on private property.

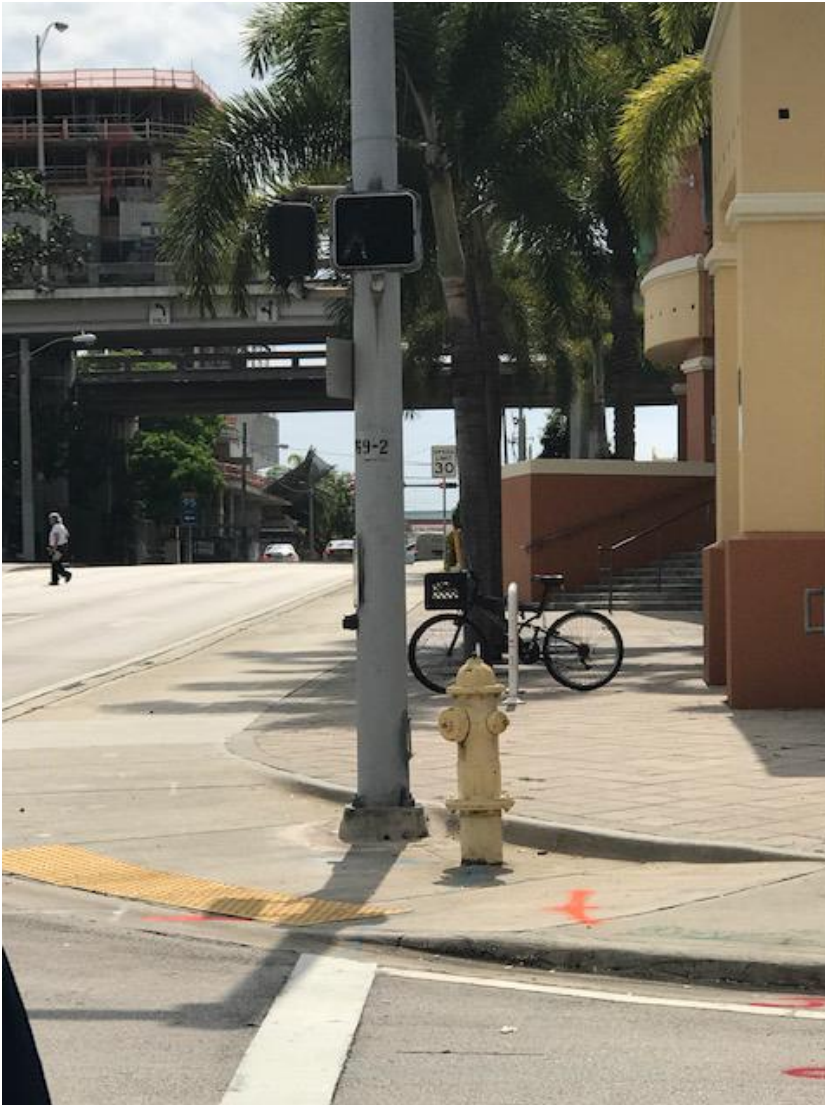
**Location: SW 3<sup>RD</sup> AVENUE AND SW 7<sup>TH</sup> STREET INTERSECTION****Issue #35: Pedestrian Crossing Signal**

The figure displayed on the pedestrian signal on the northwest corner of the intersection facing east is not visible.

- Short-Term or Maintenance Project –  
Replace the pedestrian signal head for proper display.

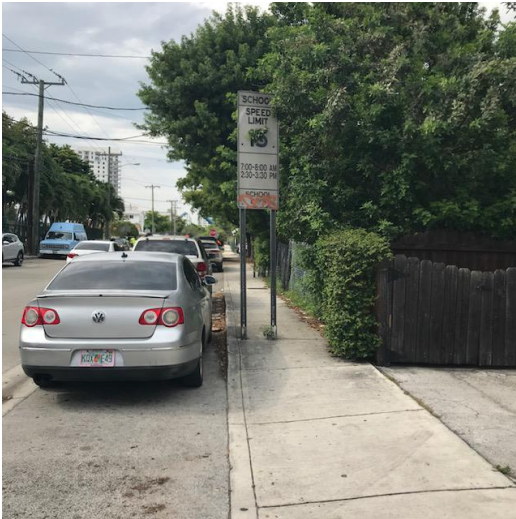
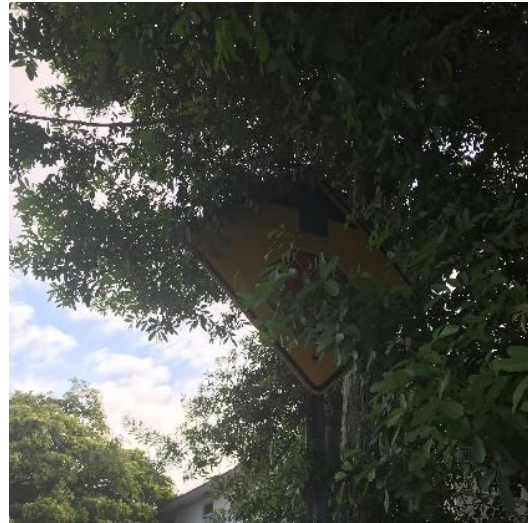
**Location: SW 4<sup>TH</sup> AVENUE BETWEEN SW 4<sup>TH</sup> STREET AND SW 5<sup>TH</sup> STREET INTERSECTION****Issue #36: Speed Limit Sign**

A school speed limit sign facing northbound traffic on the east side of SW 4<sup>th</sup> Avenue between SW 4<sup>th</sup> Street and SW 5<sup>th</sup> Street is blocked by vegetation. The school speed limit sign poles block the sidewalk.

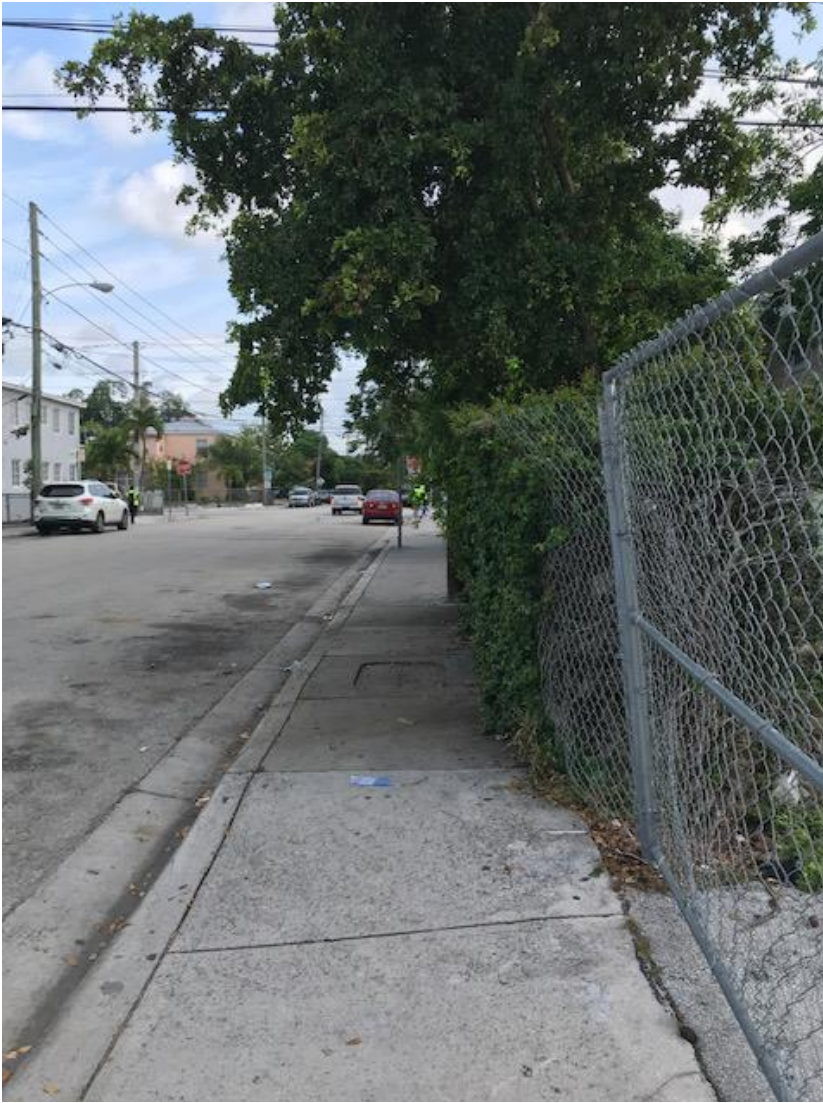
**Issue #37: Sidewalk Obstruction**

The sidewalk on the east side of SW 5<sup>th</sup> Avenue between SW 7<sup>th</sup> Street and SW 8<sup>th</sup> Street is obstructed by overgrown vegetation. In addition, the fence was observed to encroach onto the sidewalk.

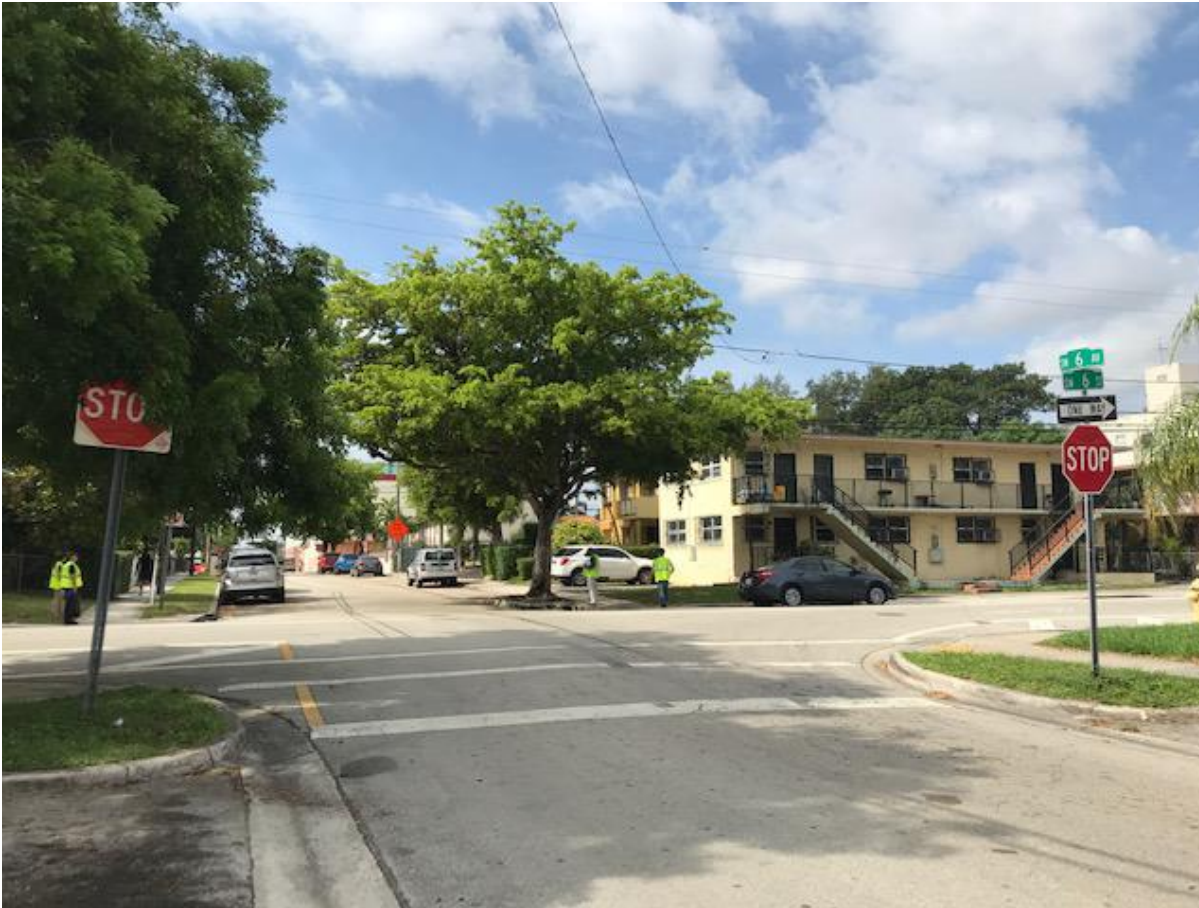
**Location: SW 6<sup>TH</sup> AVENUE AND SW 6<sup>TH</sup> STREET INTERSECTION****Issue #38: Stop Sign Covered by Vegetation**

Additional regulatory signs should be provided at the unsignalized intersection of SW 6<sup>th</sup> Avenue and SW 6<sup>th</sup> Street to alert drivers of one-way roadway conditions. SW 6<sup>th</sup> Avenue is a one-way roadway with southbound traffic and SW 6<sup>th</sup> Street is a one-way roadway with westbound traffic.

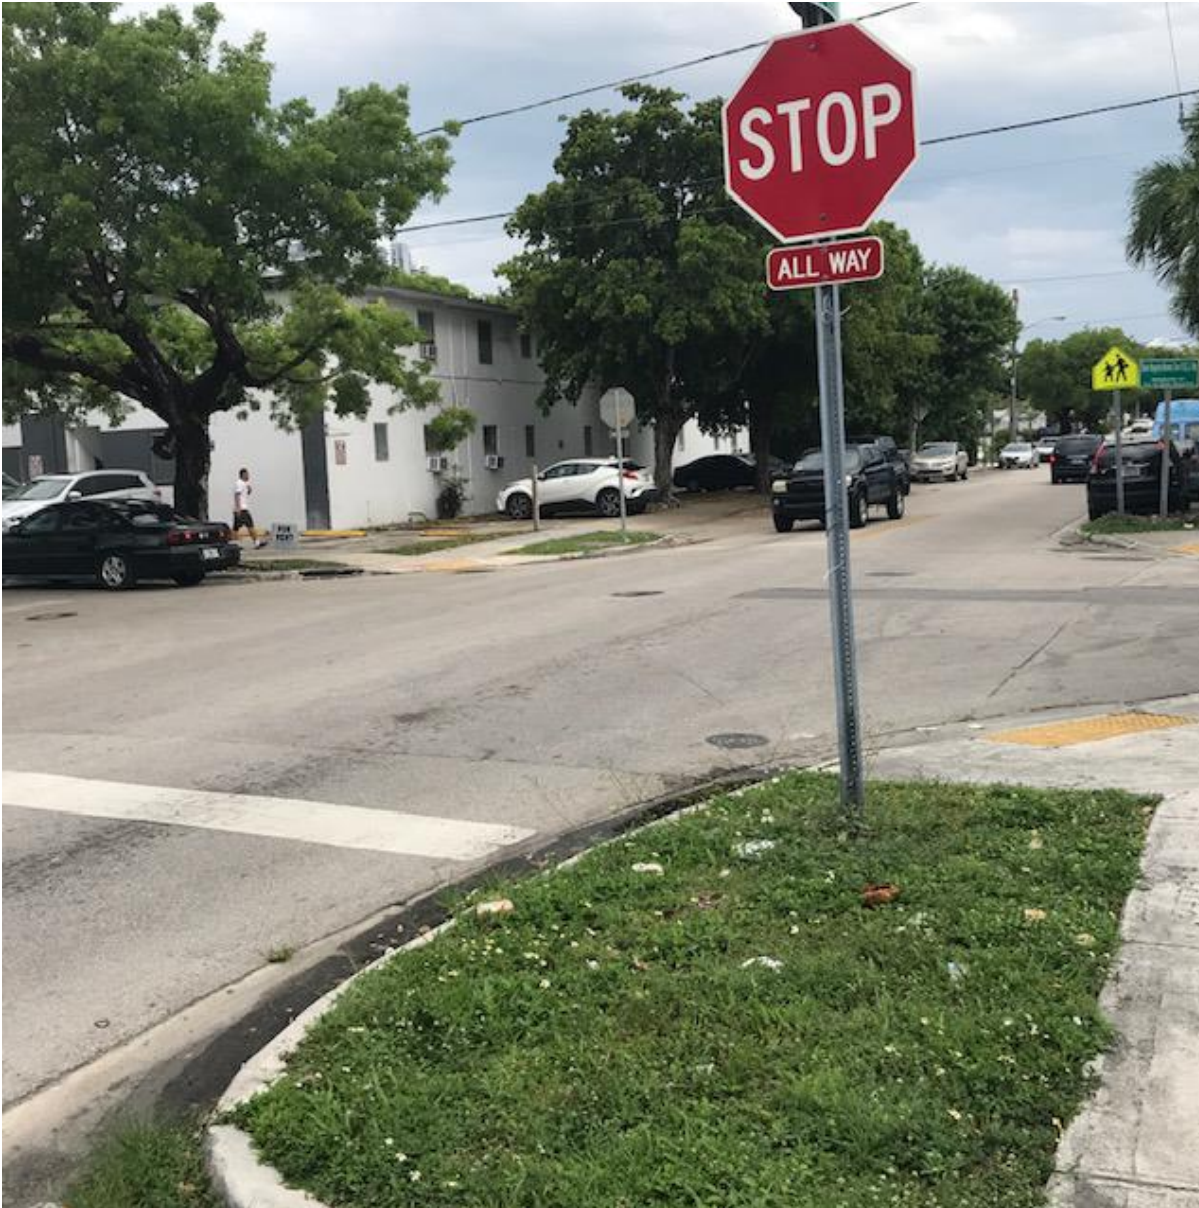
**Location: SW 4<sup>TH</sup> AVENUE AND SW 4<sup>TH</sup> STREET INTERSECTION****Issue #39: Pedestrian Crossing**

Marked crosswalks are missing on all intersection approaches.

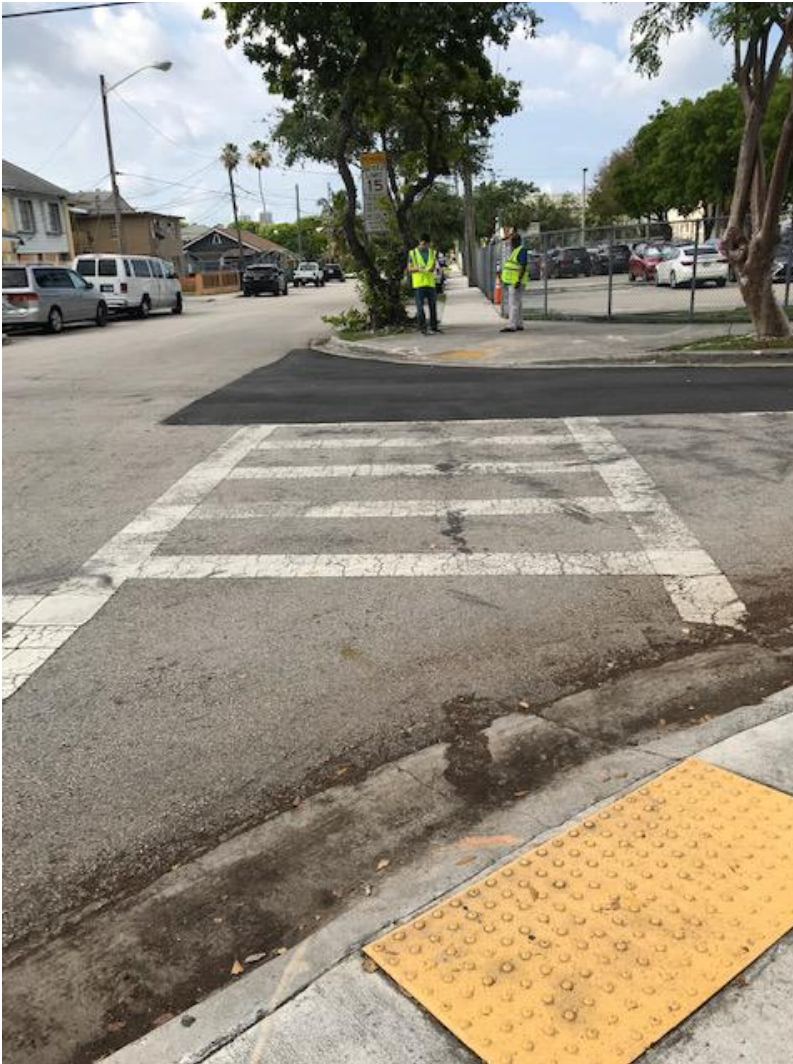
**Location: SW 6<sup>TH</sup> AVENUE AND SW 3<sup>RD</sup> STREET INTERSECTION****Issue #40: Pedestrian Crossing**

Eastbound intersection approach (west leg) has been repaved over the stop bar and crosswalk.

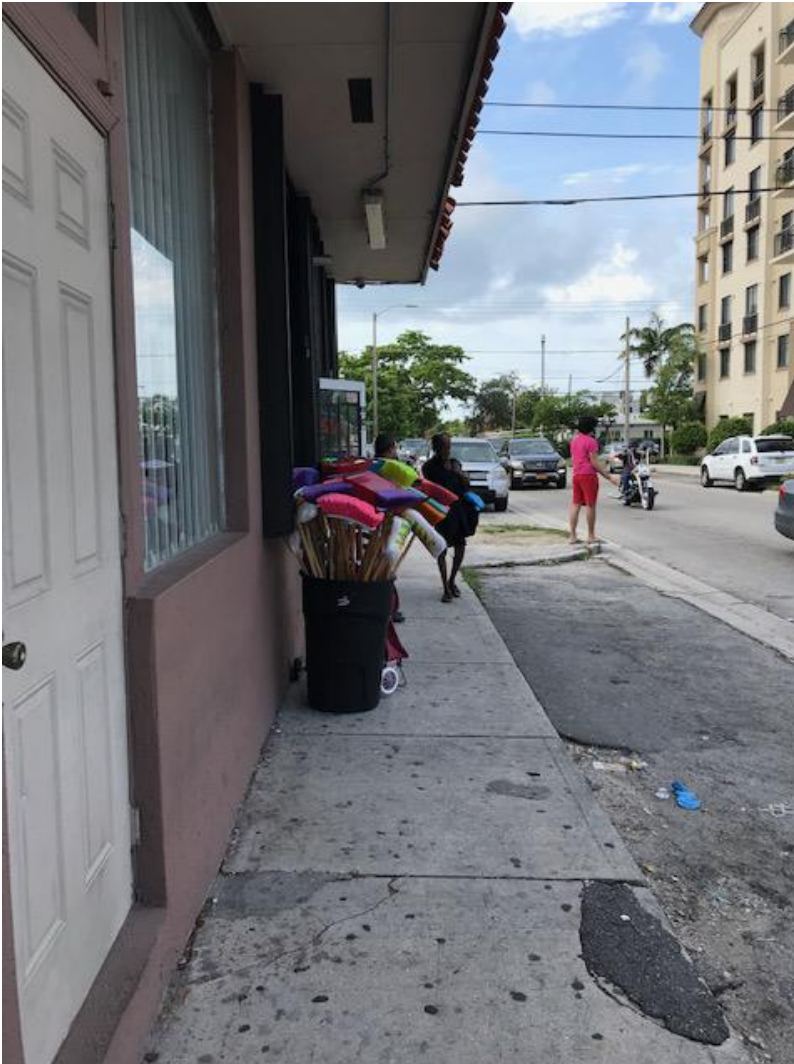
**Issue #41: Sidewalk Obstruction**

Store items are blocking the sidewalk on the east side of SW 5<sup>th</sup> Avenue.

- Short-Term or Maintenance Project –  
Coordinate with the shop owner to remove items from the sidewalk.

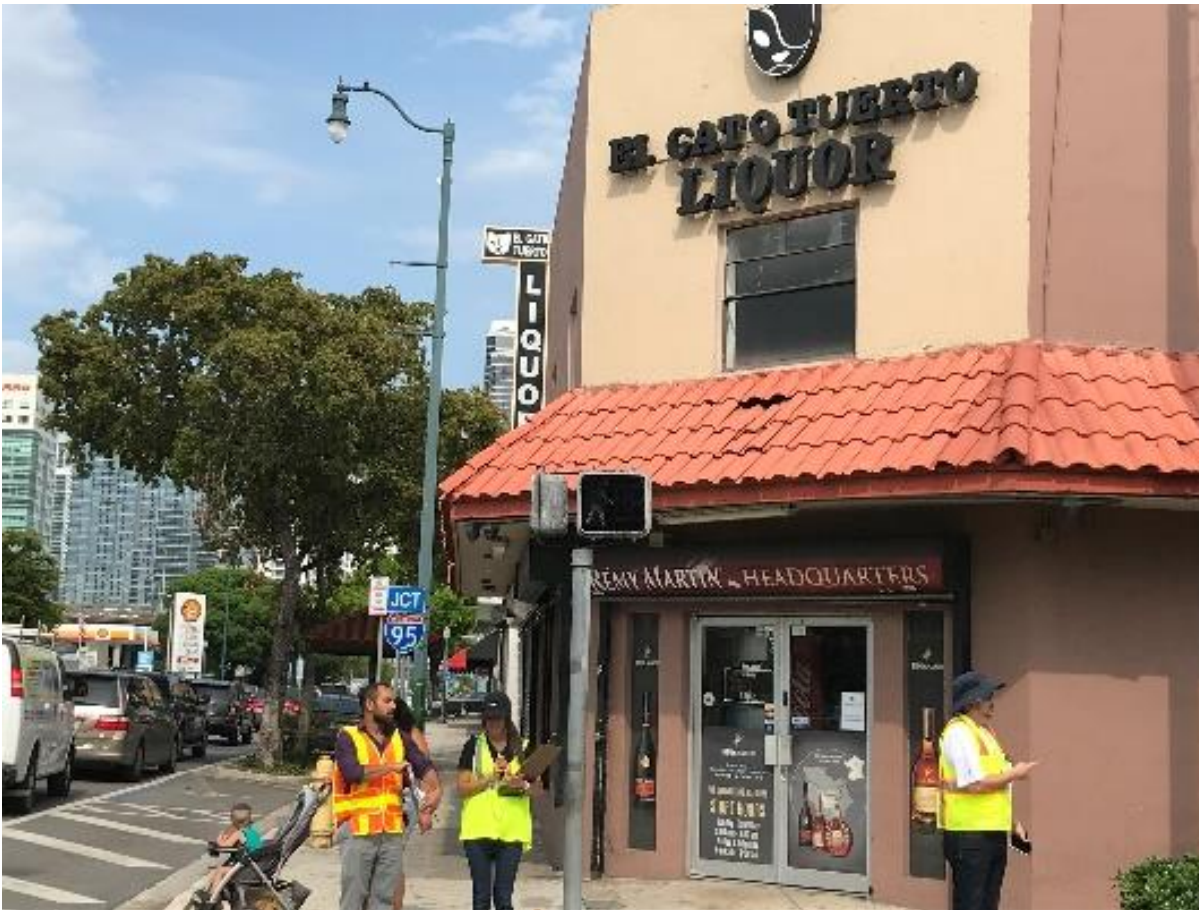
**Location: SW 5<sup>TH</sup> AVENUE AND SW 8<sup>TH</sup> STREET INTERSECTION****Issue #42: Pedestrian Signal Heads**

The signals on the pedestrian signal heads on the southeast and southwest corners of the intersection are not visible.

- Short-Term or Maintenance Project –  
Conduct maintenance for malfunctioning pedestrian signal heads or replace them.

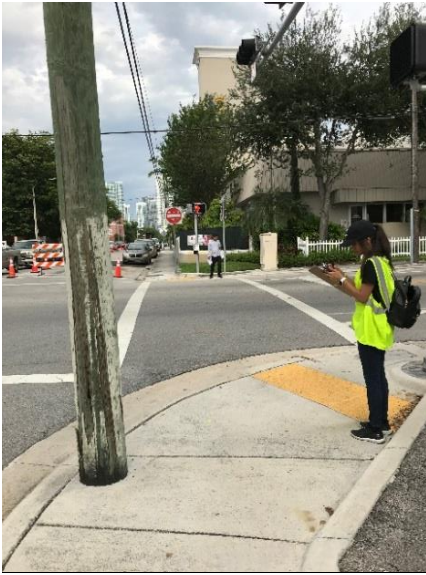
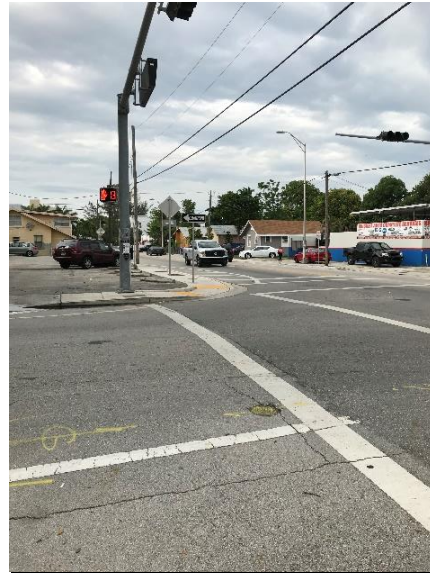
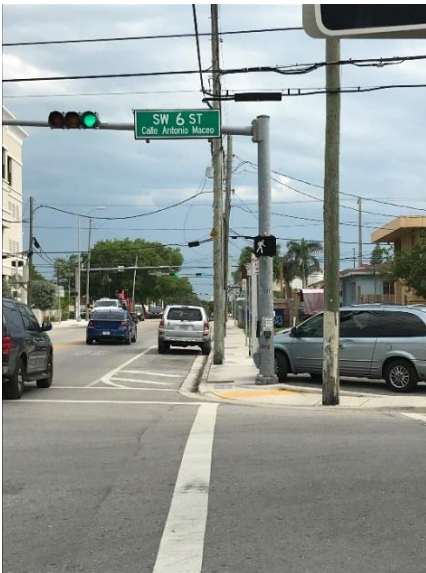
**Location: SW 8<sup>TH</sup> AVENUE AND SW 6<sup>TH</sup> STREET INTERSECTION****Issue #43: Pedestrian Crossing**

The pedestrian truncated dome surfaces at the ramps are not properly installed.

- Near-Term Project –  
Reinstall or replace the truncated dome surfaces to properly guide pedestrians to the crosswalks.

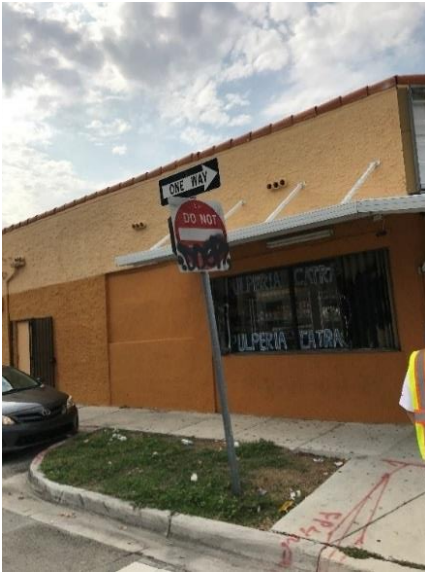
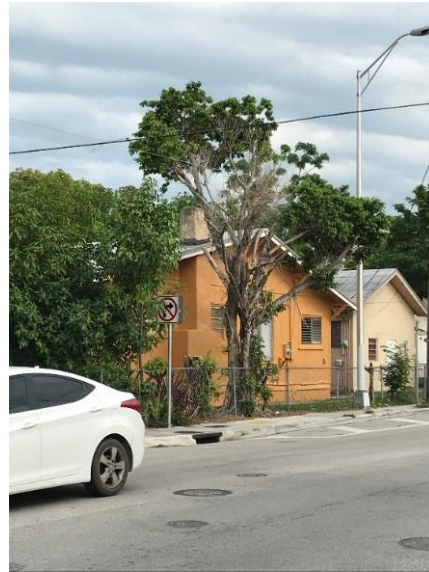
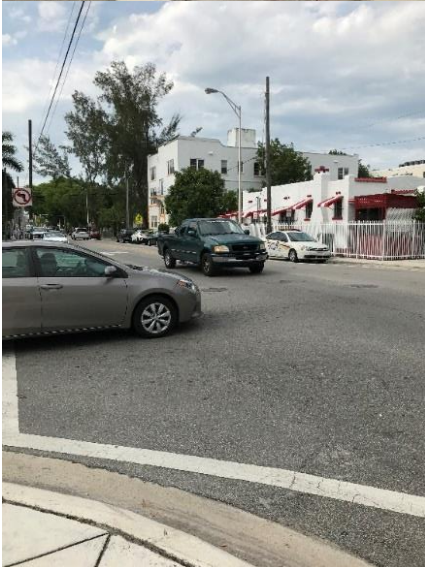
**Location: SW 8<sup>TH</sup> AVENUE AND SW 5<sup>TH</sup> STREET INTERSECTION****Issue #44: Pedestrian Crossing**

The Do Not Enter sign on the west leg of the intersection is vandalized with graffiti. In addition, the No Right Turn on the southeast corner, facing SW 8<sup>th</sup> Avenue southbound traffic, is blocked by vegetation. There are no marked east-west pedestrian crossings along SW 8<sup>th</sup> Avenue between SW 4<sup>th</sup> Street and SW 6<sup>th</sup> Street.

- Short-Term or Maintenance Project –  
Replace the Do Not Enter sign. Conduct maintenance to trim outgrown vegetation.
- Long-Term Project –  
Conduct a study to evaluate the need for an east-west crosswalk along SW 8<sup>th</sup> Avenue.

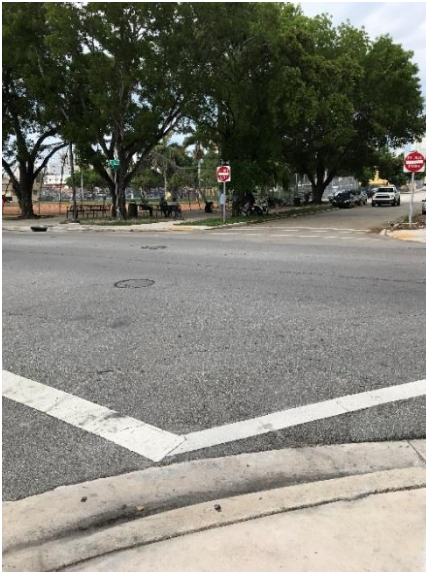
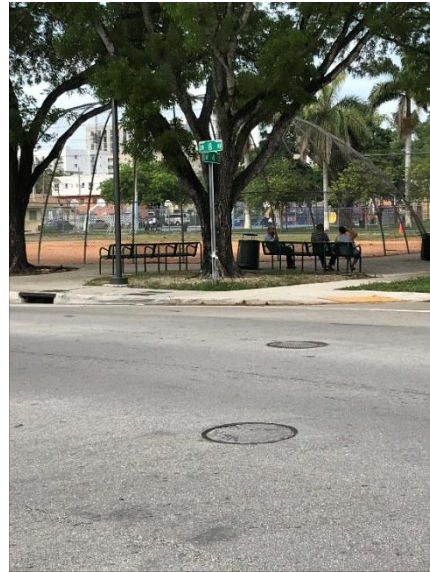
**Location: SW 8<sup>TH</sup> AVENUE AND SW 4<sup>TH</sup> STREET INTERSECTION****Issue #45: Pedestrian Crossing**

The mid-block crossing is located approximately 70 feet north of the intersection. When the pedestrian signal is activated, vehicles traveling northbound stop and block the SW 8<sup>th</sup> Avenue and SW 4<sup>th</sup> Street intersection.

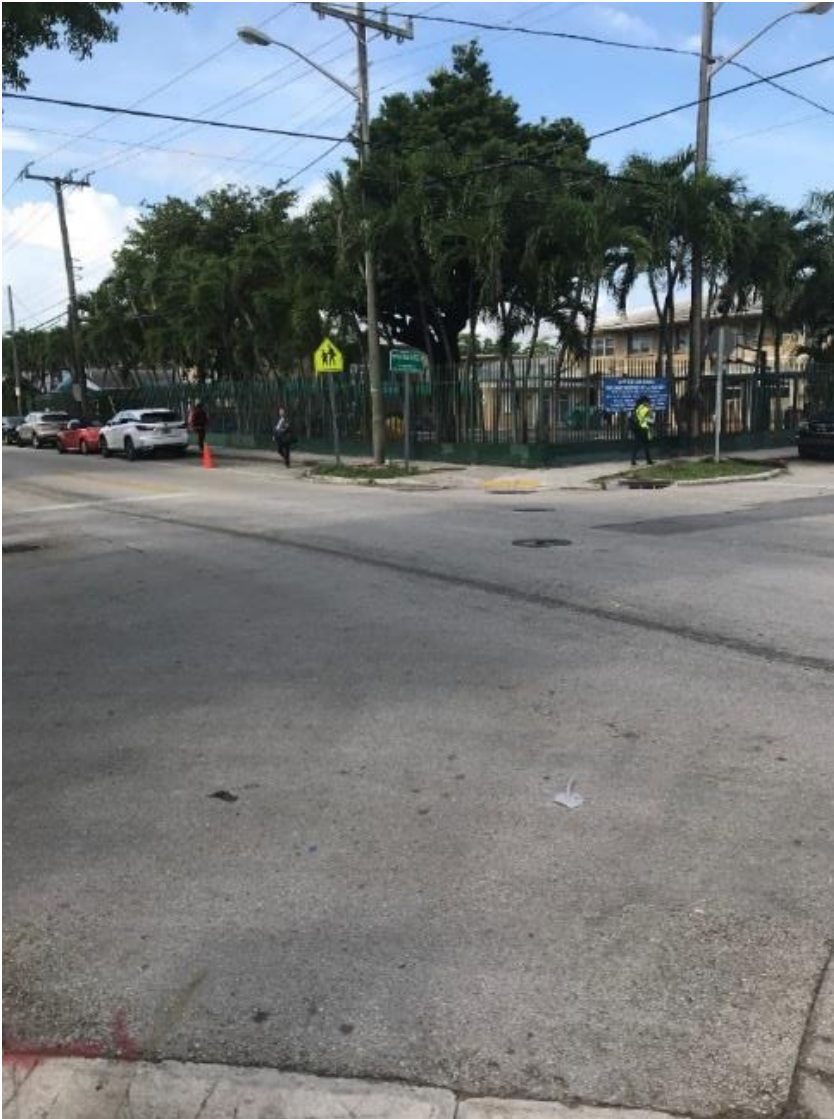
**Location: SW 4<sup>TH</sup> AVENUE AND SW 4<sup>TH</sup> STREET INTERSECTION****Issue #46: Pedestrian Crossing**

Crosswalk marking is missing at the intersection.

- Short-Term or Maintenance Project – Install missing crosswalks.

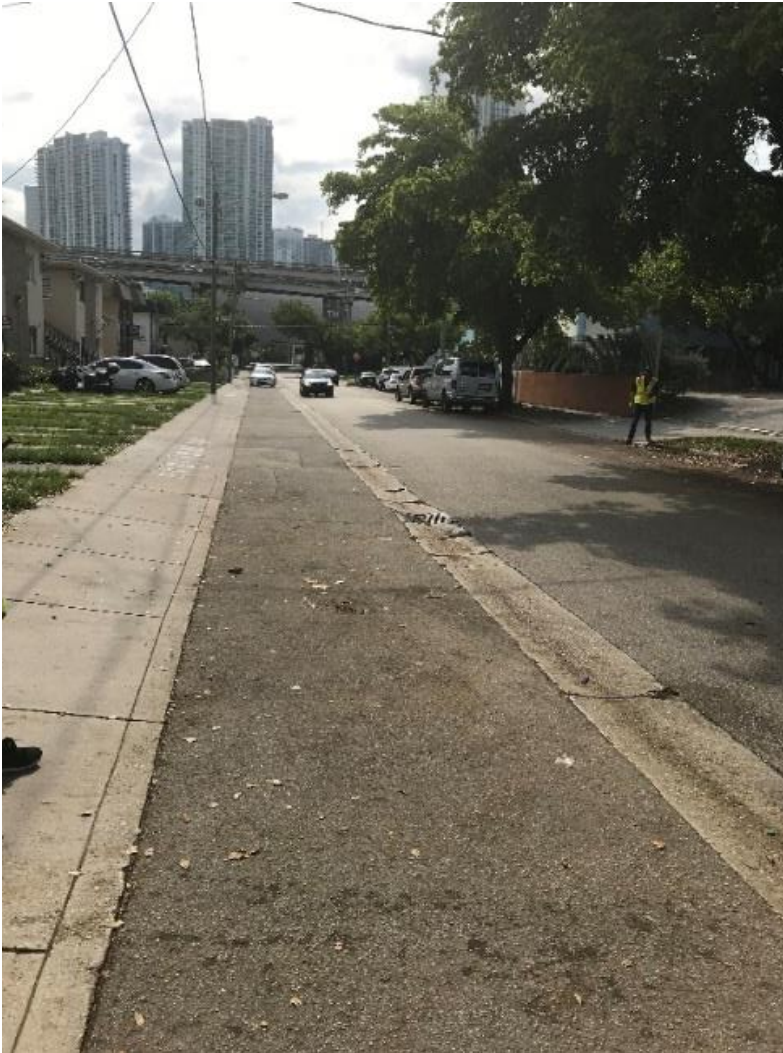
**Location: SW 4<sup>TH</sup> STREET BETWEEN SW 4<sup>TH</sup> AVENUE AND SW 5<sup>TH</sup> AVENUE****Issue #47: Pedestrian Access**

Due to the adjacent driveways on the sidewalk, a majority of the sidewalk on both sides of SW 4<sup>th</sup> Street is sloped. This roadway feature creates potential issues for wheelchairs to use the sidewalk in addition to potential conflicts with parked vehicles.

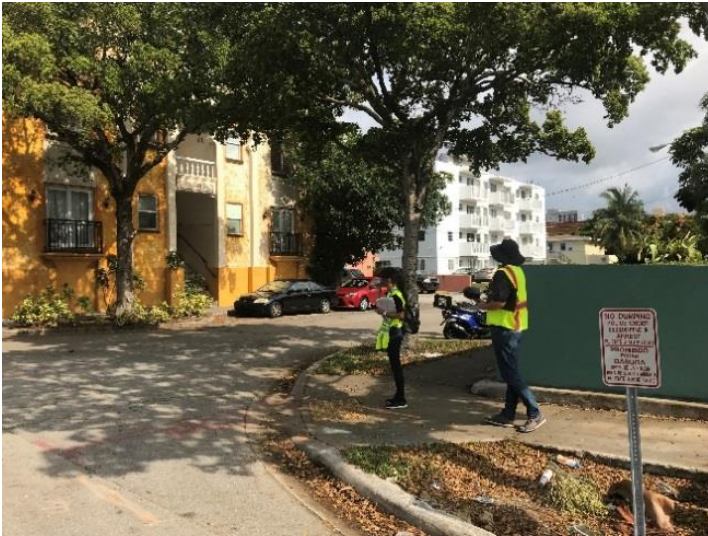
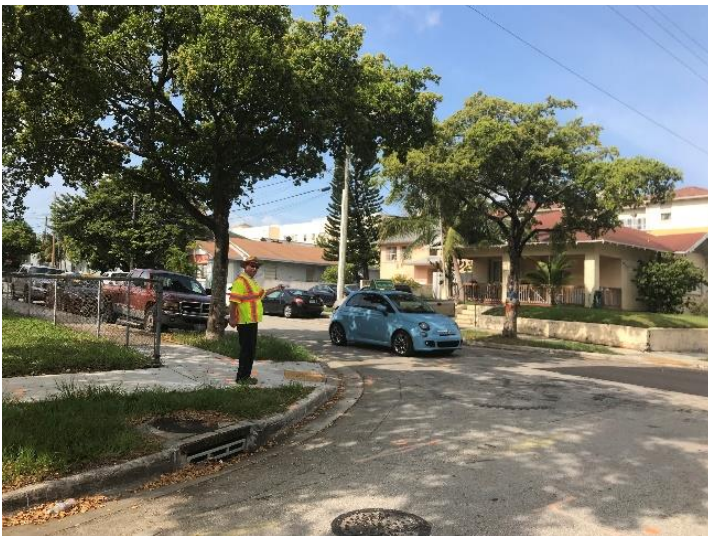
**Location: SW 5<sup>TH</sup> AVENUE AND SW 4<sup>TH</sup> STREET INTERSECTION****Issue #48: Pedestrian Crossing**

The crosswalk markings are missing on the controlled approaches (east and west legs). In addition, there is poor sight distance due to the fence and parked vehicles near the intersection.
