# SENIOR LIVING FACILITIES ROAD SAFETY AUDIT

## WORK ORDER # GPC VII-02

OCTOBER  
2019

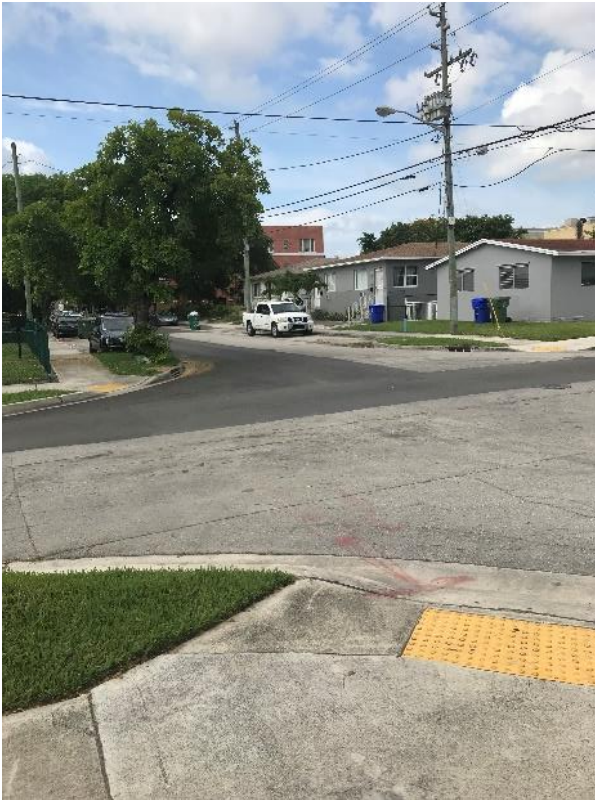
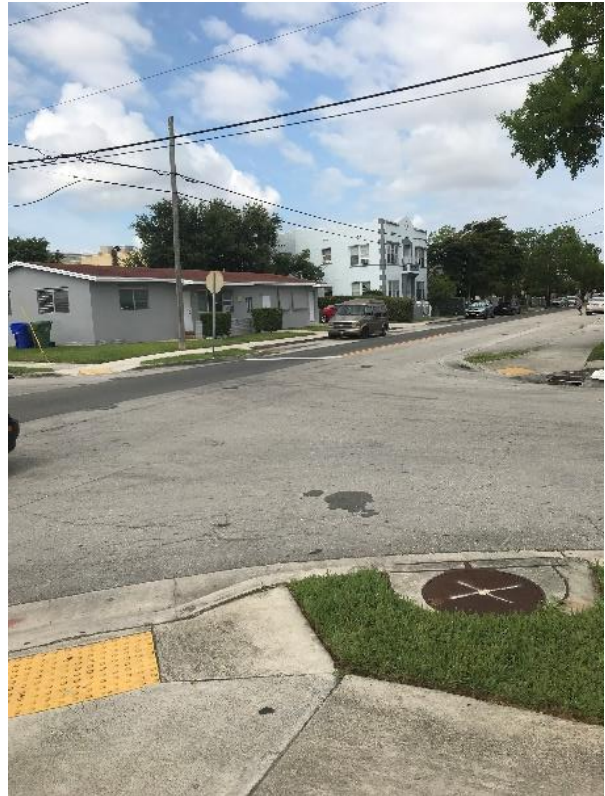
**Location: SW 7<sup>TH</sup> AVENUE AND SW 5<sup>TH</sup> STREET INTERSECTION****Issue #49: Pedestrian Crossing**

The crosswalk markings are missing along SW 5<sup>th</sup> Street.

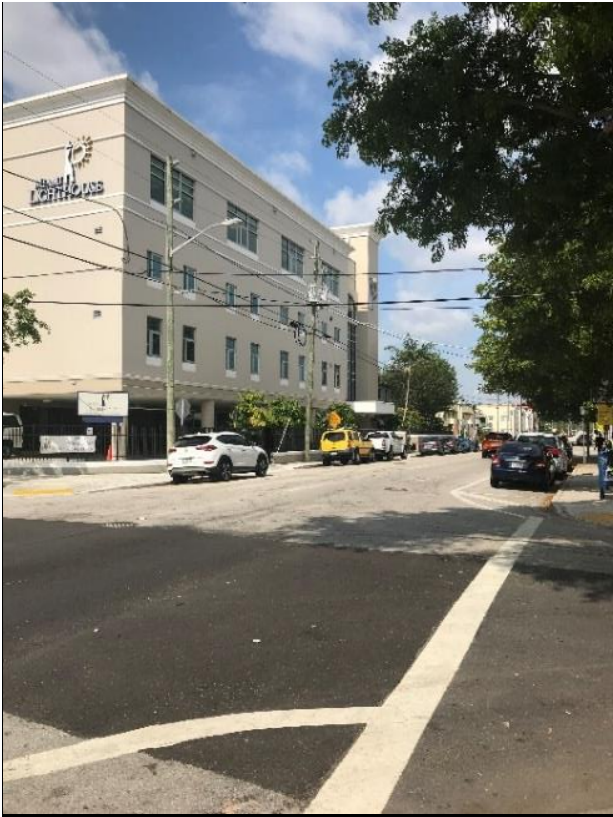
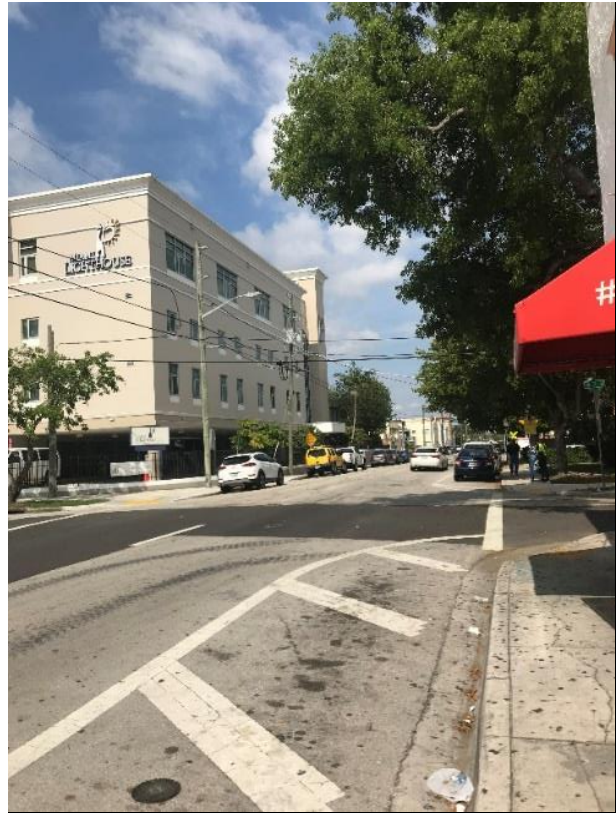
**Location: SW 6<sup>TH</sup> STREET AND SW 7<sup>TH</sup> COURT INTERSECTION****Issue #50: Pedestrian Crossing**

Miami Lighthouse for the Blind is located on the SW corner of the intersection with access points on the south and west legs. Marked pedestrian crossings along SW 6<sup>th</sup> Street between SW 8<sup>th</sup> Avenue and SW 4<sup>th</sup> Avenue are faded or missing. Signage on north sidewalk is blocked by landscape.

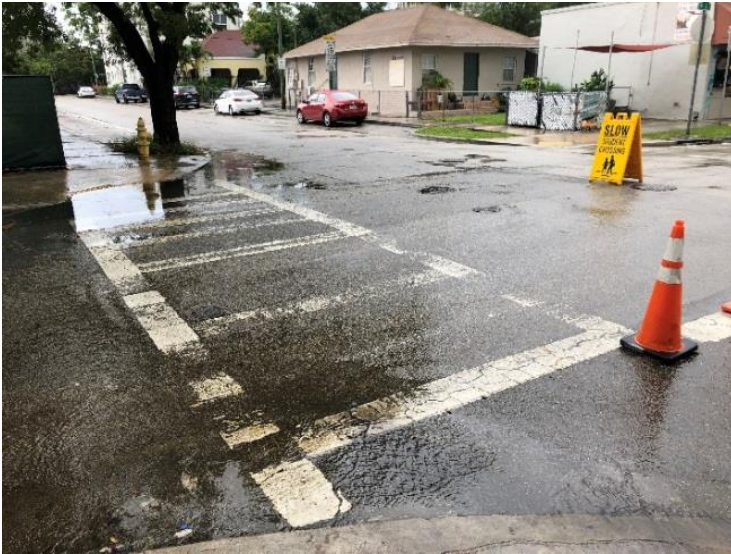
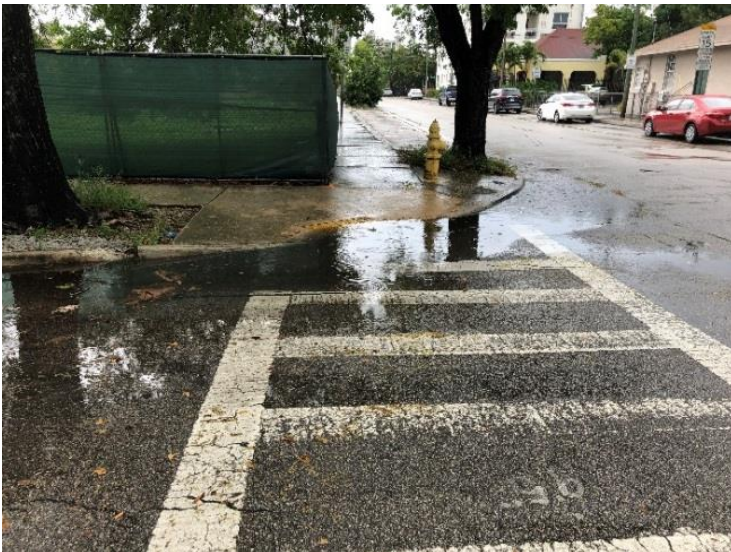
**Location: SW 7<sup>TH</sup> AVENUE AND SW 3<sup>RD</sup> STREET INTERSECTION****Issue #51: Drainage**

The inlet on the northwest corner of the intersection is partially clogged with debris. The curb ramp is inaccessible when it rains.

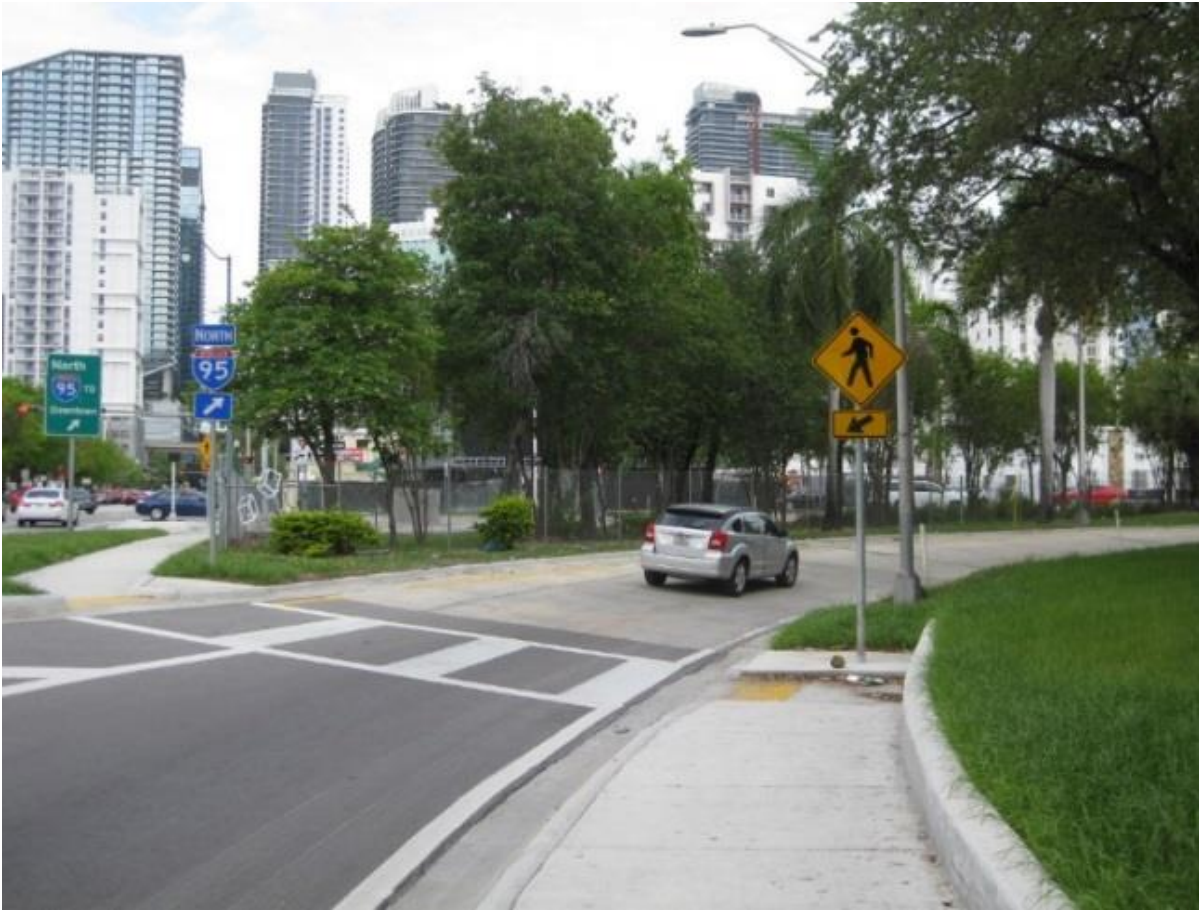
**Location: SW 8<sup>TH</sup> STREET ON-RAMP TO I-95 NORTHBOUND****Issue #52: Pedestrian Crossing**

Traffic headed to the I-95 ramp traffic on SW 8<sup>th</sup> Street was observed not yielding to pedestrians on crosswalk.

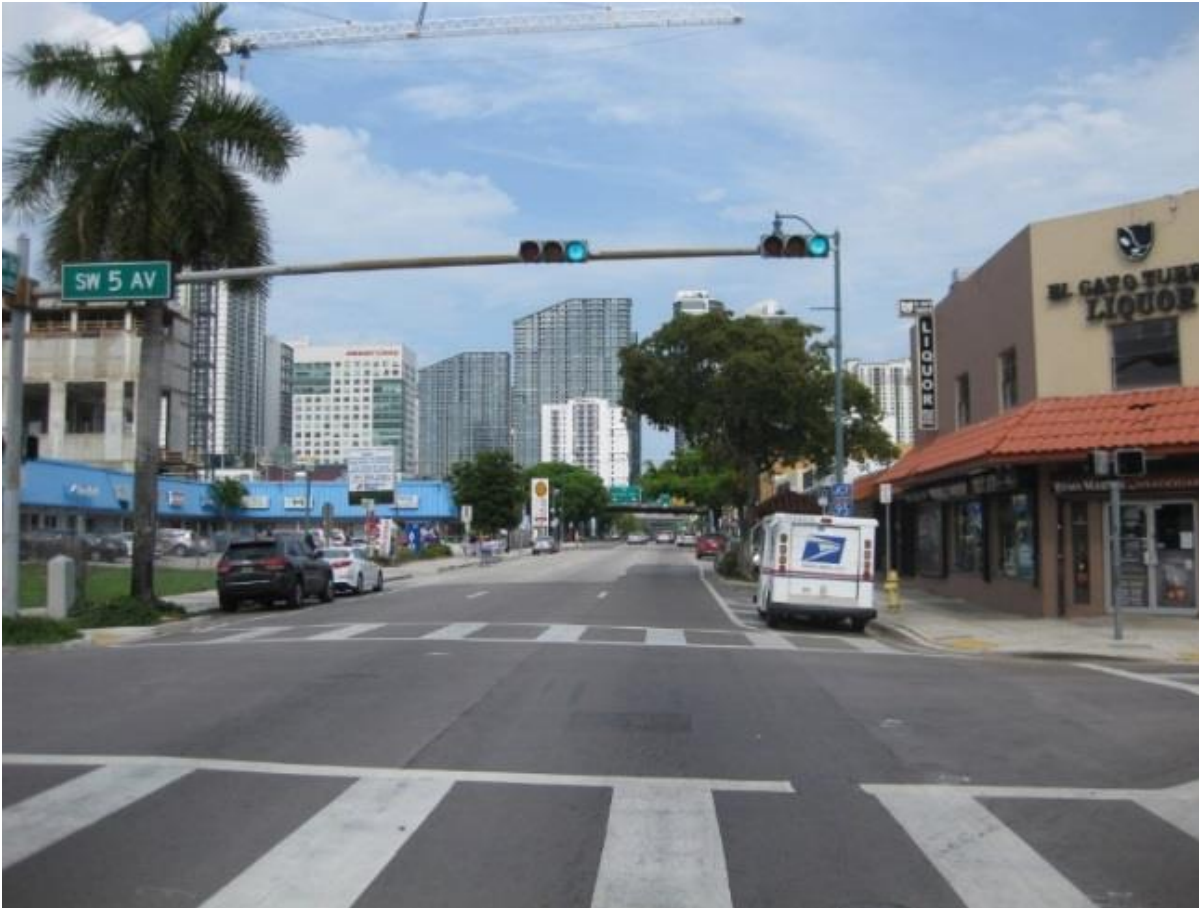
**Location: SW 8<sup>TH</sup> STREET AND SW 5<sup>TH</sup> AVENUE INTERSECTION****Issue #53: Traffic Signal Heads**

The signal heads are not located over the center of the roadway. A motorist in the left-most eastbound lane could have difficulty seeing the signal indications if a large truck or sightseeing bus were in the center lane.

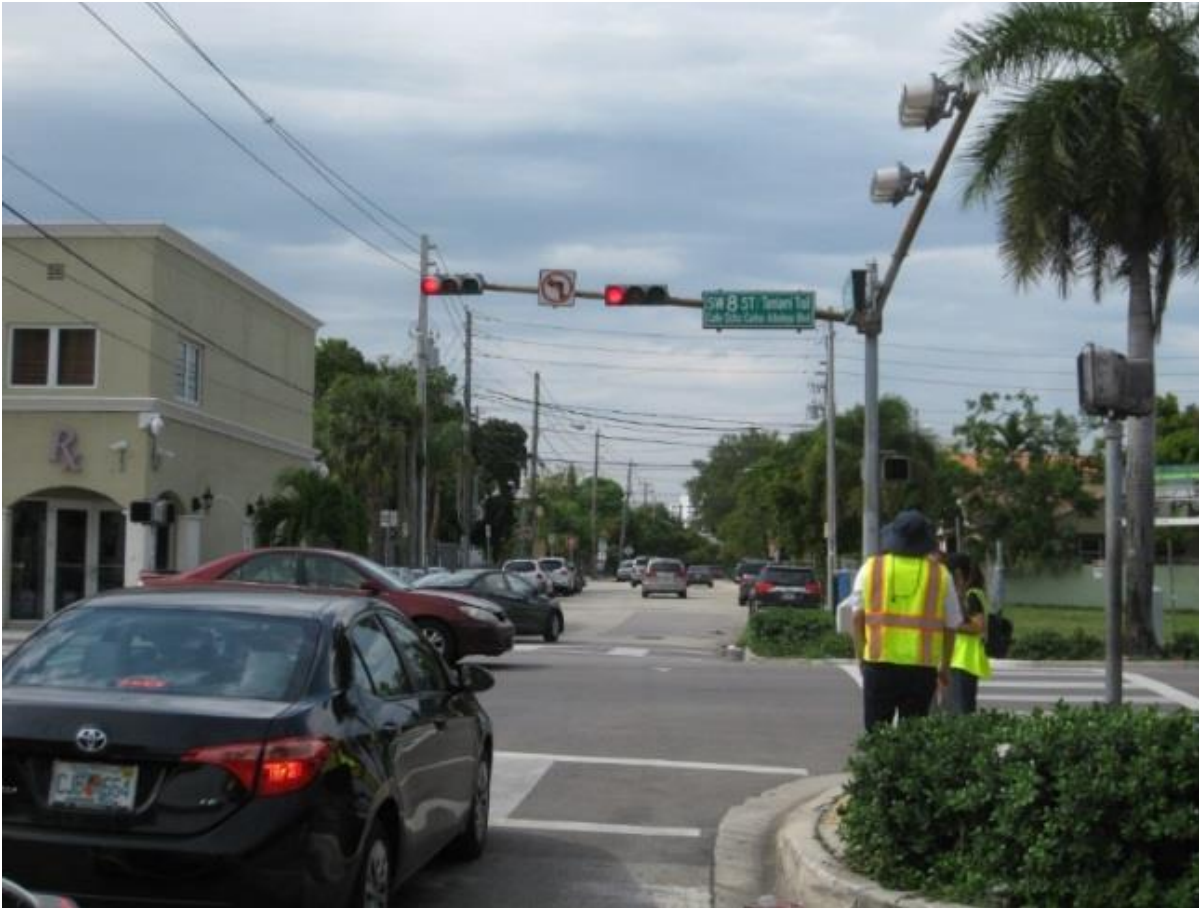
**Location: SW 8<sup>TH</sup> STREET AND SW 5<sup>TH</sup> AVENUE INTERSECTION****Issue #54: One-Way Signs**

One-way signs are missing at the intersection.

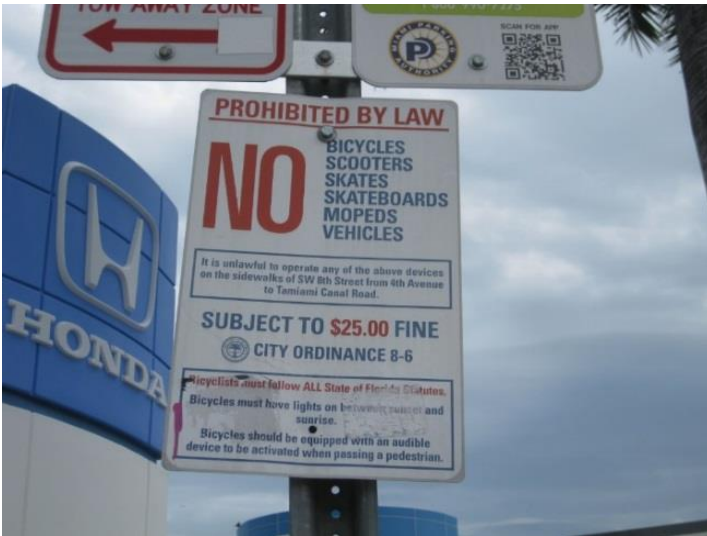
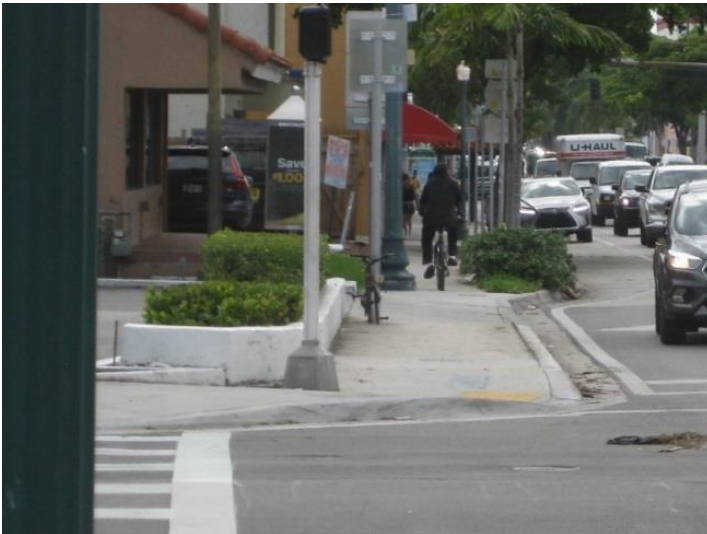
## Issue #55: Sidewalk User Sign

The RSA Team observed a single sign, located on the southside of SW 8<sup>th</sup> Street just east of SW 7<sup>th</sup> Avenue, which prohibits bicycles, scooters, skates, skateboards, mopeds and other vehicles from using the sidewalk on SW 8<sup>th</sup> Street from SW 4<sup>th</sup> Avenue to Tamiami Canal Road (Palmetto Expressway). The sign references City ordinance 8-6. Bicyclists were observed using the sidewalk. Signing to regulate use of a facility should be easy to read.

- Near-Term Project –  
Recommend further study to determine if the regulation is enforced and remove or provide additional signs that are easy to read along the corridor.

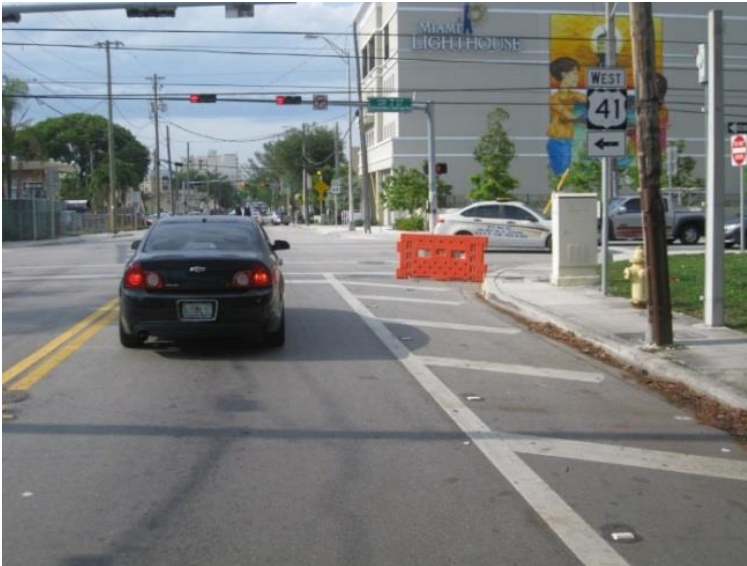
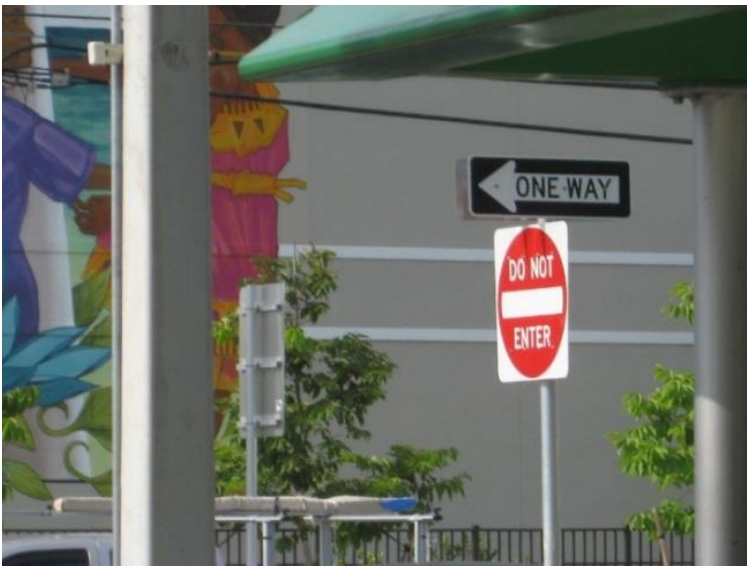
**Location: SW 7<sup>TH</sup> STREET AND SW 8<sup>TH</sup> AVENUE INTERSECTION****Issue #56: Sign Visibility**

The nearside One-Way regulatory sign is located 30 feet from the northbound approach making it difficult for an approaching driver to see the sign.

- Short-Term or Maintenance Project –  
Relocate the sign closer to the intersection to be within driver's sight.

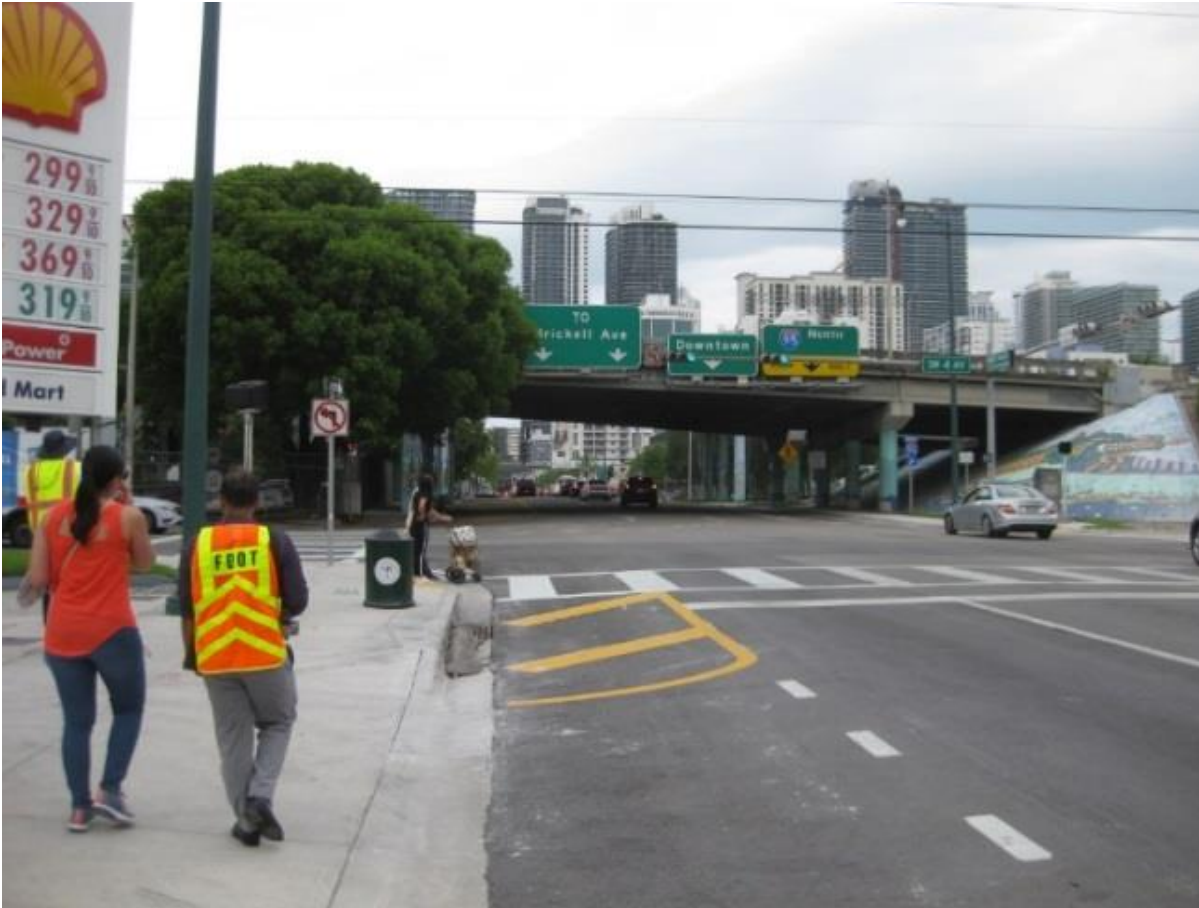
**Location: SW 4<sup>TH</sup> AVENUE AND SW 8<sup>TH</sup> STREET INTERSECTION****Issue #57: Sign Visibility**

There are no One-Way arrow signs installed at the intersection for eastbound traffic. Also, the No Left Turn sign mounted on the traffic signal mast arm has degraded and is hard to see.

- Short-Term or Maintenance Project –  
Install One-Way signs (R6-1) on the near right and the far-left corners of the intersection facing eastbound traffic on SW 8<sup>th</sup> Street according to the MUTCD Section 2B.40.07.  
Replace No Left Turn sign (R3-2) facing eastbound traffic on SW 8<sup>th</sup> Street.

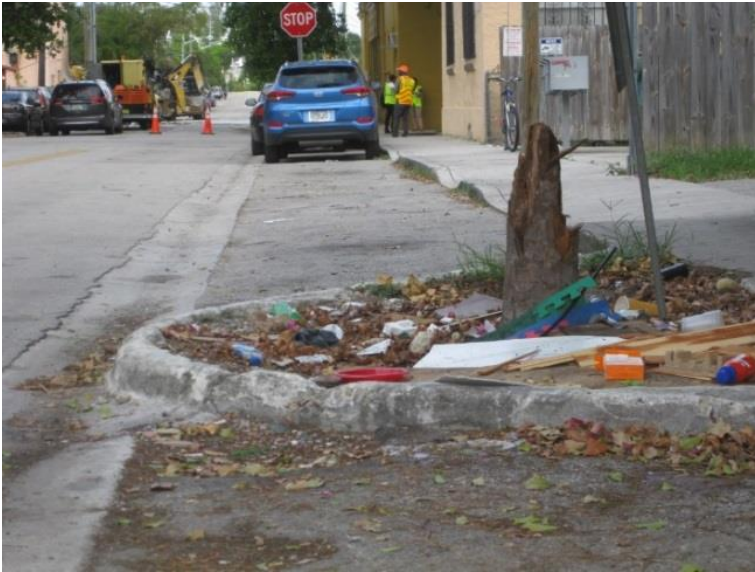
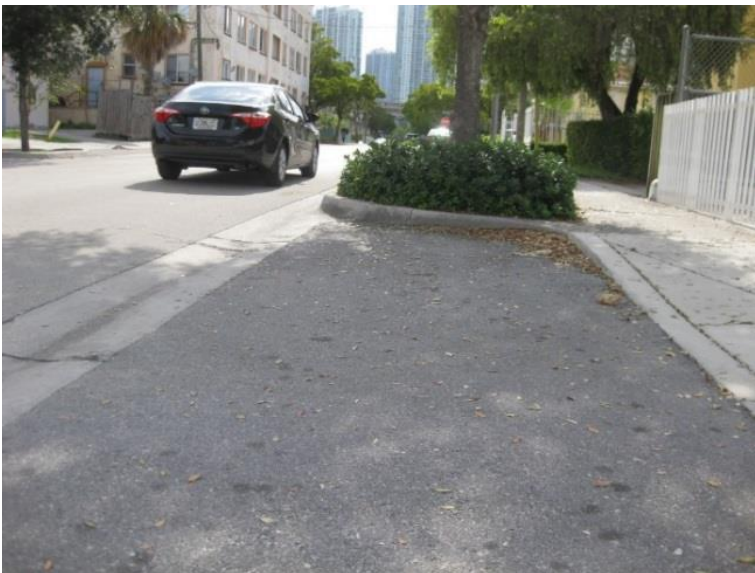
**Location: SW 4<sup>TH</sup> STREET NEAR SW 4<sup>TH</sup> AVENUE****Issue #58: Curb Bulb-Out**

A curb bulb-out to control parking has been struck numerous times. The bulb-out is hard to see in the dark.

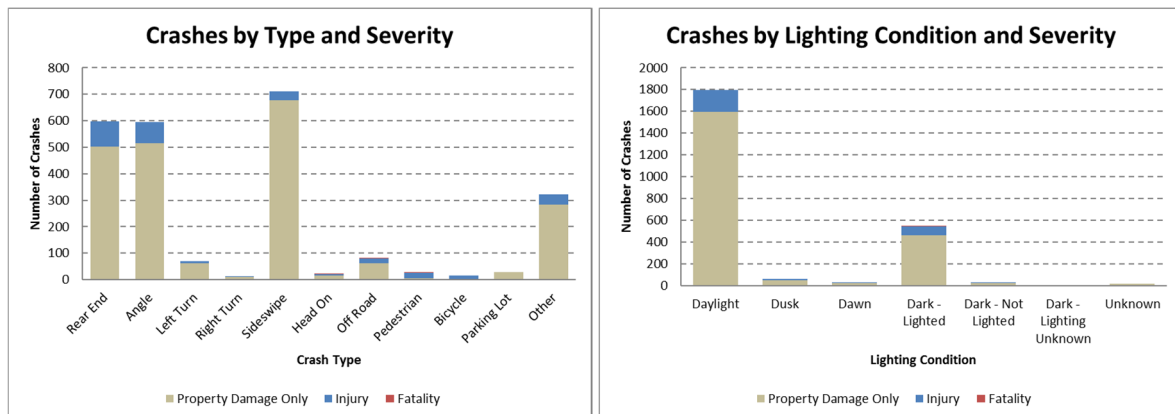
Among the crashes that occurred during non-daylight conditions, general trends are similar to those presented for all crashes in the study area. Sideswipe, rear-end, and angle crashes remain the predominant crash types, with crashes per year increasing from 2014 through 2018. Non-daylight crashes do occur more heavily on weekends, with the highest crash day being Saturday (140 crashes, 21 percent). High crash locations of the non-daylight crashes are similar to overall high crash locations, with clusters occurring at the signalized intersections on SW 7th St and SW 8th St and along US 441. Eight-four (84) percent of the non-daylight crashes were PDO crashes, 15 percent were injury crashes, and all three (3) fatal crashes that occurred in the study area occurred in non-daylight conditions (0.4 percent of non-daylight crashes).

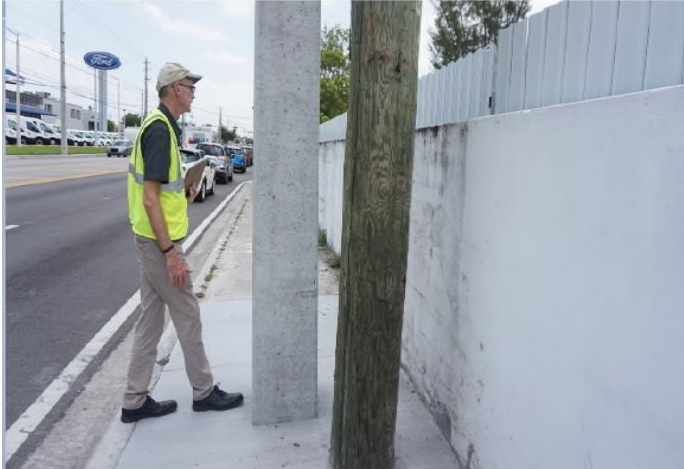
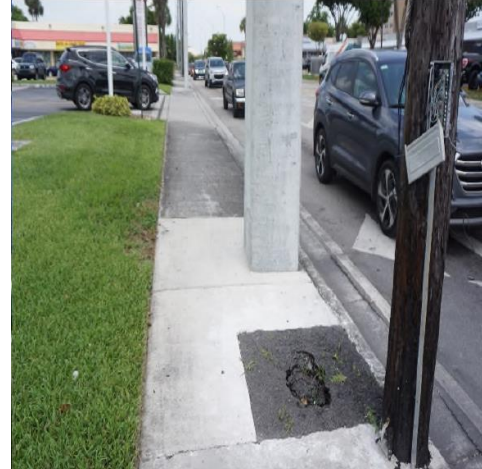
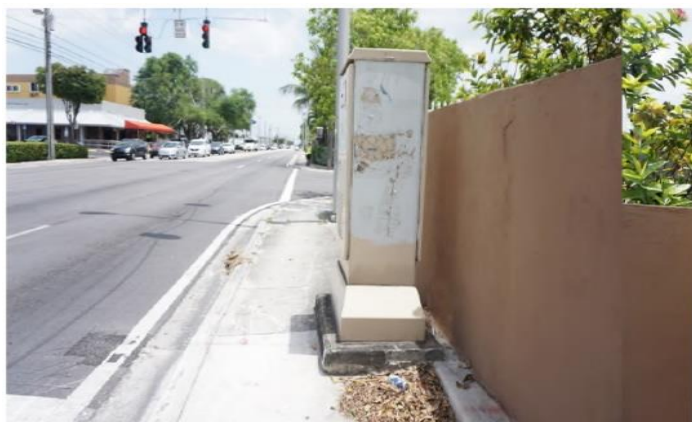
#### Issue #1: Narrow and Partially Obstructed Sidewalks

Some sidewalks were observed to be narrow and/or are obstructed by utilities, sign poles, and vegetation.

- Short-Term or Maintenance Project –  
Vegetation adjacent to sidewalks throughout the corridor should be properly maintained; may require code enforcement on private property.
- Long-Term Project –  
Recommend further study to determine if alternative sidewalk alignment and/or additional right-of-way is necessary to allow for wider sidewalk where obstructions are present.

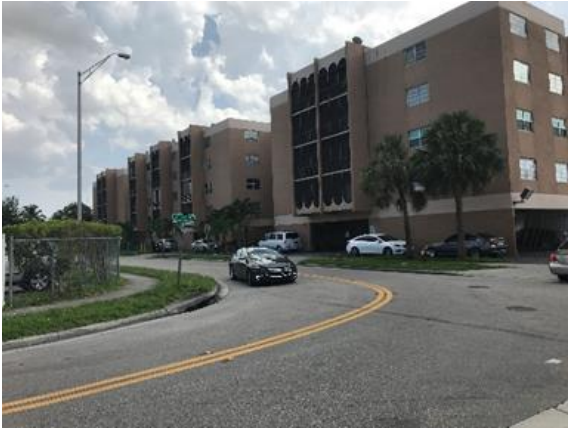
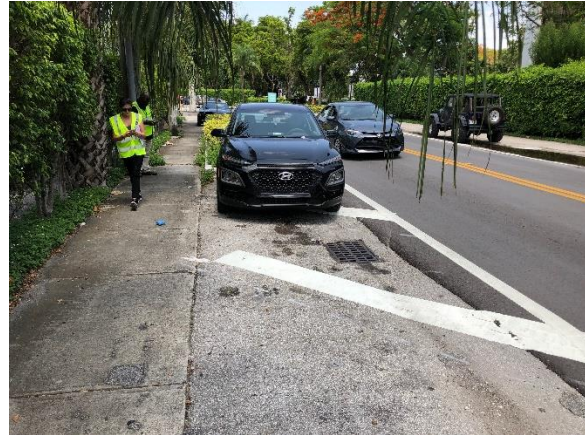
**Issue #2: Poor Sight Distance at Intersections**

Due to on street parking and other objects such as structures, walls/fences, and trees, many intersections have insufficient sight distance for vehicles.

- Short-Term or Maintenance Project – Recommend further study to determine if removing sight obstructions and reducing on-street parking near intersections is needed to increase sight distance.

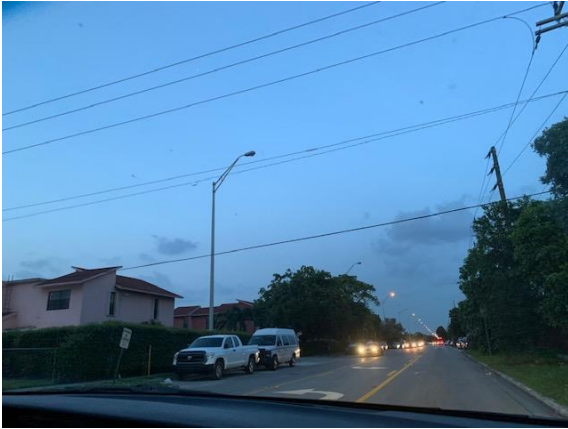
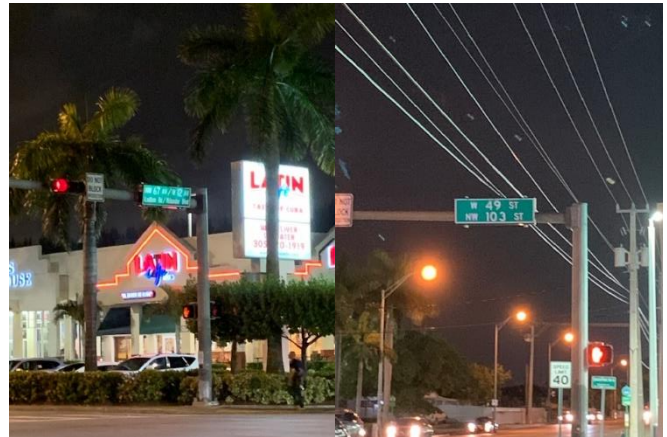
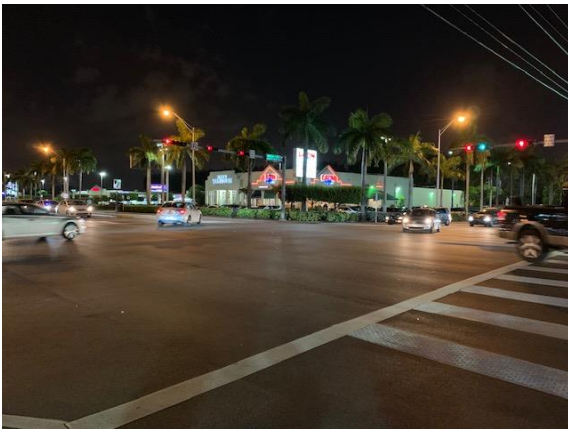
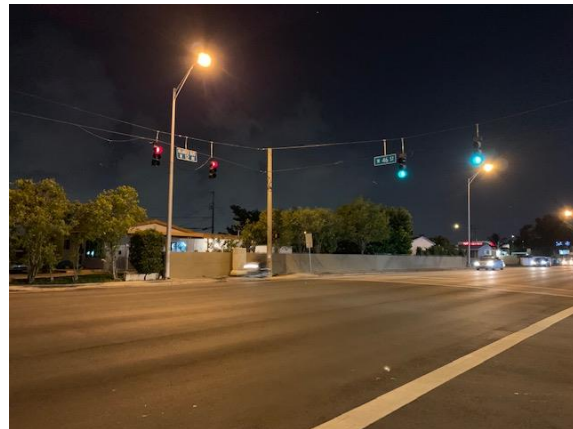
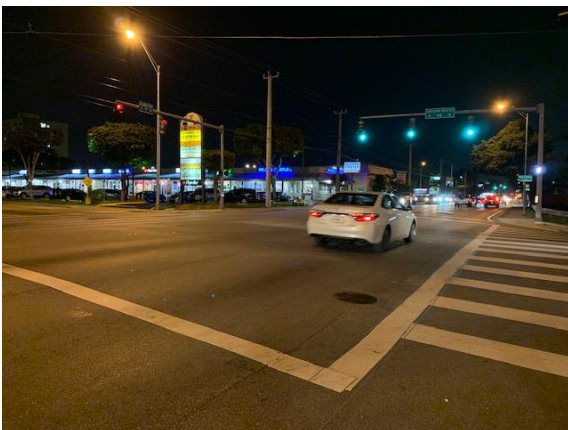
**Issue #3: Nighttime Issues**

**Description of Issue:****Lighting Issues –**

- W 44<sup>th</sup> Place by W 14<sup>th</sup> Avenue, multiple overhead streetlights are out on W 44<sup>th</sup> Place
- W 42<sup>nd</sup> Place west of W 12<sup>th</sup> Lane, an overhead streetlight is out
- W 43<sup>rd</sup> Place east of W 16<sup>th</sup> Avenue, an overhead streetlight is out
- W 49<sup>th</sup> Place, west of W 12<sup>th</sup> Avenue, an overhead streetlight is out

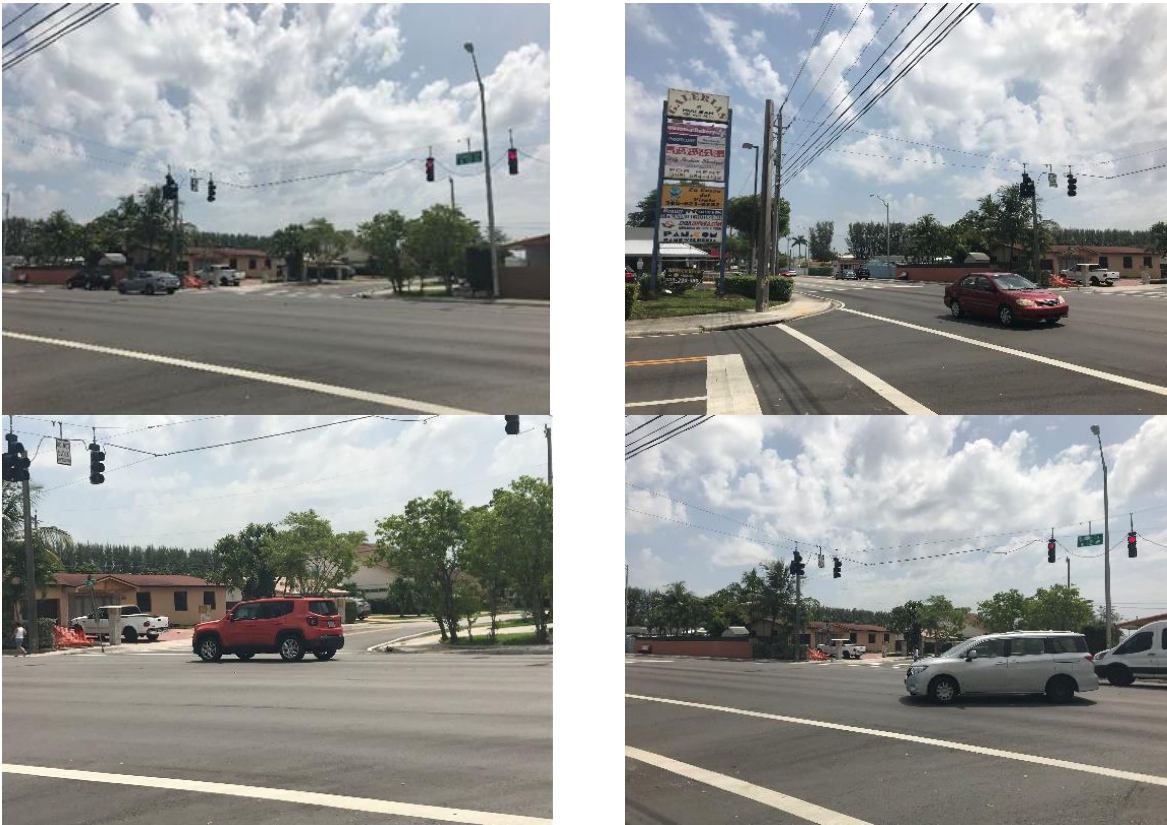
##### Issue #4: Pedestrian Facility

The intersection is signalized for the north, south and west legs. However, the east leg is stop controlled with a Right-Turn Only restriction. There are marked crosswalks on the east, west, and south legs of the intersection, the north leg does not have marked crosswalk. Pedestrian signals along with push buttons are available for the south leg (east-west peds), however pedestrian signal heads are missing on the east and west legs (north-south peds).

- Near-Term Project –  
Install pedestrian signal heads and push buttons on the west leg.
- Long-Term Project –  
Evaluate incorporating the east leg as part of the intersection, including pedestrian signal heads and push buttons. In addition, consider adding a marked crosswalk on the north leg.

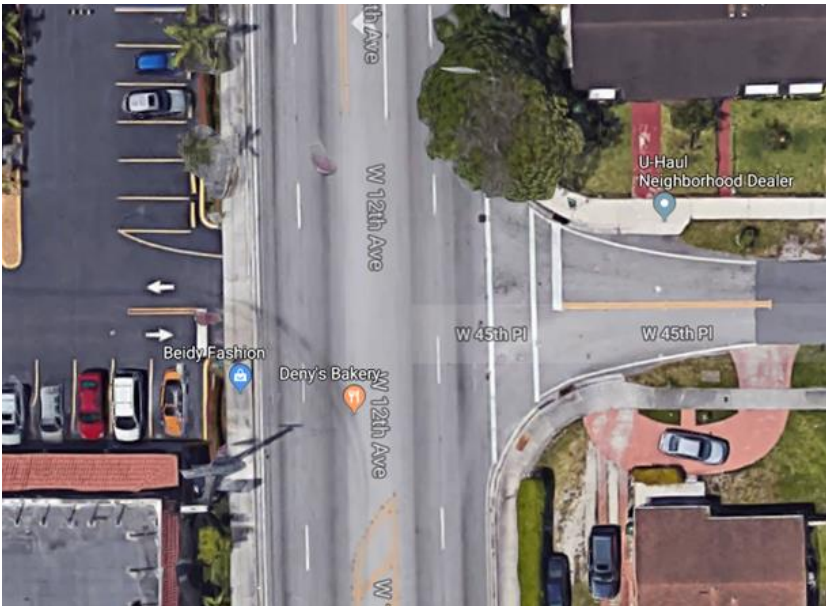
**Location: W 12<sup>TH</sup> AVENUE AND W 45<sup>TH</sup> PLACE INTERSECTION****Issue #5: Traffic Control**

The intersection is the only location that vehicles from the neighborhood to the east are allowed to turn left to head southbound on W 12<sup>th</sup> Avenue, W 46<sup>th</sup> Street and W 48<sup>th</sup> Street are stop controlled with right-turn only restrictions. It was observed that a majority of the vehicles exiting this intersection were turning left. There is a driveway access located across this intersection on the west side of W 12<sup>th</sup> Avenue.

- Near-Term Project –  
Consider restricting turning movements to right-in right-out only for both the east and west intersection legs with a bi-directional median.

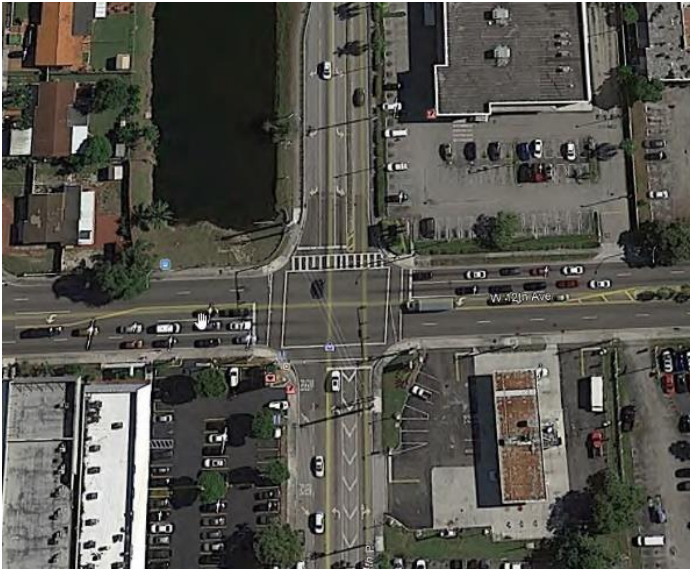
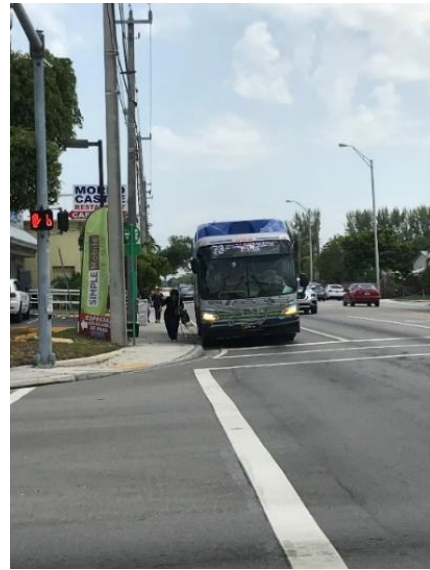
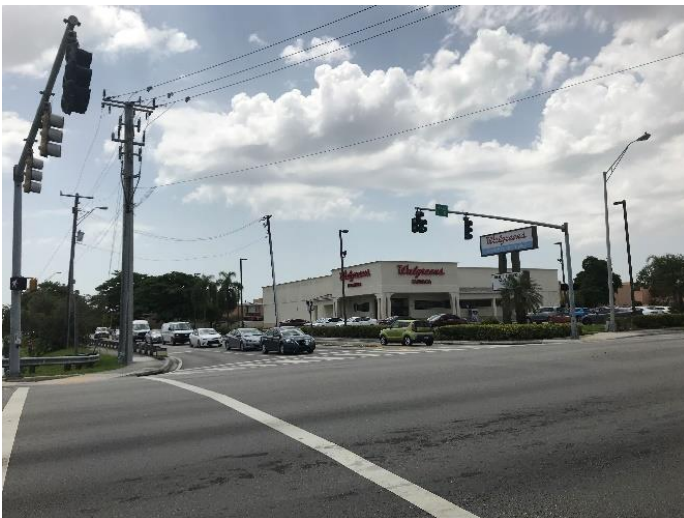
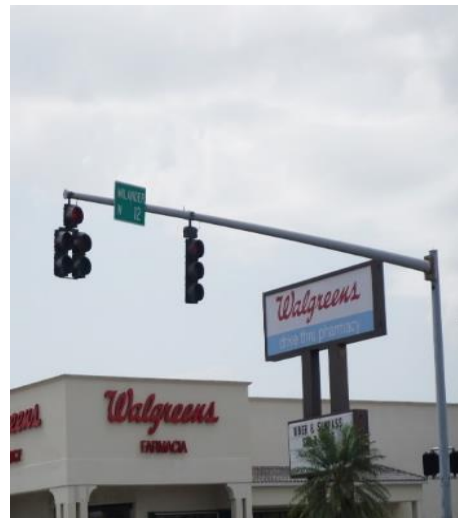
**Location: W 12<sup>TH</sup> AVENUE AND W 44<sup>TH</sup> PLACE INTERSECTION****Issue #6: Pedestrian Facility**

It was observed that only the east leg crosswalk has special emphasis markings.

- Short-Term or Maintenance Project –  
Install special emphasis crosswalk markings for all intersection legs.  
Replace street name sign on the mast arm across the east leg of the intersection.

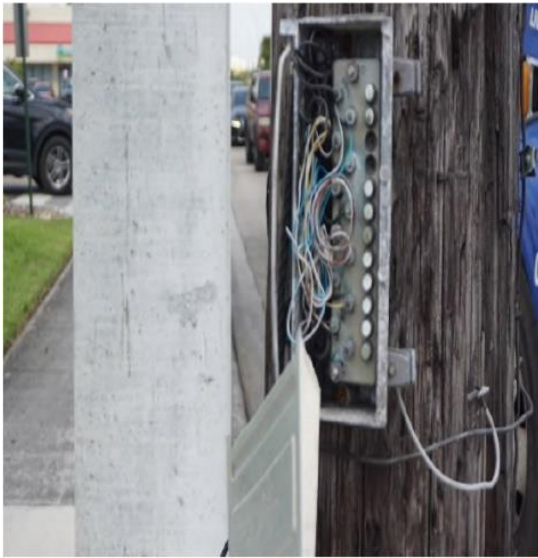
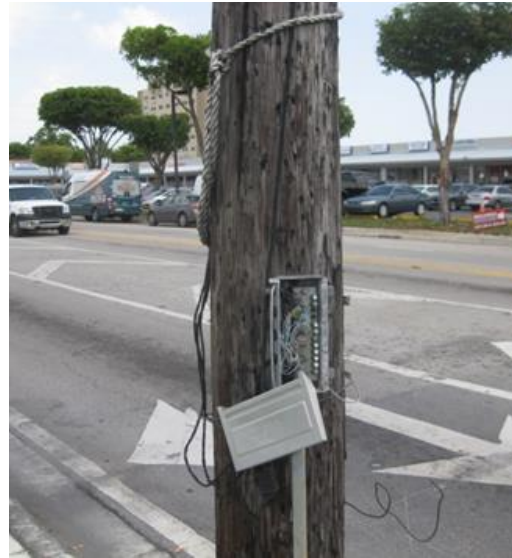
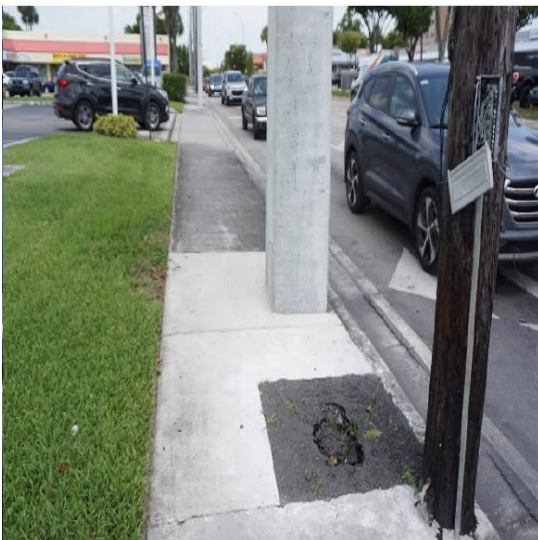
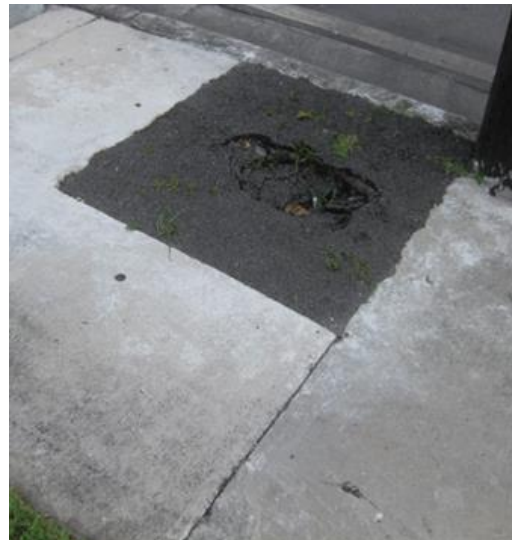
**Location: W 12<sup>TH</sup> AVENUE AND W 44<sup>TH</sup> PLACE INTERSECTION****Issue #7: Pedestrian Facility**

Abandoned telephone circuit junction box on utility pole within sidewalk area on the southwest corner of the intersection (south side of W 44<sup>th</sup> Place) has loose wires and exposed components which could pose a hazard to pedestrians and bicyclists.

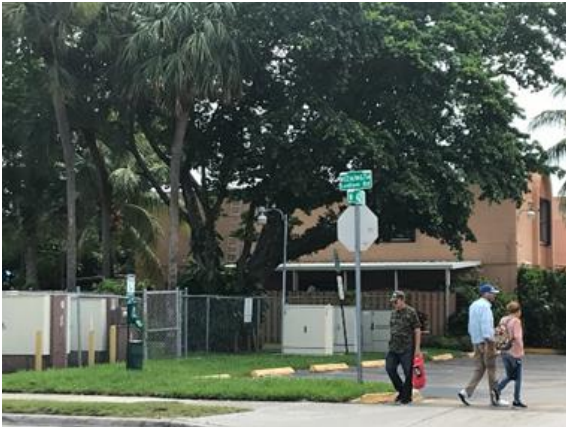
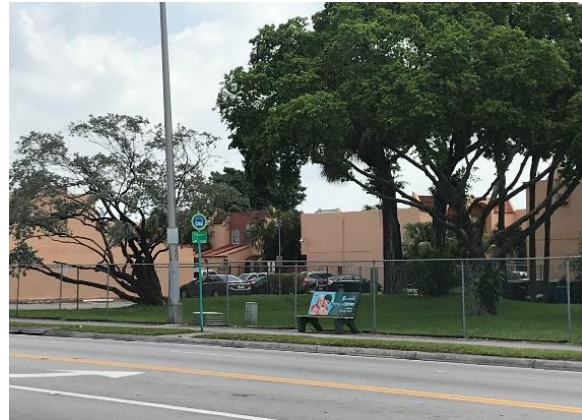
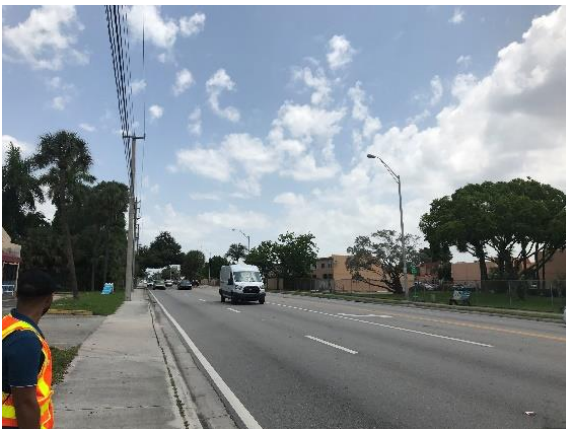
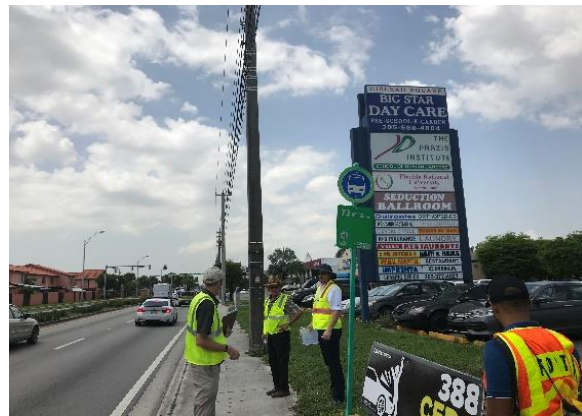
**Issue #8: Pedestrian Facility**

**Location: W 12<sup>TH</sup> AVENUE BETWEEN W 43<sup>RD</sup> PLACE AND W 41<sup>ST</sup> STREET**

This segment has bus stops northbound and southbound and the closest crosswalks (east-west) is at W 44<sup>th</sup> Place and W 37<sup>th</sup> Street or 0.15 and 0.07 miles, respectively. In addition, there were no pedestrian signal heads present at the intersection of W 12<sup>th</sup> Avenue and W 41<sup>st</sup> Street. Attached is the ridership for Route 73 for these bus stops for 2018 and 2019.

- Near-Term Project –
  - Add a crosswalk to the north leg at the intersection of W 12<sup>th</sup> Avenue and W 41<sup>st</sup> Street.
  - Add pedestrian signals at the intersection of W 12<sup>th</sup> Avenue and W 41<sup>st</sup> Street.
- Long-Term Project –
  - Consider:
    - evaluating the need for a midblock crosswalk north of W 42<sup>nd</sup> Street,
    - relocating the southbound bus stop north of W 42<sup>nd</sup> Street.

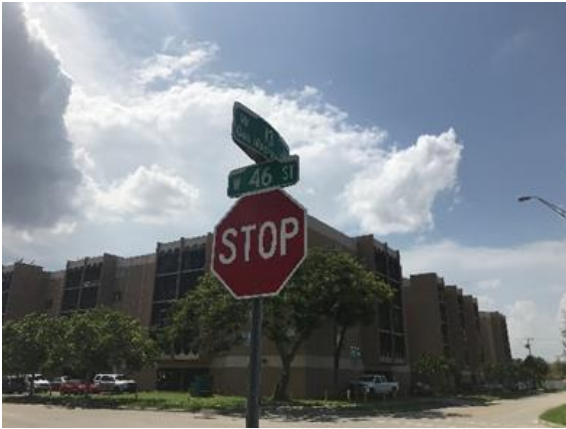
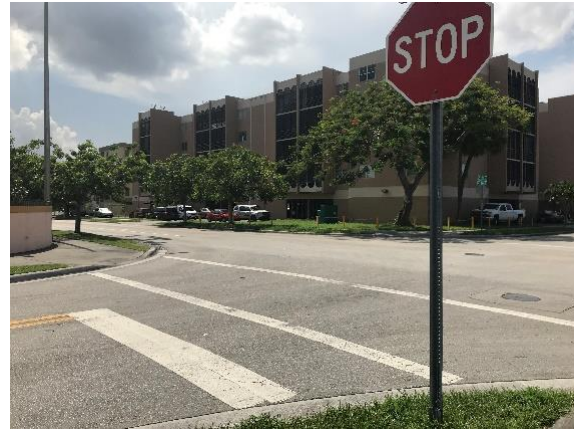
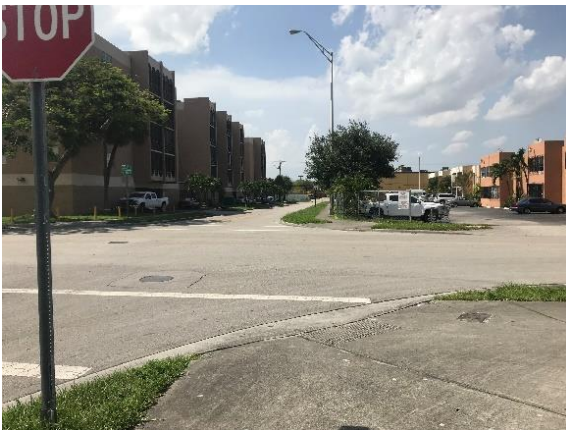
**Location: W 13<sup>TH</sup> LANE AND W 46<sup>TH</sup> STREET INTERSECTION****Issue #9: Traffic Control**

Residents from Hialeah Residence shared that they use this intersection to cross north-south. The intersection provides crosswalks on the north and south legs to accommodate east-west crossings and no crosswalks are provided for the north-south crossings. It was observed that vehicles traveling east-west speed along W 46<sup>th</sup> Street as the only controlled intersections are at W 12<sup>th</sup> Avenue and W 16<sup>th</sup> Avenue (0.50 miles). The curb ramps are missing detectable warnings.

- Long-Term Project –  
Conduct analysis for traffic calming measures along the segment, including a roundabout at the intersection of W 46<sup>th</sup> Street and W 13<sup>th</sup> Lane. Consider adding midblock crossing/additional crossing along this segment north-south.

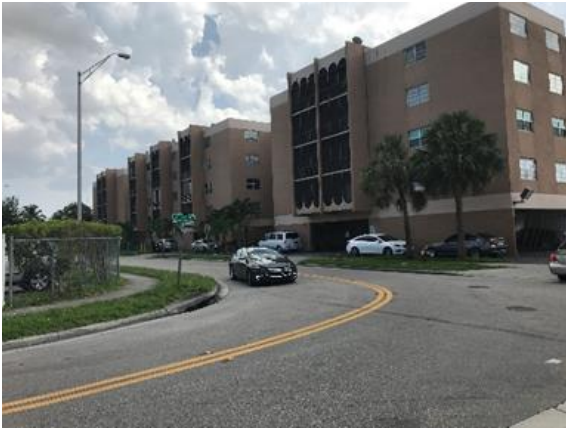
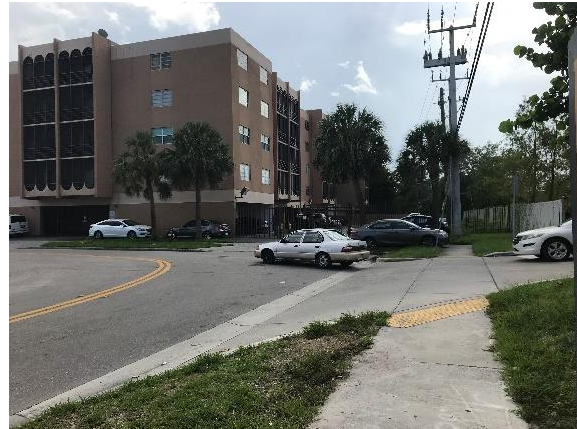
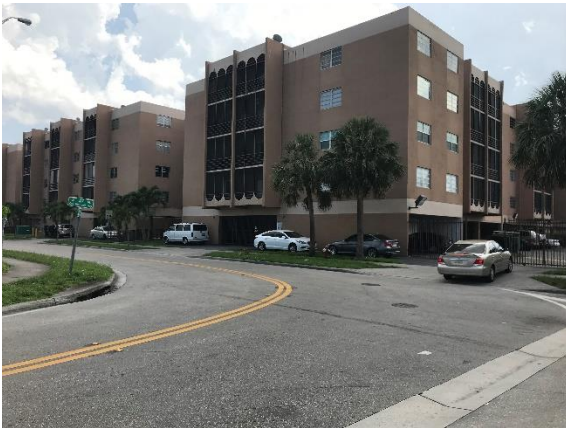
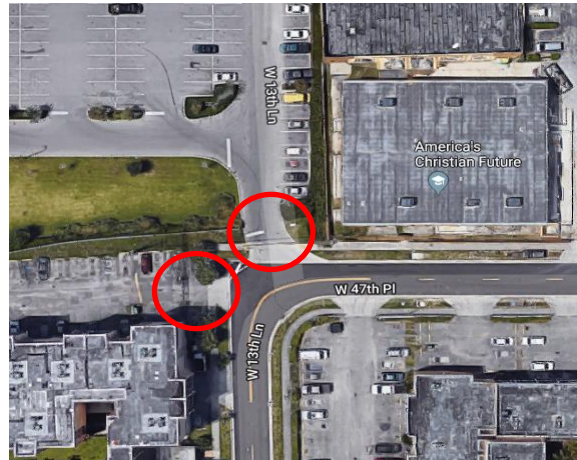
**Location: W 13<sup>TH</sup> LANE AND W 47<sup>TH</sup> PLACE INTERSECTION****Issue #10: Traffic Control**

Two driveway entrances are located adjacent to each other at the bend of a 90-degree curve. The driveway into the shopping center to the north was observed to be used as a cut-through route, experiencing relatively heavy use. Due to the 90-degree curve, visibility of the driveways is limited on several of the approaches.

- Long-Term Project –  
Conduct an evaluation for the need of an all-way stop-controlled intersection at this location, especially to avoid conflicts between northbound vehicles accessing the driveways and westbound vehicles coming from W 47<sup>th</sup> Place headed southbound on W 13<sup>th</sup> Lane.

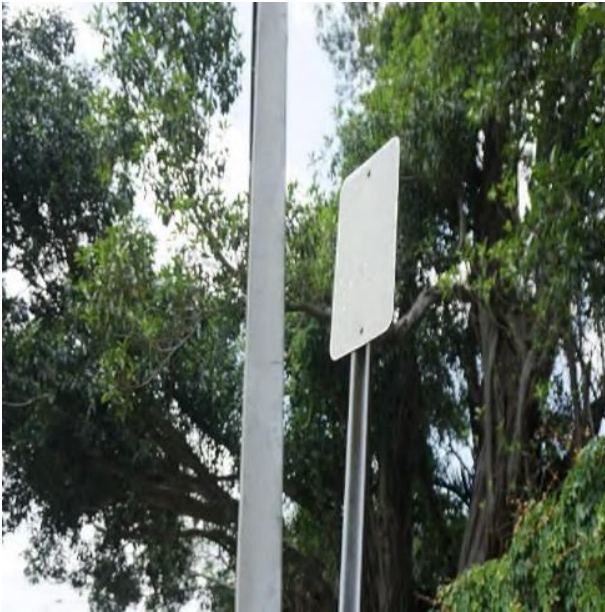
**Location: W 12<sup>TH</sup> AVENUE AND W 43<sup>RD</sup> PLACE INTERSECTION (FACING SOUTH)****Issue #11: Signage**

Sign is faded and illegible on the west side of W 12<sup>th</sup> Avenue along southbound lanes just south of W 43<sup>rd</sup> Place.

- Short-Term or Maintenance Project – Review necessity of sign and replace as required.
