# SENIOR LIVING FACILITIES ROAD SAFETY AUDIT

## WORK ORDER # GPC VII-02

OCTOBER  
2019

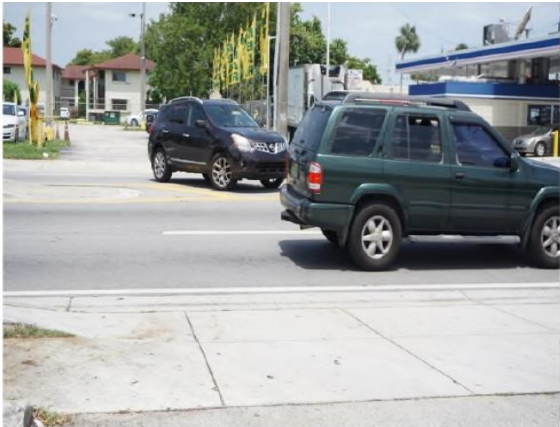
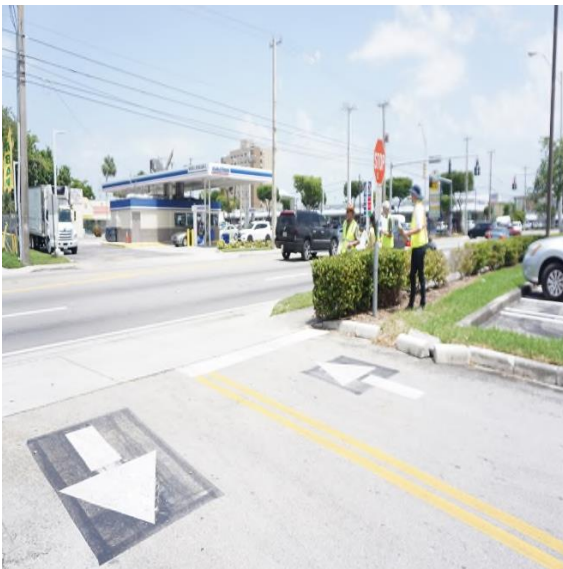
**Location: W 12<sup>TH</sup> AVENUE AND W 44<sup>TH</sup> PLACE INTERSECTION****Issue #12: Traffic Control**

Vehicles exiting the Walgreens on the southeast corner of the intersection through the driveway on the east side of W 12<sup>th</sup> Avenue currently turn right to travel northbound or make an illegal left turn to travel southbound. The left turn movement drive over the yellow restricted pavement marking. The queue to make this movement can cause a disruption of traffic flow for vehicles driving northbound on W 12<sup>th</sup> Avenue.

- Near-Term Project –  
Modify driveway lane configuration to allow right turn only movements from the W 12<sup>th</sup> Avenue southeast corner of the intersection. Pavement arrow markings and a lane assignment should be installed showing right turn only.  
In addition, extend the median island to prevent the southbound crossing movement.

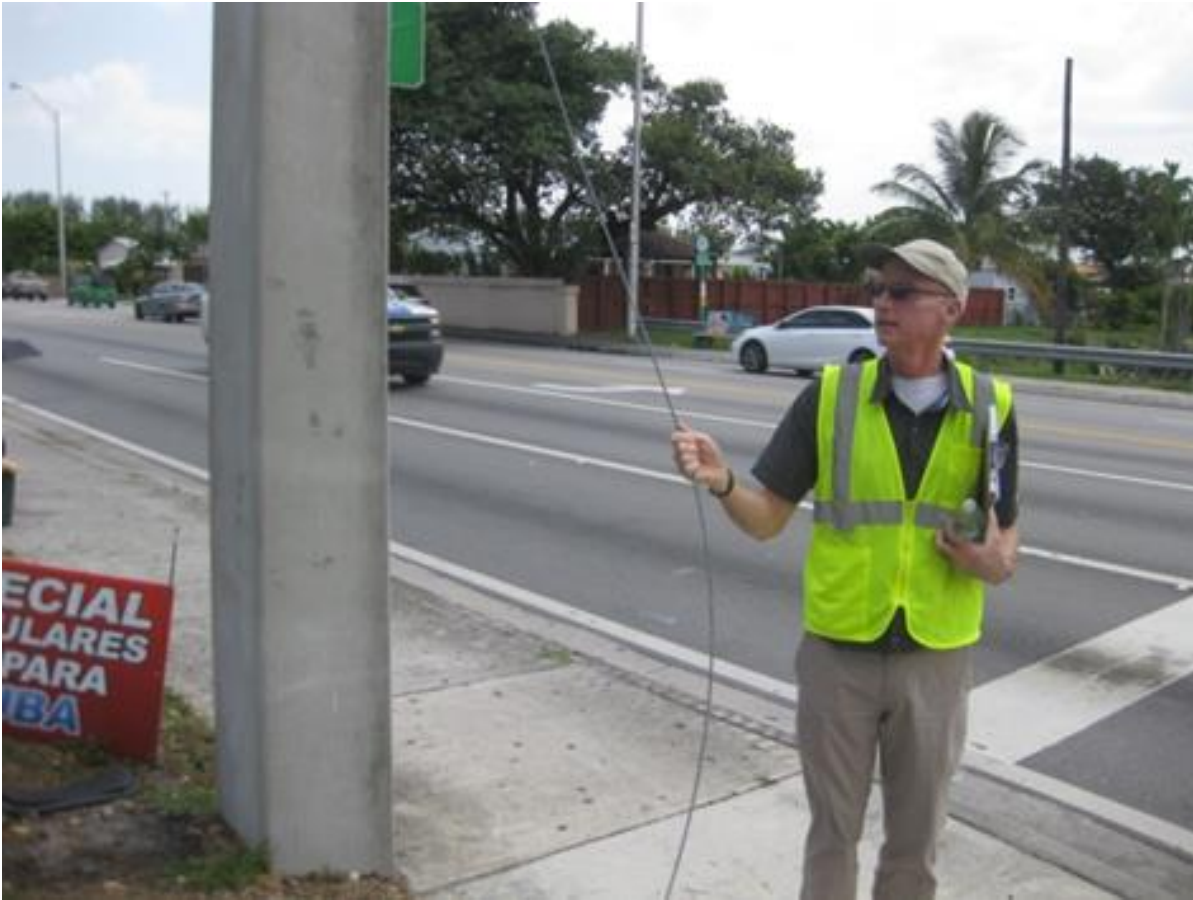
**Location: W 12<sup>TH</sup> AVENUE AND W 44<sup>TH</sup> PLACE INTERSECTION****Issue #13: Pedestrian Facility**

A length of broken cable hangs from a transmission line pole and is loosely coiled on ground near sidewalk on the northwest corner of the intersection. If disturbed, a pedestrian or bicyclist could become entangled.

- Short-Term or Maintenance Project –  
Contact appropriate maintaining agency to remove or reattach cable as appropriate.

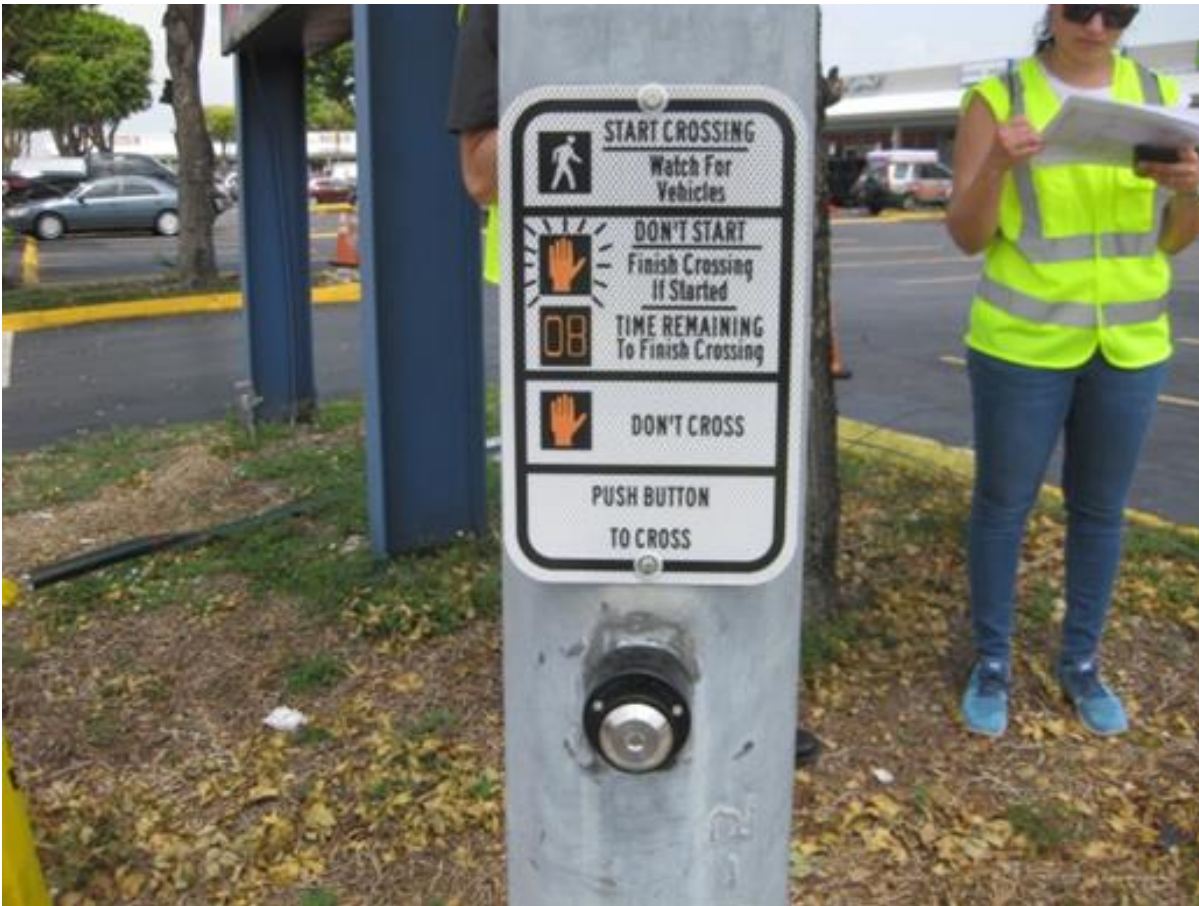
**Location: W 12<sup>TH</sup> AVENUE AND W 44<sup>TH</sup> PLACE INTERSECTION****Issue #14: Pedestrian Facility**

The pedestrian pushbuttons and attendant signs on all four corners are on a 45-degree angle with respect to the streets they control. The name of the street for which the pedestrian signals are activated, W 12<sup>th</sup> Avenue, is missing from the sign. (Pedestrian signals for the east and west legs of the intersection display WALK automatically during the north-south through movement and do not have pushbuttons.) A pedestrian could be confused by the configuration and improperly cross an approach. (A bicyclist who pushed the button while the RSA team was present thought the pushbutton controlled the pedestrian signals to cross W 44<sup>th</sup> Place.)

- Short-Term or Maintenance Project –  
Modify or install new pushbutton signs indicating the pushbutton is for crossing W 12<sup>th</sup> Avenue.

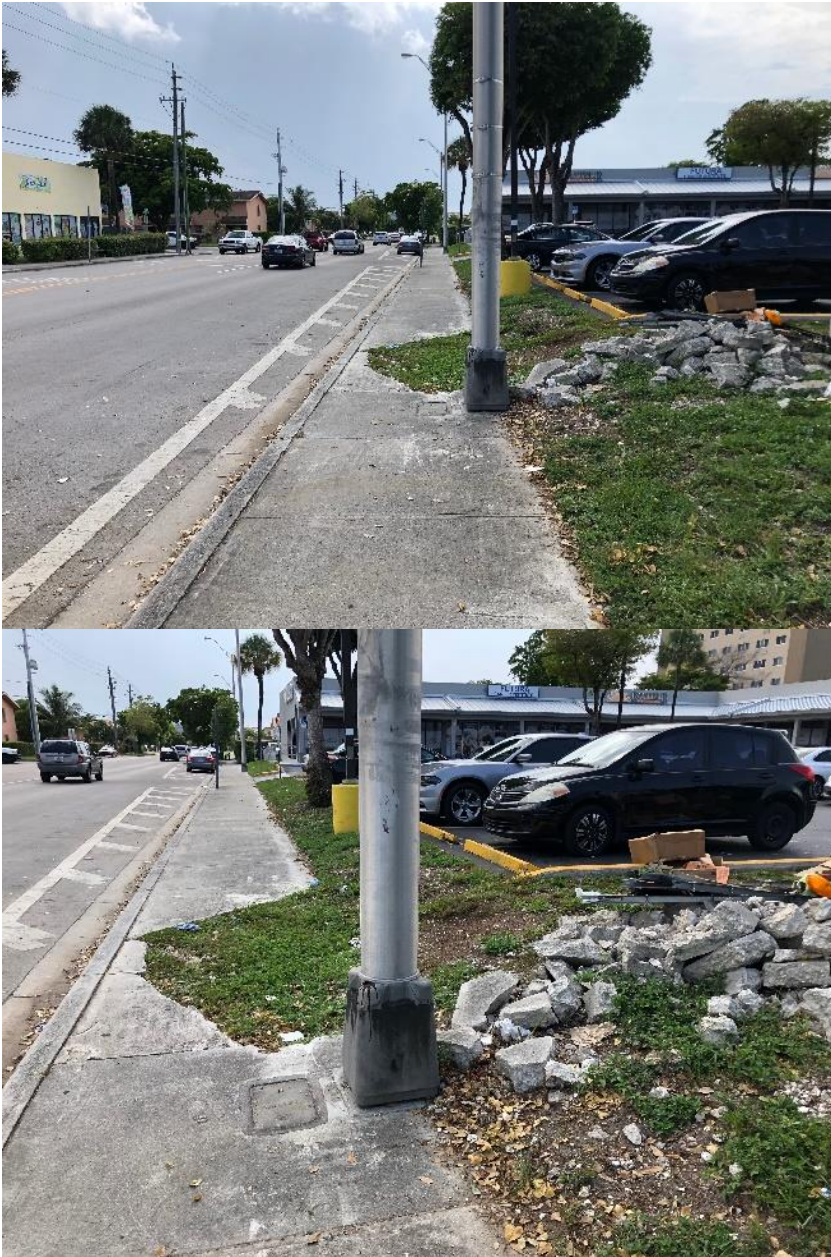
**Location: W 12<sup>TH</sup> AVENUE AND W 44<sup>TH</sup> PLACE INTERSECTION****Issue #15: Pedestrian Facility**

A section of sidewalk on the north side of W 44<sup>th</sup> Place just west of W 12<sup>th</sup> Avenue is missing, and grass has begun to grow in its place.

- Near-Term Project –  
Fill in missing section of sidewalk.

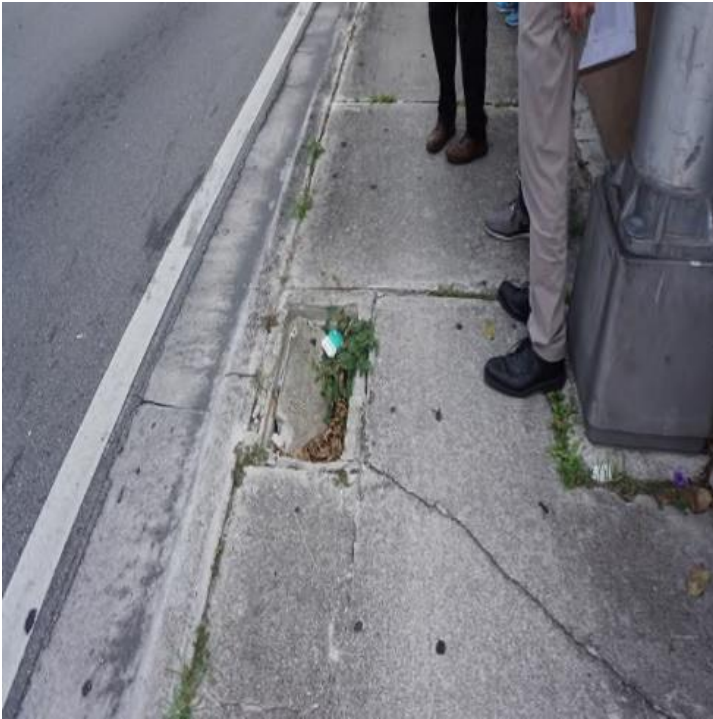
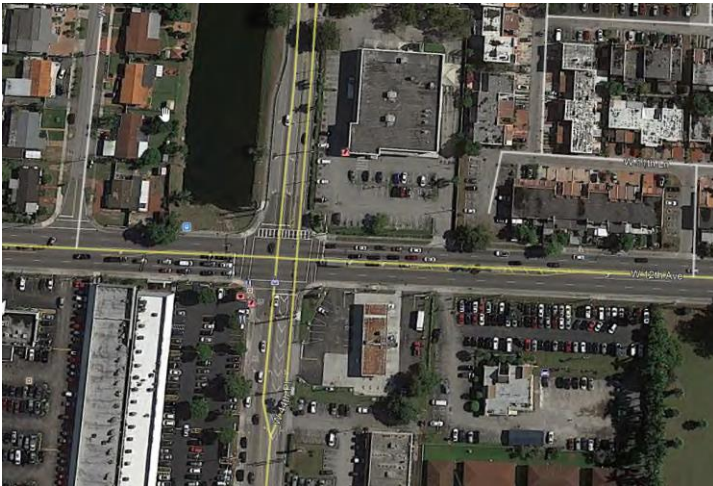
**Location: W 12<sup>TH</sup> AVENUE AND W 45<sup>TH</sup> PLACE INTERSECTION****Issue #16: Pedestrian Facility**

Exposed signal enclosure on the east side of W 12<sup>th</sup> Avenue along the northbound lanes just north of W 45<sup>th</sup> Place. Becomes a tripping hazard within the minimum width of the sidewalk.

- Short-Term or Maintenance Project – Replace the lid of the signal enclosure.

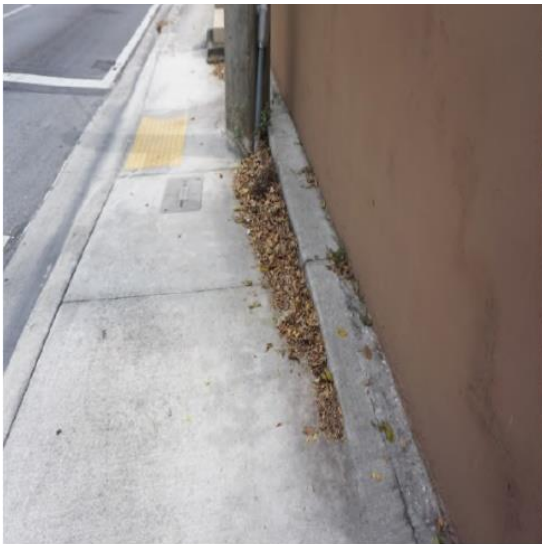
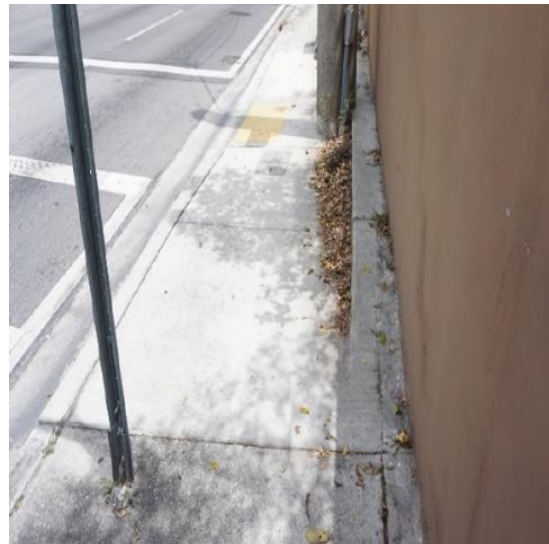
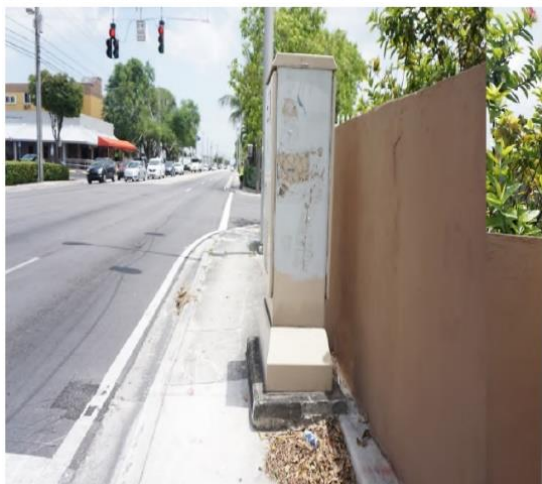
**Location: W 12<sup>TH</sup> AVENUE AND W 46<sup>TH</sup> STREET INTERSECTION****Issue #17: Pedestrian Facility**

Sidewalk clear width less than 32 inches due to a post mounted Do Not Block the intersection sign and cabinet on the southeast corner of the intersection.

- Short-Term or Maintenance Project – Consider alternative sign mounting options or placement in order to remove the sidewalk obstruction.
- Near-Term Project – Consider relocating the cabinet to allow for adequate sidewalk width.

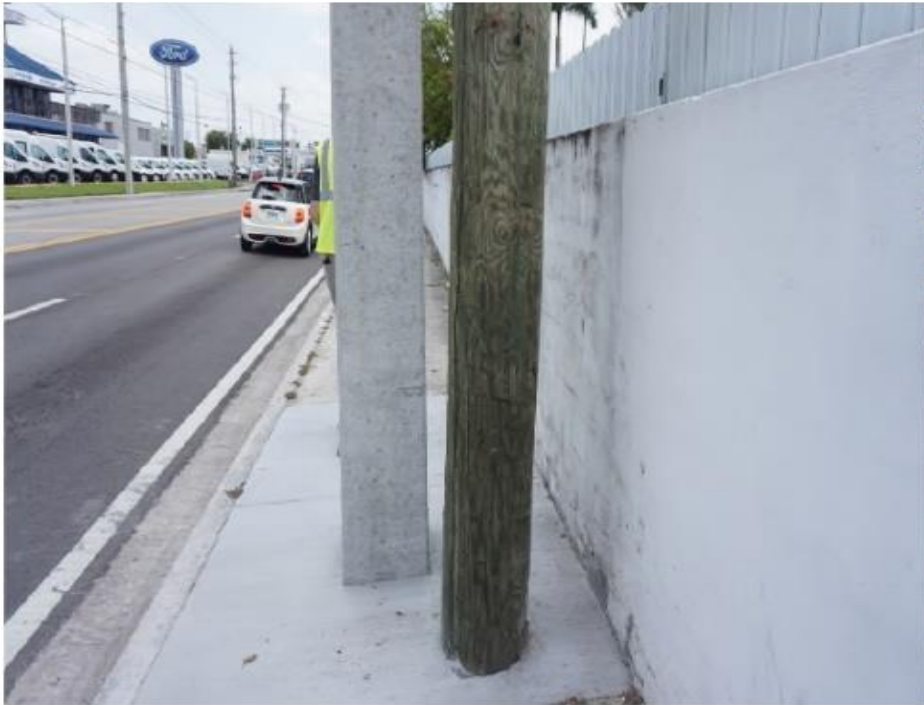
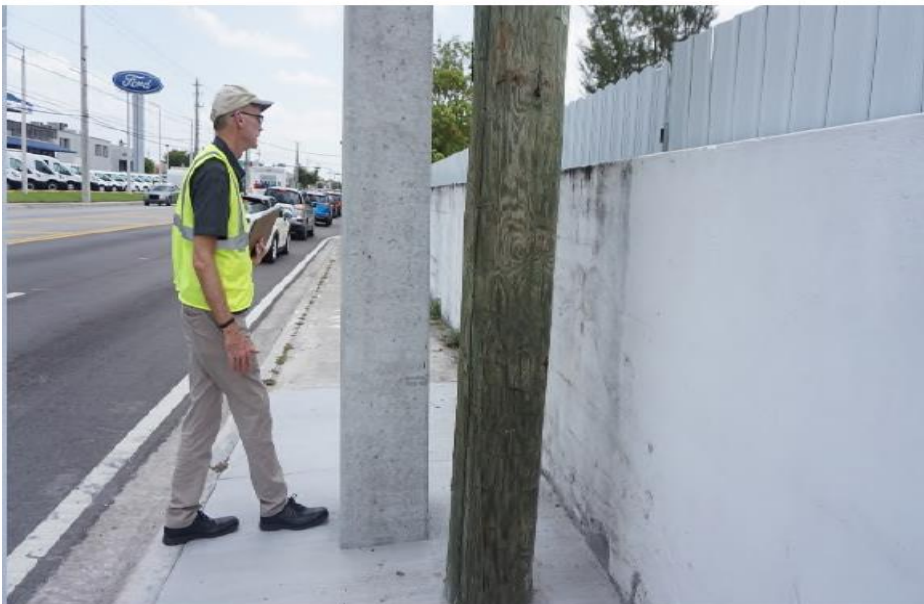
**Location: W 12<sup>TH</sup> AVENUE AND W 47<sup>TH</sup> STREET INTERSECTION****Issue #18: Pedestrian Facility**

Sidewalk clear width less than 32 inches on the east side of W 12<sup>th</sup> Avenue just north of W 47<sup>th</sup> Street.

- Near-Term Project –  
Coordinate with utilities to relocate pole to satisfy ADA standards.

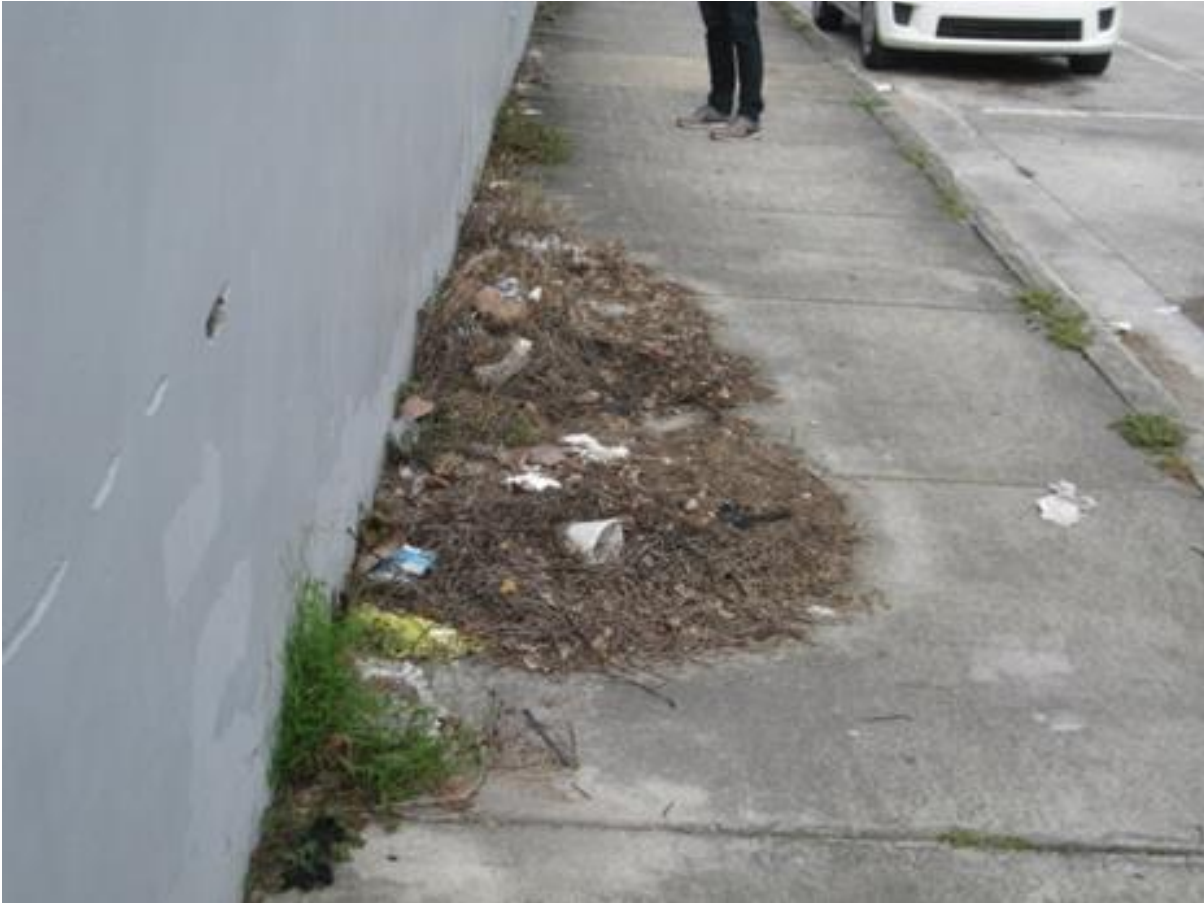
**Location: Location: W 12<sup>TH</sup> AVENUE AND W 47<sup>TH</sup> STREET INTERSECTION****Issue #19: Pedestrian Facility**

A significant amount of debris and trash was observed on the sidewalk of the north side of W 47<sup>th</sup> Street, east of W 12<sup>th</sup> Avenue.

- Short-Term or Maintenance Project –  
Remove trash and debris from sidewalk.

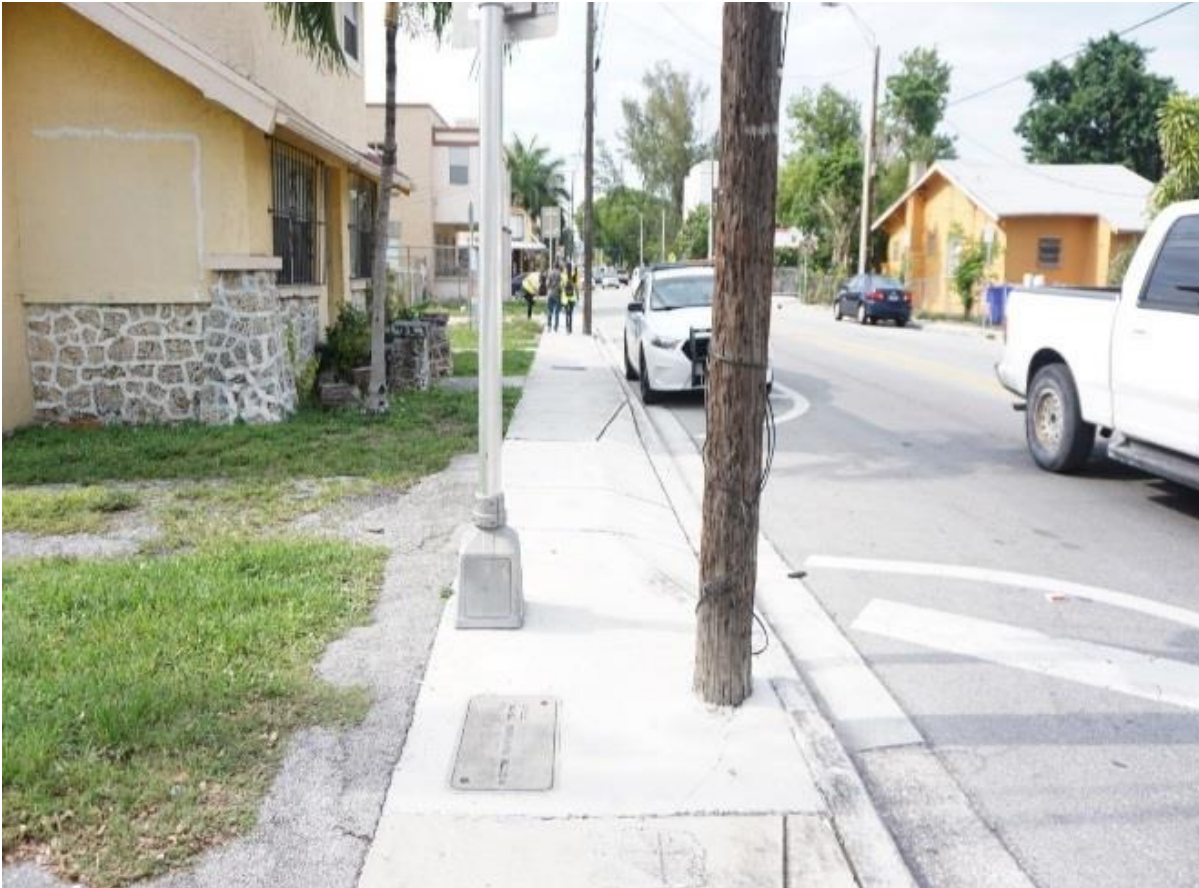
**Location: W 12<sup>TH</sup> AVENUE AND W 50<sup>TH</sup> PLACE INTERSECTION (FACING NORTH)****Issue #20: Pedestrian Facility**

Sidewalk appears to drop gradually in grade. Area could be difficult to traverse.

- Near-Term Project –  
Correct sidewalk grades to allow safe usage.

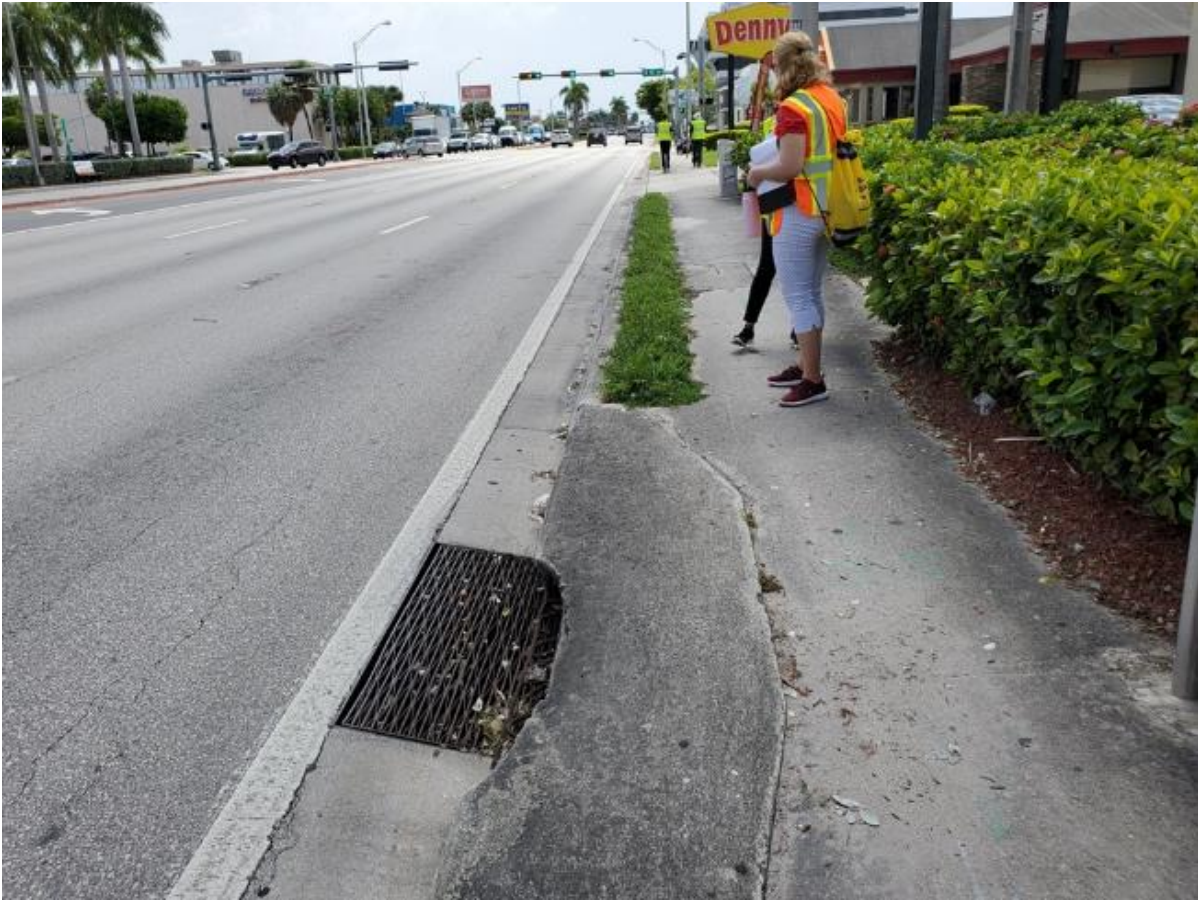
**Location: 1012-14 W 49<sup>TH</sup> STREET****Issue #21: Pedestrian Facility**

On the south side of W 49<sup>th</sup> Street just west of W 10<sup>th</sup> Avenue, the curb area of sidewalk over the drainage grate is crumbling and a significant chunk has broken off, creating a tripping hazard.

- Near-Term Project –  
Repair or replace the broken sidewalk.

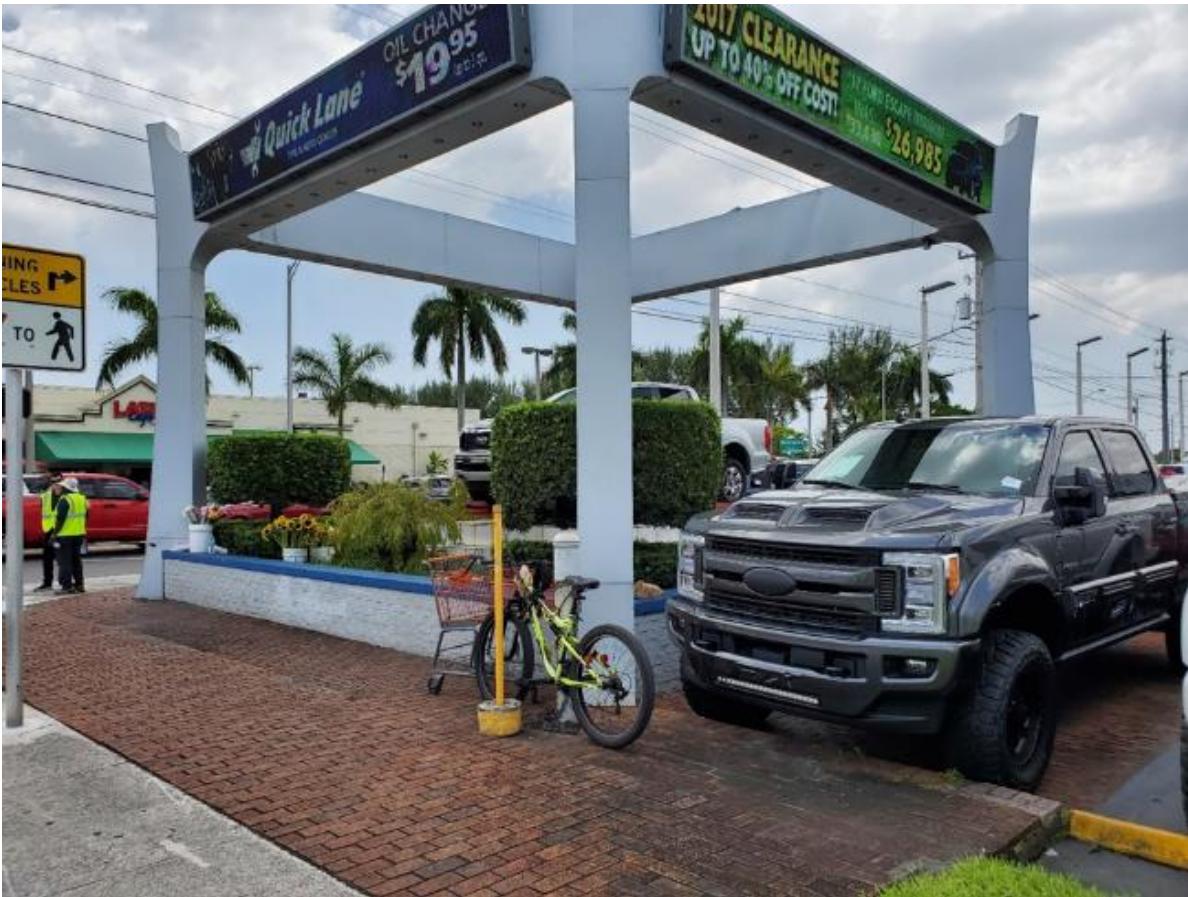
**Location: W 12<sup>TH</sup> AVENUE AND W 49<sup>TH</sup> STREET****Issue #22: Bicycle Facility**

Bicyclist resorting to using sign poles from car dealership to secure their bicycle on the southwest corner of the intersection.

- Short-Term or Maintenance Project – Increase the number of bike racks along W 49<sup>th</sup> Street. Several cyclists were observed along W 49<sup>th</sup> Street during the field visit.

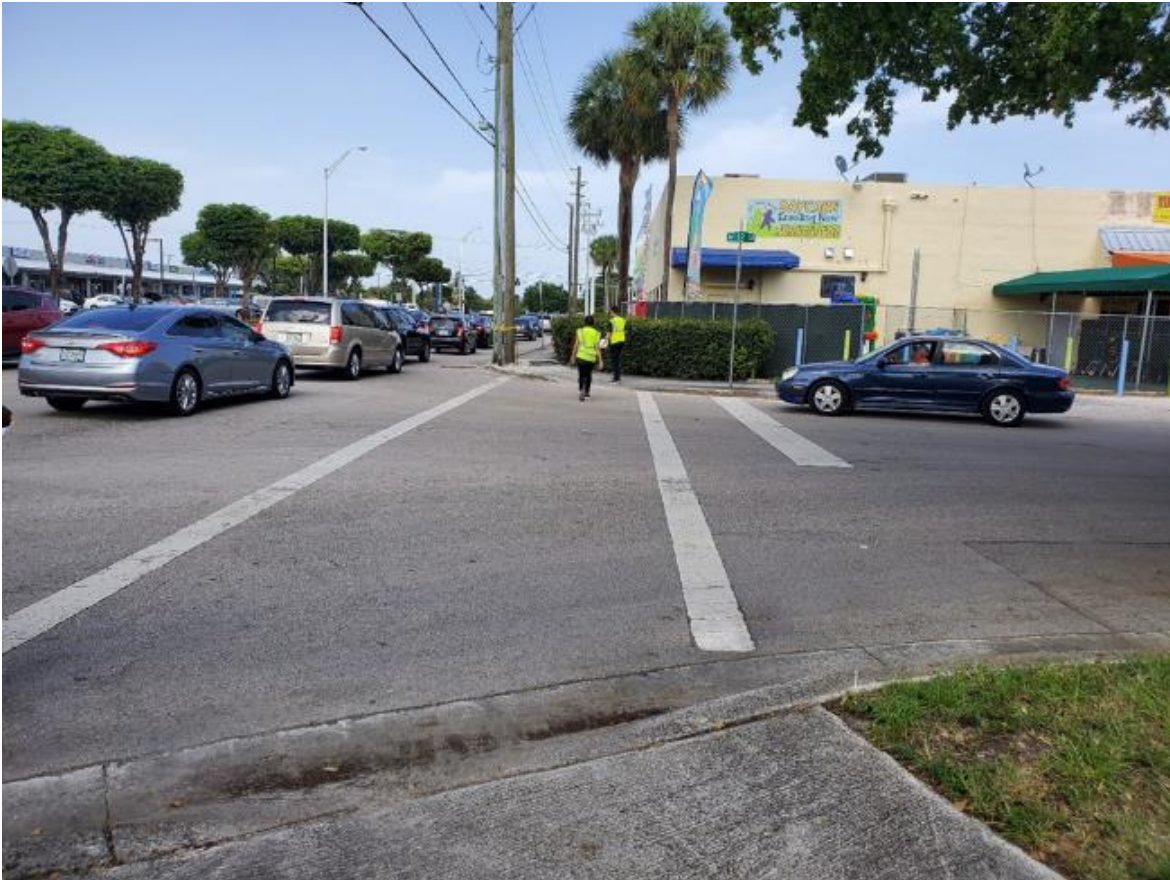
**Location: W 12<sup>TH</sup> LANE AND W 44<sup>TH</sup> PLACE INTERSECTION****Issue #23: Pedestrian Facility**

Crosswalk on W 12<sup>th</sup> Lane does not have truncated domes at both ends.

- Short-Term or Maintenance Project –  
Install truncated domes on curb ramps.

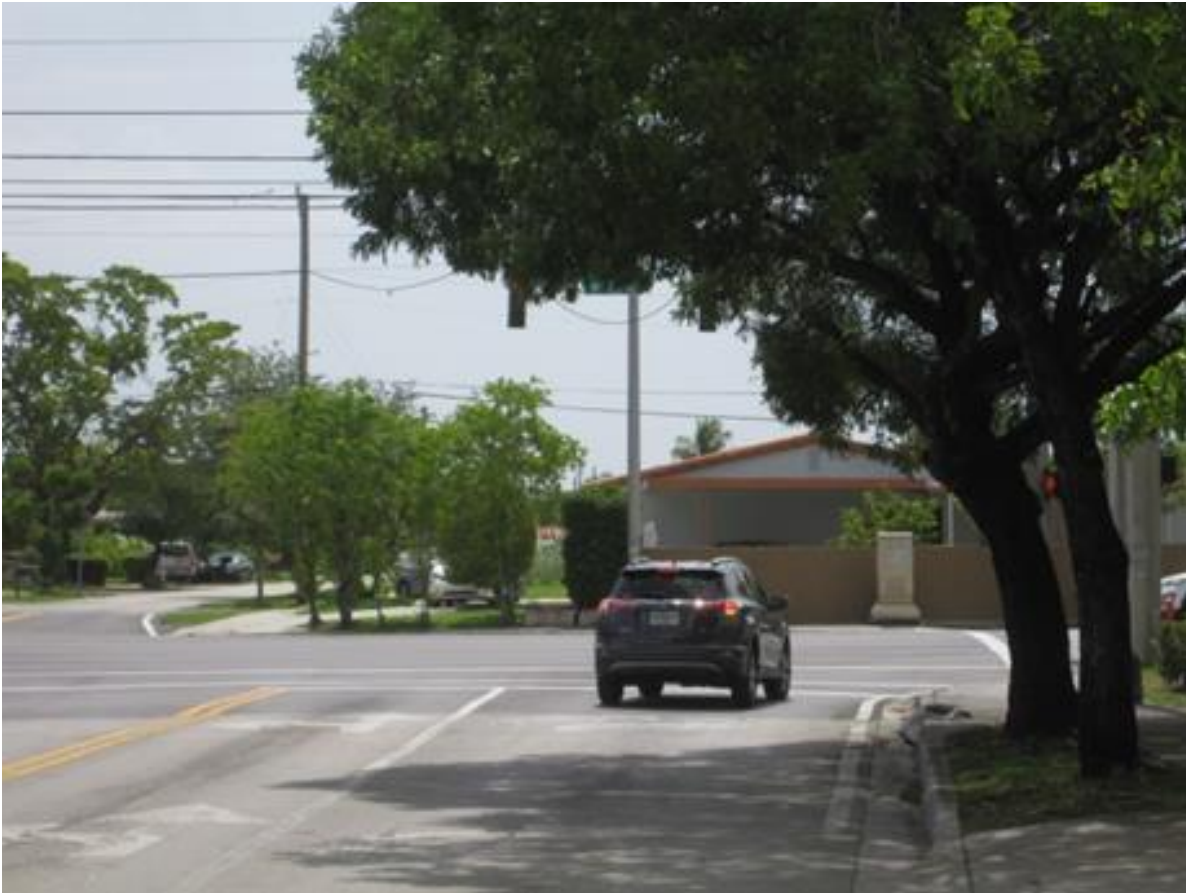
**Location: W 12<sup>TH</sup> AVENUE AND W 46<sup>TH</sup> STREET INTERSECTION****Issue #24: Traffic Control**

Overhead limbs of roadside trees obscure driver's view of traffic signal heads until vehicle is close to the intersection on the eastbound approach on W 46<sup>th</sup> Street.

- Short-Term or Maintenance Project – Trim overhead foliage.

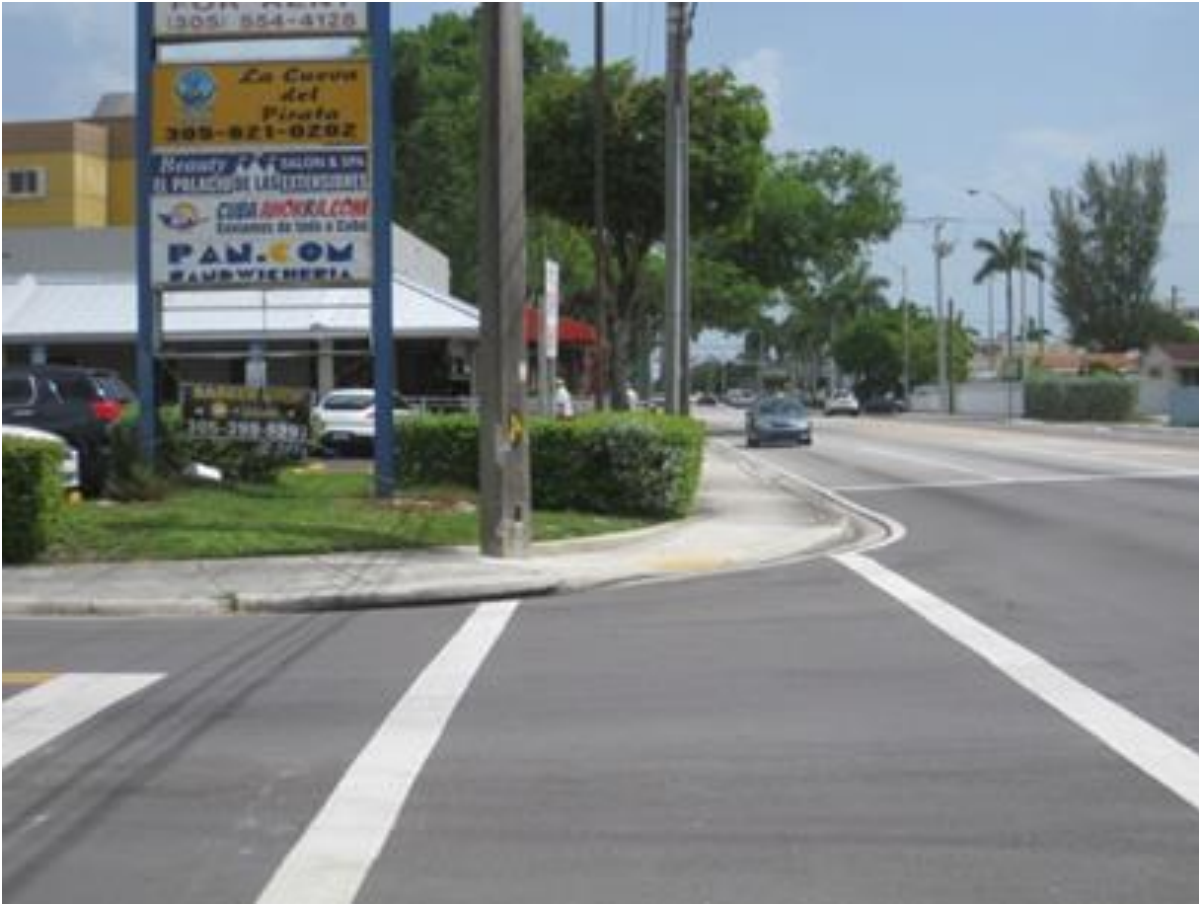
**Location: W 12<sup>TH</sup> AVENUE AND W 46<sup>TH</sup> STREET INTERSECTION****Issue #25: Pedestrian Facility**

There are no pedestrian signal heads on the west leg of the intersection. Signal poles are existent on each corner.

- Near-Term Project –  
Install pedestrian signal heads with pushbuttons to allow WALK during N-S through phase.

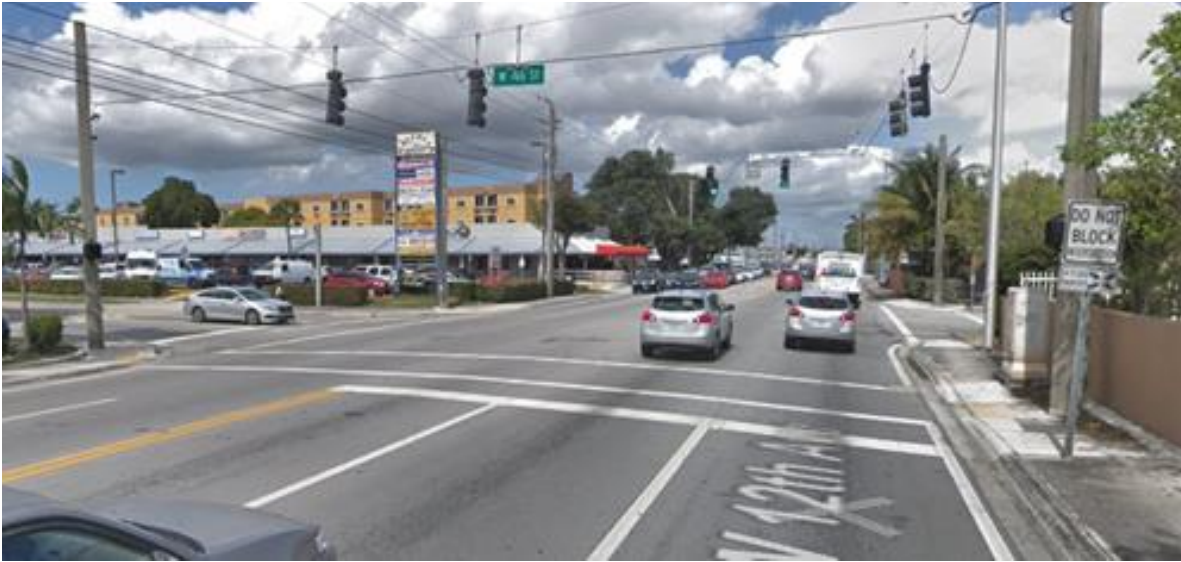
**Location: W 12<sup>TH</sup> AVENUE AND W 46<sup>TH</sup> STREET INTERSECTION****Issue #26: Pedestrian Facilities**

This crosswalk is the only one at the intersection having pedestrian signals. Observations of the pedestrian signal operations reveal a 7-second WALK followed by a 10-second flashing don't walk countdown. The countdown period is insufficient to allow the pedestrian to cross the five traffic lanes or 65 feet.

- Near-Term Project –  
Adjust pedestrian signal clearance intervals on W 12<sup>th</sup> Avenue to accommodate at a minimum a walking speed of 3.5 seconds for all pedestrian crossing times.

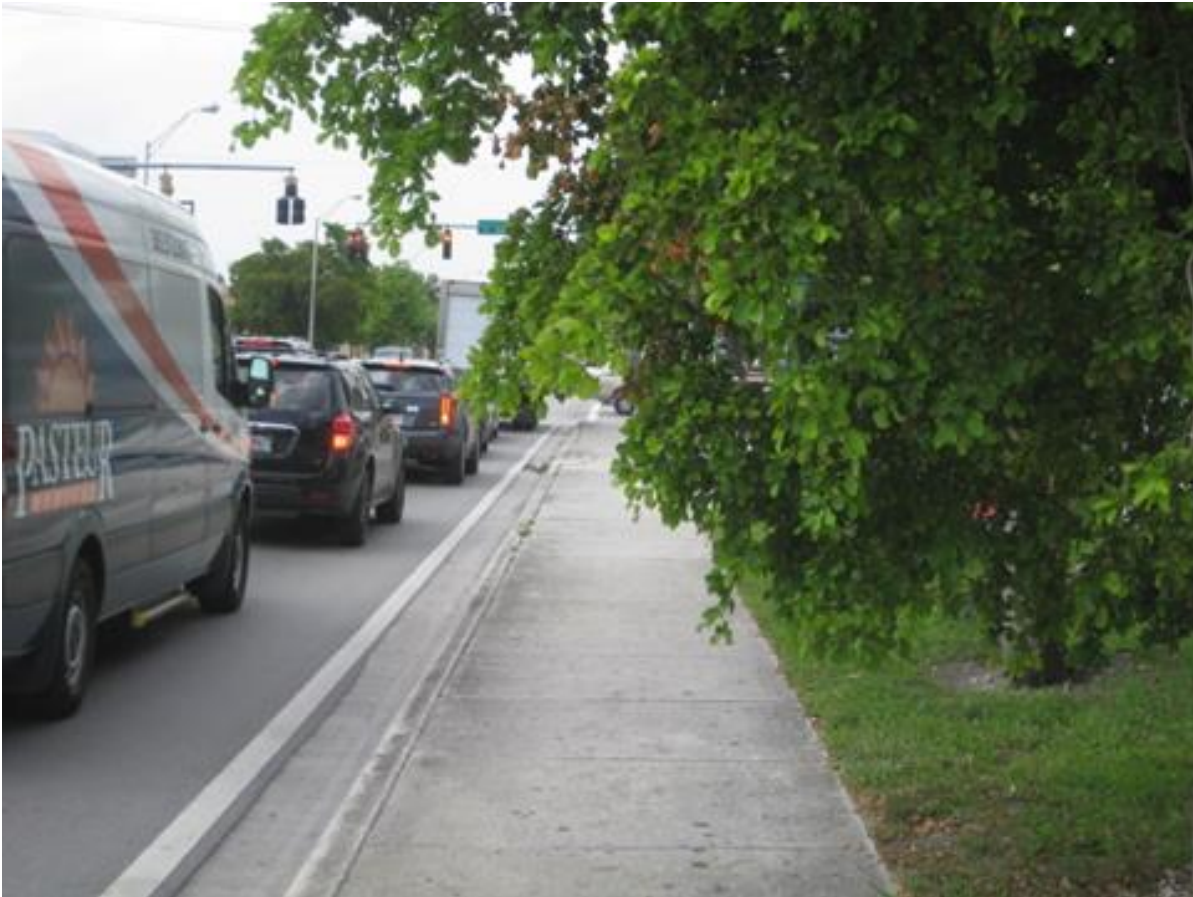
**Location: W 12<sup>TH</sup> AVENUE AND W 46<sup>TH</sup> STREET INTERSECTION****Issue #27: Pedestrian Facility**

Roadside tree foliage impedes pedestrian movements on the sidewalk on the east side of W 12<sup>th</sup> Avenue just south of W 46<sup>th</sup> Street.

- Short-Term or Maintenance Project – Trim foliage.

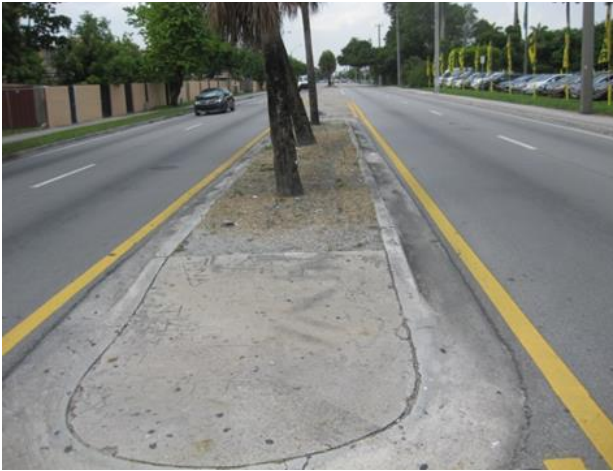
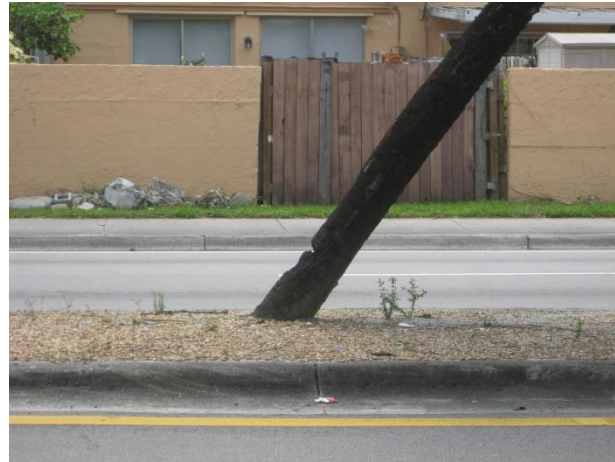
**Location: W 12<sup>TH</sup> AVENUE BETWEEN W 44<sup>TH</sup> PLACE AND W 42<sup>ND</sup> PLACE****Issue #28: Roadway**

There are two raised median areas which have three and five palm trees respectively. The trees are sizable with trunks about 10-12 inches in diameter. The terminals of the curbed median are paved and tapered from pavement grade up to full-depth, Type-F curb height. This essentially forms a ramp for vehicles straying into the median area, providing no impediment to impacting the palm trees. The first palm tree in each of the two median areas bear evidence of vehicle impacts. The posted speed limit on this section of W 12<sup>th</sup> Avenue is 40 MPH. The palm trees pose a potential hazard to motorists.

- Short-Term or Maintenance Project –  
Replace the palm trees with less hazardous landscaping, such as bushes.
- Near-Term Project –  
Remove the tapered curve, providing a full curb height around the nose of the median.

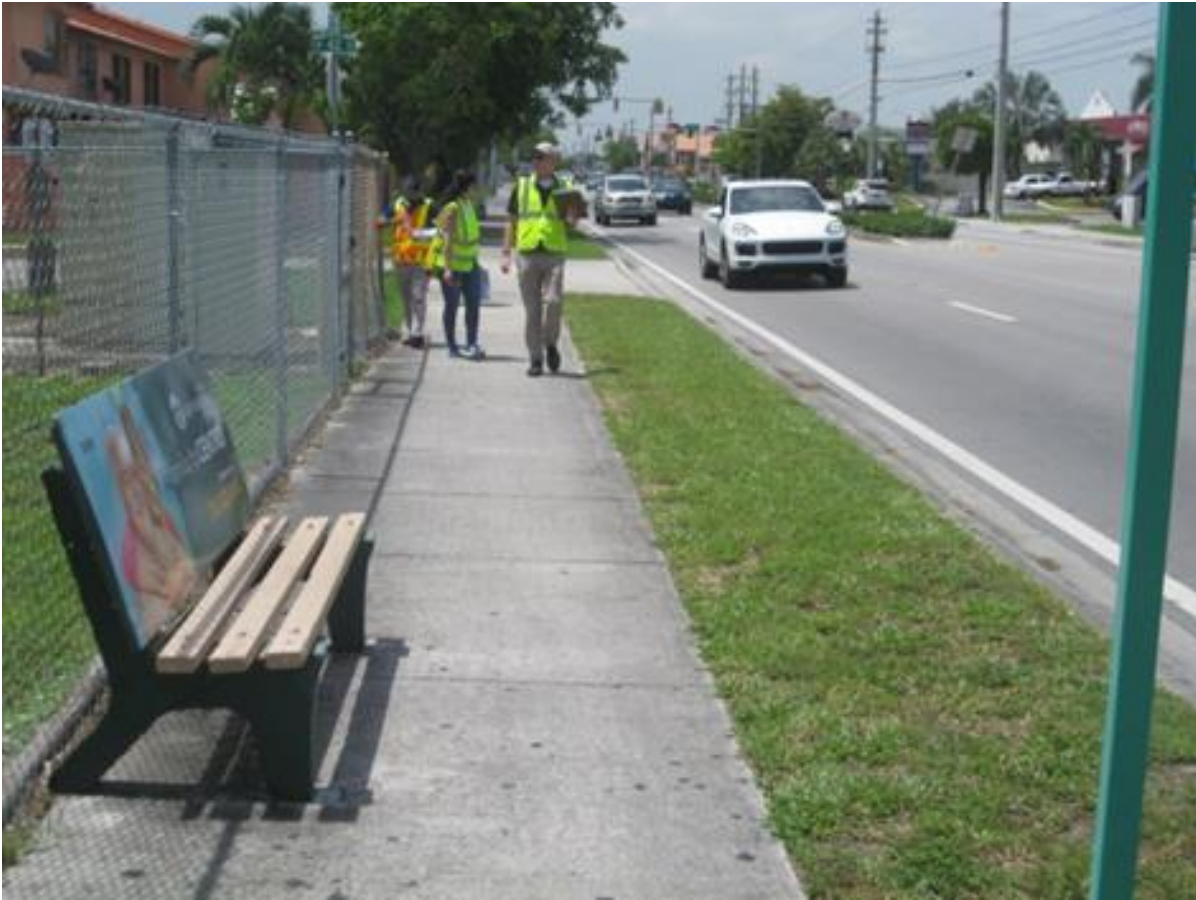
**Issue #29: Pedestrian Facility**

**Location: W 12<sup>TH</sup> AVENUE NORTH OF W 42<sup>ND</sup> STREET**

There are midblock bus stops on both sides of W 12<sup>th</sup> Avenue, several hundred feet north of a raised median section. Pedestrians disembarking buses most likely cross W 12<sup>th</sup> Avenue at the bus stop locations instead of walking south to W 41<sup>st</sup> Street which is a signalized intersection.

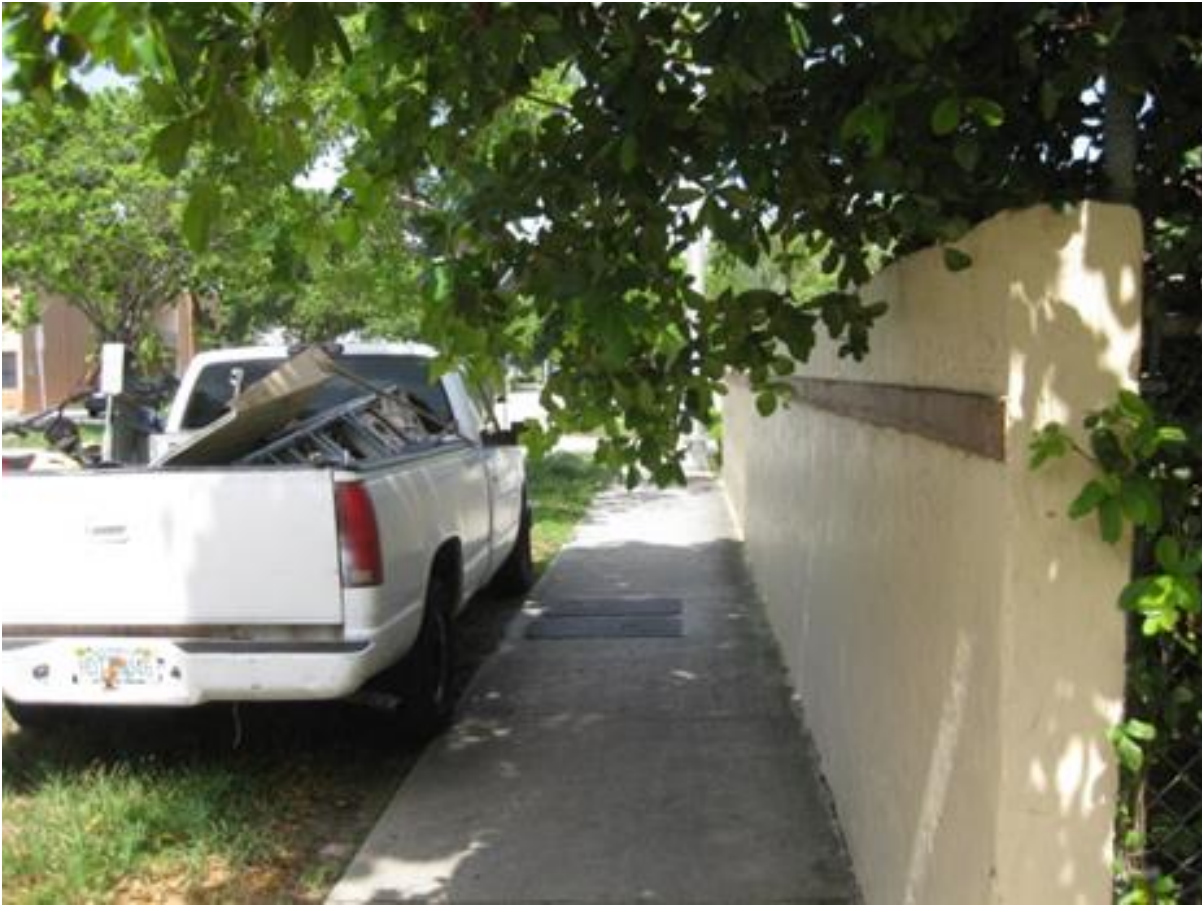
**Issue #30: Pedestrian Facility**

**Location: W 46<sup>TH</sup> STREET BETWEEN W 12<sup>TH</sup> AVENUE AND W 15<sup>TH</sup> AVENUE**

Overhead branches from trees on adjacent private properties encroach upon sidewalks and impede pedestrians and bicyclists at several locations along W 46<sup>th</sup> Street.

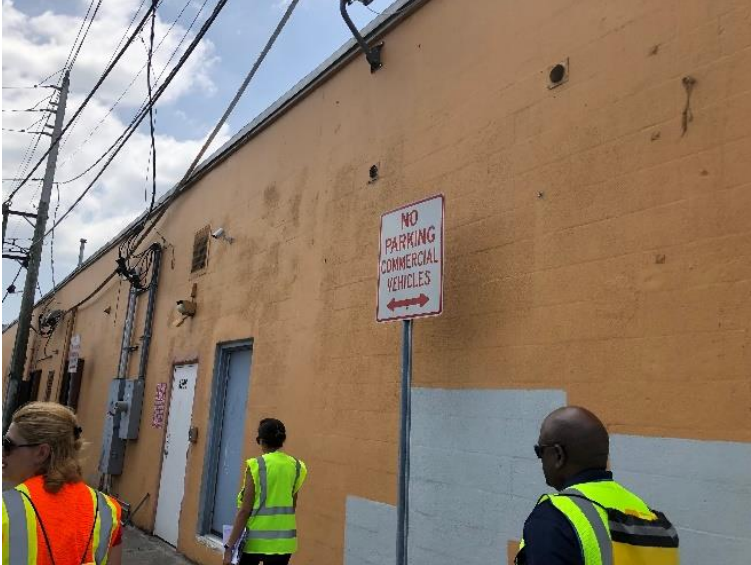
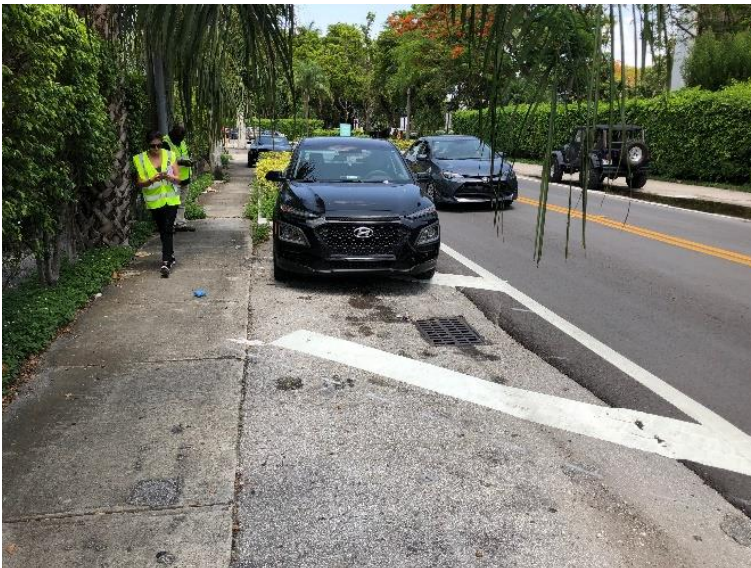
**Issue #31: Parking**

**Location: W 49<sup>TH</sup> PLACE BETWEEN W 14<sup>TH</sup> LANE AND W 12<sup>TH</sup> LANE**

Vehicles parking in restricted parking zones along the southside sidewalk on W 49<sup>th</sup> Place restrict line of sight for vehicles attempting to pull out onto the road.

- Near-Term Project –  
Increase enforcement of parking restrictions.

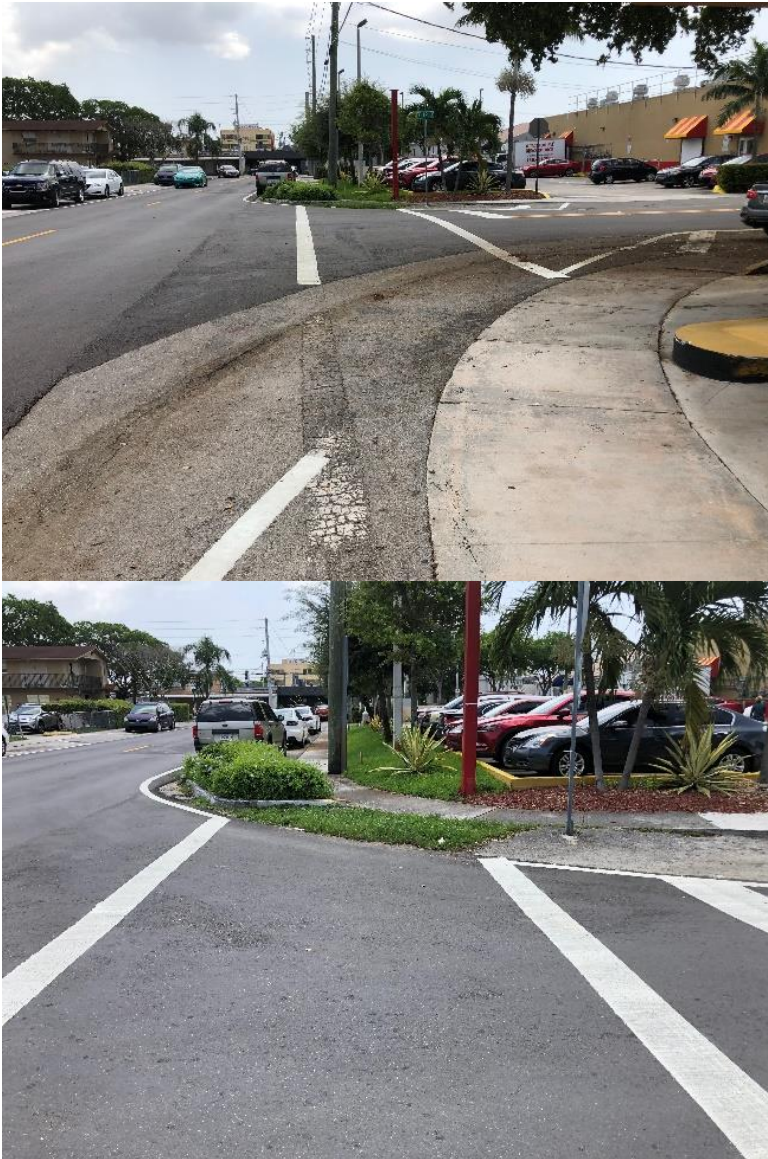
**Location: W 12<sup>TH</sup> LANE AND W 49<sup>TH</sup> PLACE INTERSECTION****Issue #32: Pedestrian Facility**

Crosswalk paint is worn out on the south side of the intersection. The southeast corner of the intersection is missing a curb ramp and access to the sidewalk is blocked by landscape.
