# SENIOR LIVING FACILITIES ROAD SAFETY AUDIT

## WORK ORDER # GPC VII-02

OCTOBER  
2019

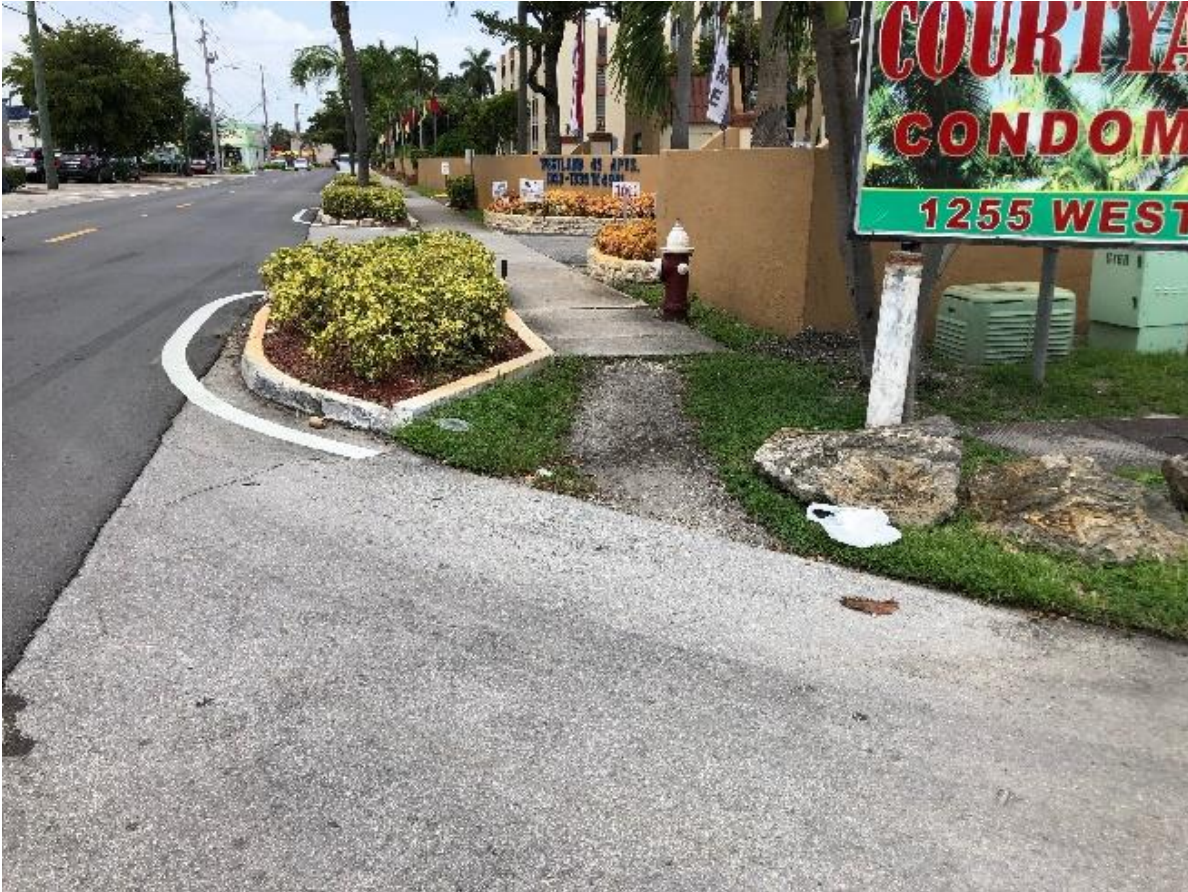
**Issue #33: Pedestrian Facility**

The sidewalk ends as it connects to the driveway at Courtyards II Condominium and turns into a gravel pathway. This creates a tripping hazard for pedestrians.

- Near-Term Project –  
Fill in missing section of sidewalk.

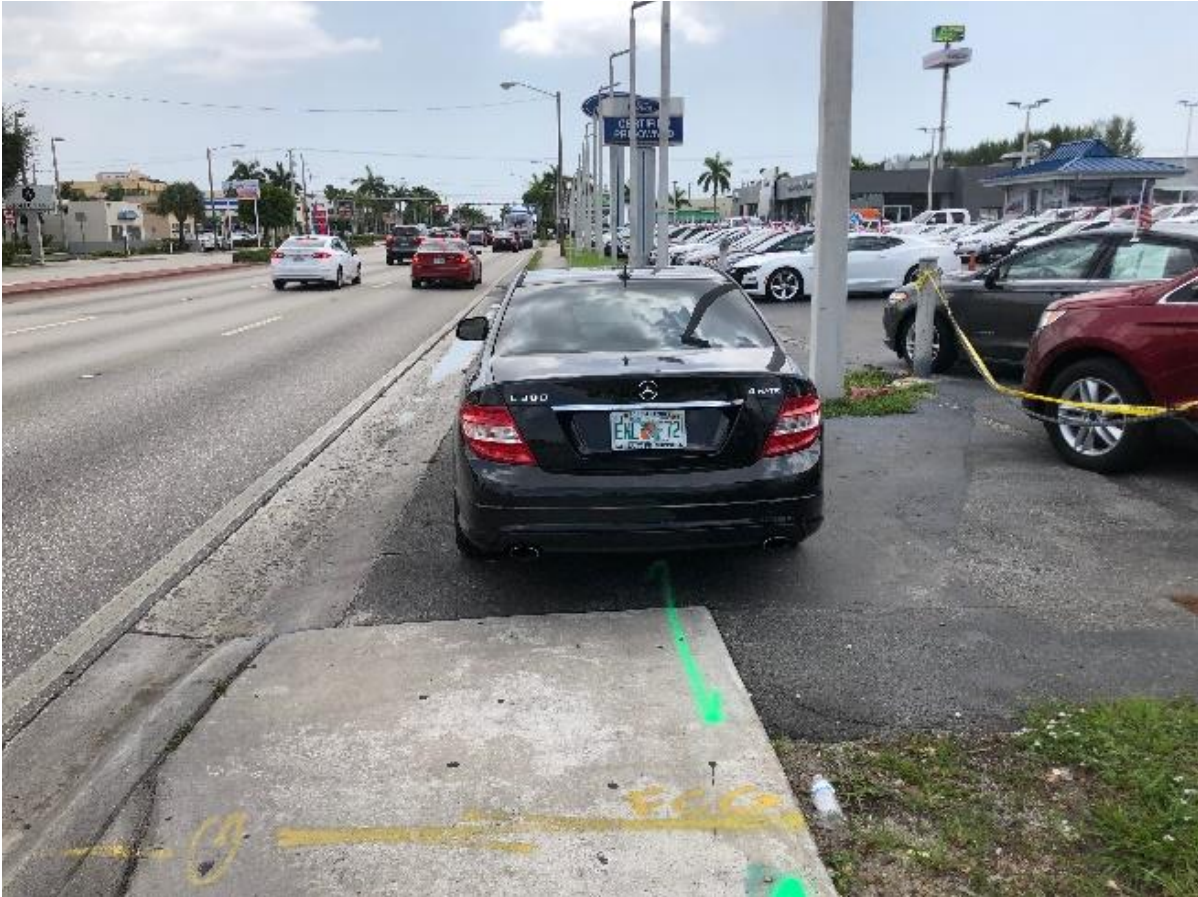
**Location: W 12<sup>TH</sup> AVENUE AND W 49<sup>TH</sup> PLACE INTERSECTION****Issue #34: Pedestrian Facility**

The Ford Dealership on the southwest corner of the W 49<sup>th</sup> Place and W 12<sup>th</sup> Avenue intersection has vehicles parked in driveways that are blocking sections of the sidewalk.

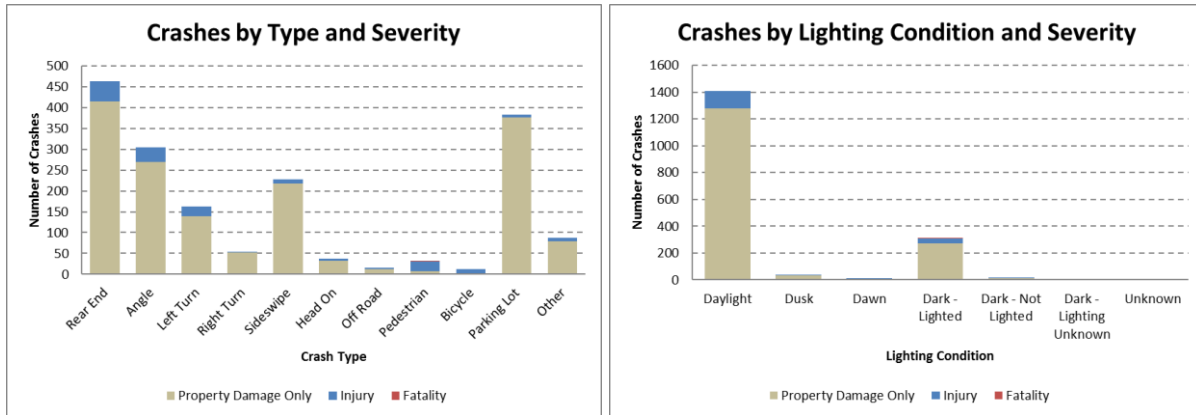
The reported crashes by crash type are displayed below. Twenty-six (26) percent (463 crashes) were rear end crashes, twenty-two (22) percent (376 crashes) were parking lot crashes, and seventeen (17)

percent (227 crashes) were angle crashes. Twenty-one (21) percent of crashes occurred under non-daylight conditions.

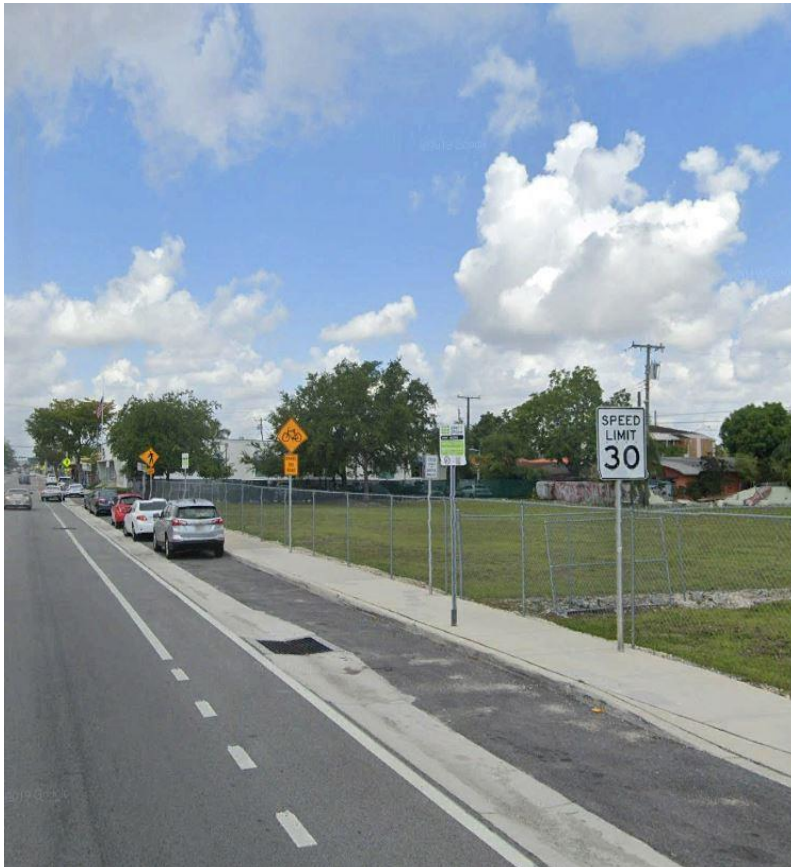
#### Issue #1: Vehicular Speed

Posted speeds are 30 MPH for the study area. Based on visual observation, speeds appear to routinely exceed 30 MPH on West Flagler Street and SW 22<sup>nd</sup> Avenue.

- Near-Term Project –  
Identify resources to enforce posted speeds; consider investigating state or federal grants to provide speed enforcement.
- Long-Term Project –  
Conduct a study to determine if travel lanes can be narrowed through resurfacing projects to reduce speeds.

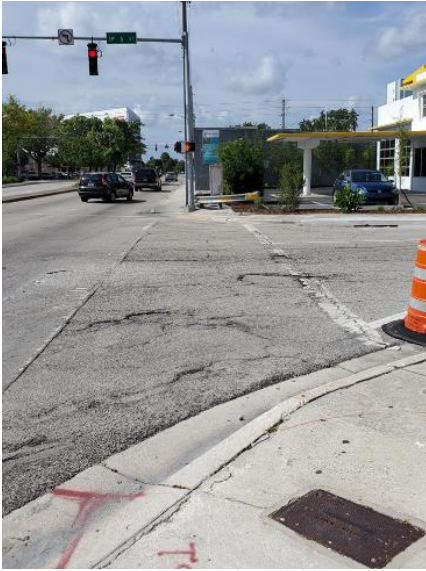
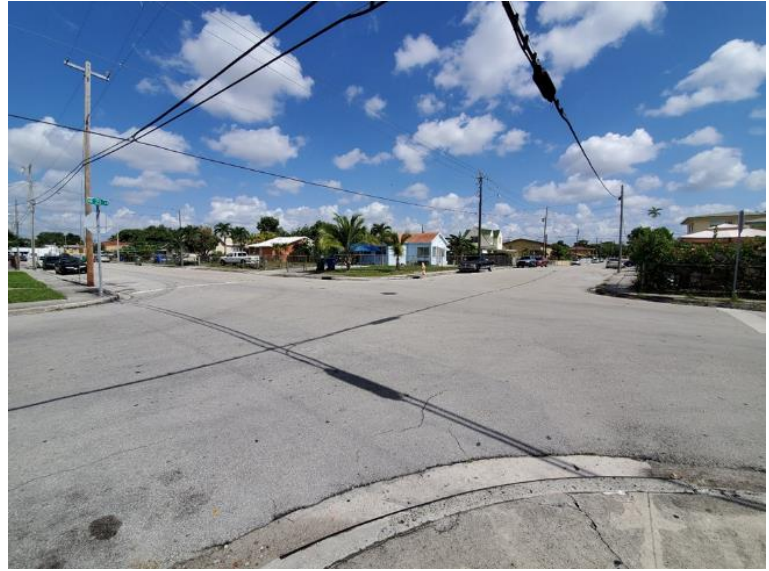
**Issue #2: Pedestrian Crossings**

Crosswalk pavement markings on major and minor streets throughout the study area are missing or faded.

- Short-Term or Maintenance Project –  
Restripe intersection crosswalks where faded.
- Near-Term Project –  
Add crosswalks at signalized and stop controlled intersection approaches where they are currently missing. These crosswalks are intended to improve pedestrian safety by facilitating pedestrian crossings at designated locations.

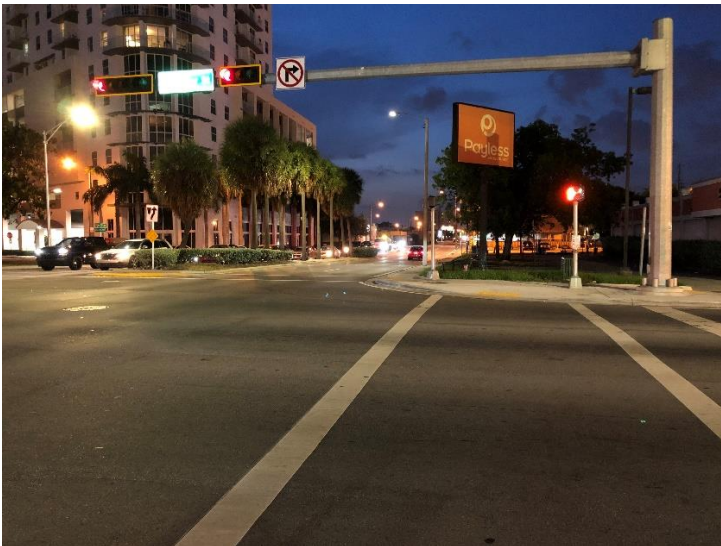
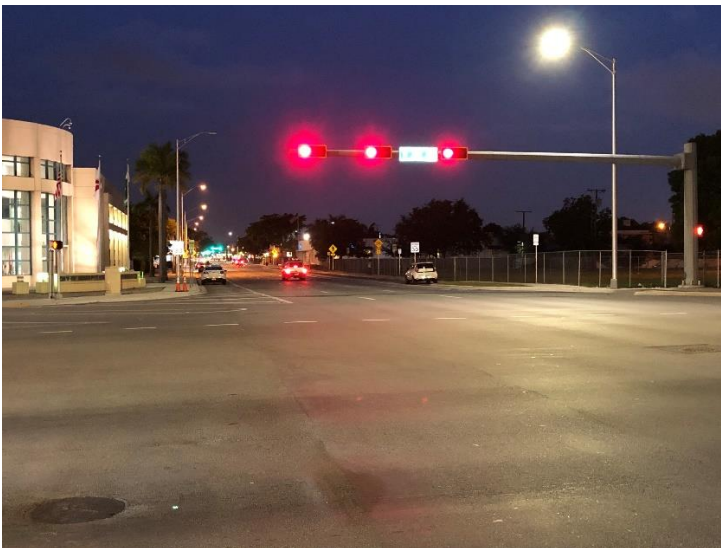
- SW 1<sup>st</sup> Street and SW 22<sup>nd</sup> Avenue has a burnt-out light on the northeast corner
- SW 1<sup>st</sup> Street and SW 22<sup>nd</sup> Avenue is missing a light on the southwest corner
- West Flagler Street east of SW 22<sup>nd</sup> Avenue at the RRFB has a burnt-out light on the south side
- West Flagler Street and SW 22<sup>nd</sup> Avenue has a burnt-out light on the northeast corner
- West Flagler Street and SW 22<sup>nd</sup> Avenue has a burnt-out light on the south side of the west leg
- West Flagler Street is not lit on the north side of the road west of SW 22<sup>nd</sup> Avenue
- West Flagler Terrace and SW 23<sup>rd</sup> Avenue has a burnt-out light on the northeast corner
- SW 2<sup>nd</sup> Terrace has a burnt-out light on the south side
- SW 4<sup>th</sup> Street between SW 21<sup>st</sup> Avenue and SW 19<sup>th</sup> Avenue has two burnt out lights

- Short-Term or Maintenance Project –  
Conduct maintenance efforts to replace burnt out lights and replace signs that are damaged or have poor retroreflectivity.
- Near-Term Project –  
Restripe lane pavement markings on Beacom Boulevard.
- Long-Term Projects –  
Conduct lighting study to determine if additional lighting is needed.

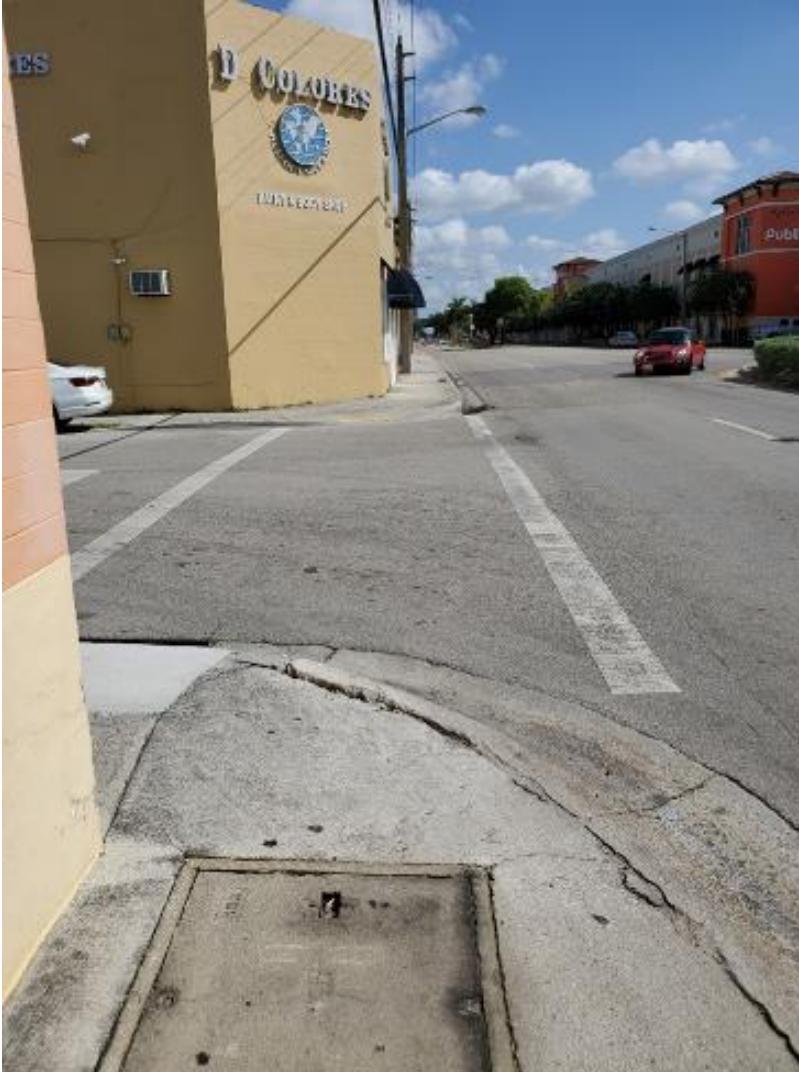
**Location: SW 22<sup>ND</sup> AVENUE AND SW 3<sup>RD</sup> STREET INTERSECTION****Issue #5: Pedestrian Facility**

The pedestrian curb ramp by the southwest corner of SW 22<sup>nd</sup> Avenue and SW 3<sup>rd</sup> Street leads pedestrians into the street and does not face the crosswalk.

- Near-Term Projects –  
Re-orient curb ramp to lead into the crosswalk and install truncated dome surface.

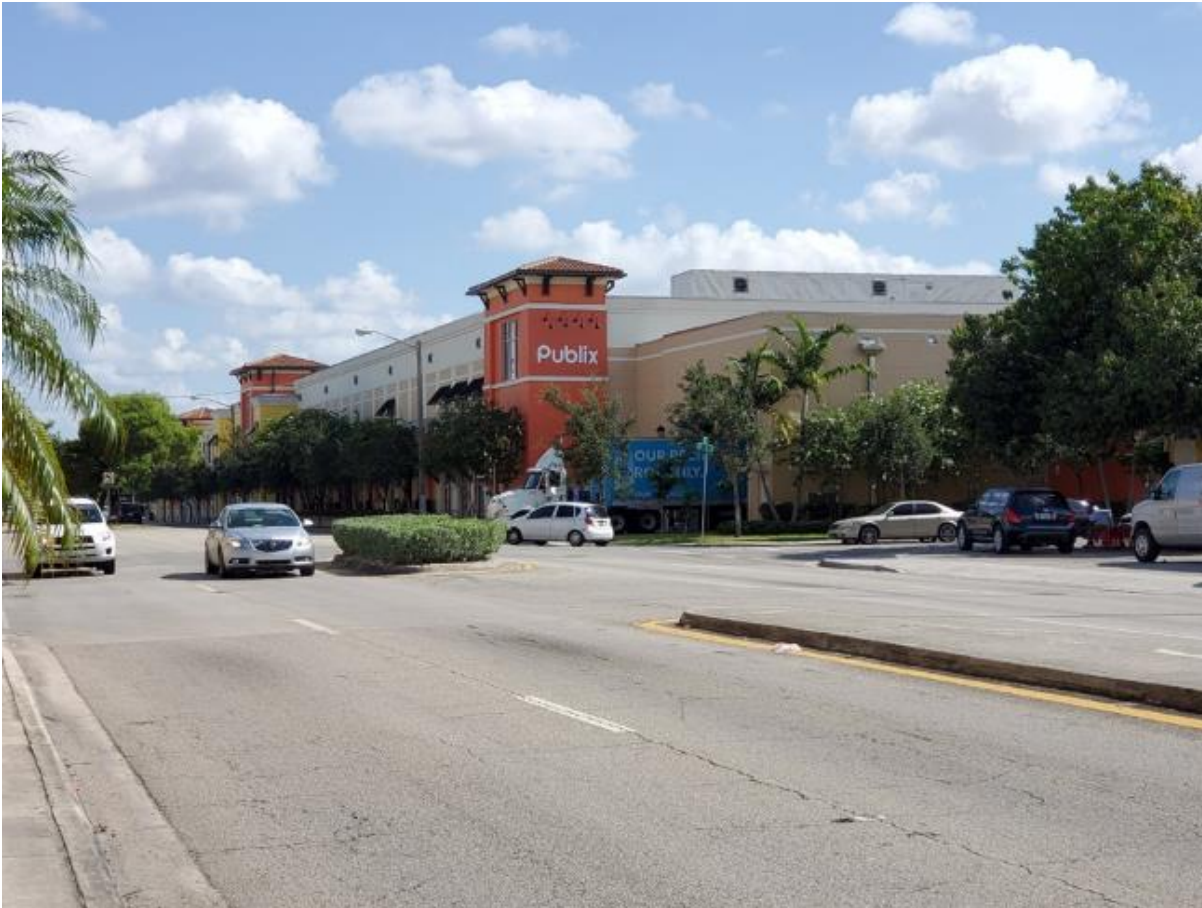
**Location: SW 22<sup>ND</sup> AVENUE AND SW 3<sup>RD</sup> STREET INTERSECTION****Issue #6: Pedestrian Facility**

There are no marked east-west pedestrian crossings along SW 22<sup>nd</sup> Avenue between SW 1<sup>st</sup> Street and SW 6<sup>th</sup> Street (approximately 0.3 miles).

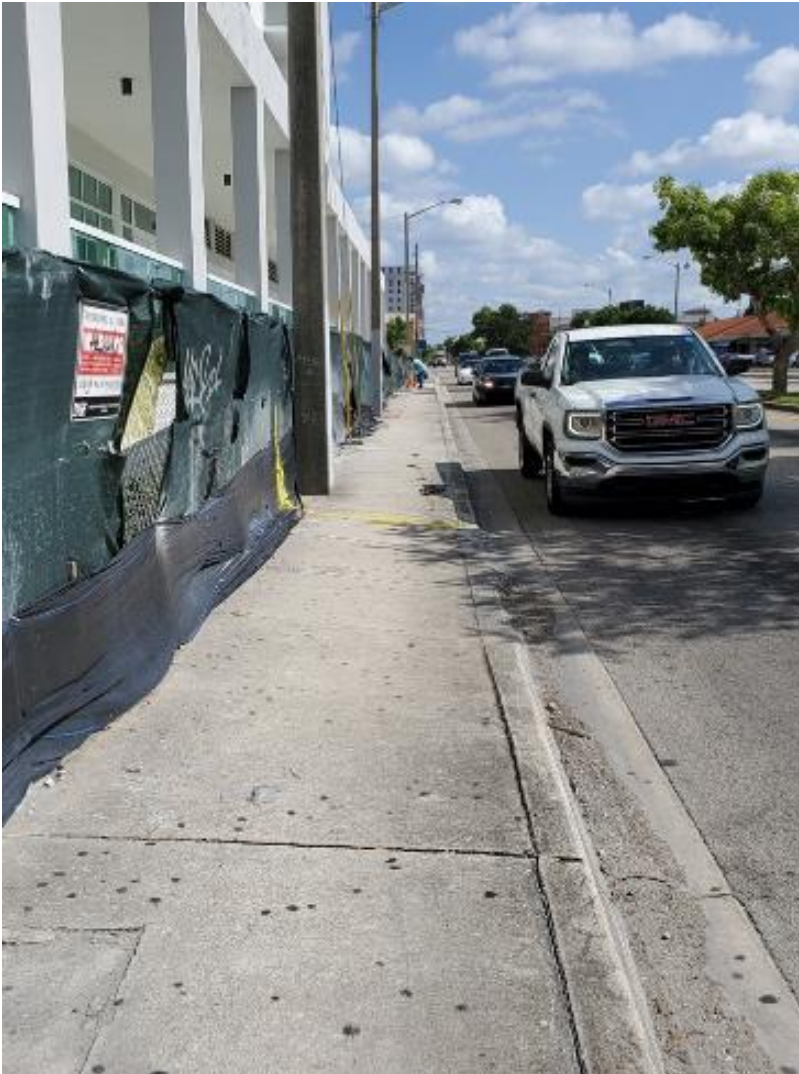
**Issue #7: Pedestrian Facility**

With the construction of the multi-story residential building on the west side of SW 22<sup>nd</sup> Avenue just north of SW 6<sup>th</sup> Street, there are several former driveways that require unnecessary undulation on the sidewalk surface to pedestrians and bicyclists.

- Near-Term Project –  
Reconstruct sidewalk to remove unnecessary driveway ramps and level the sidewalk grade.

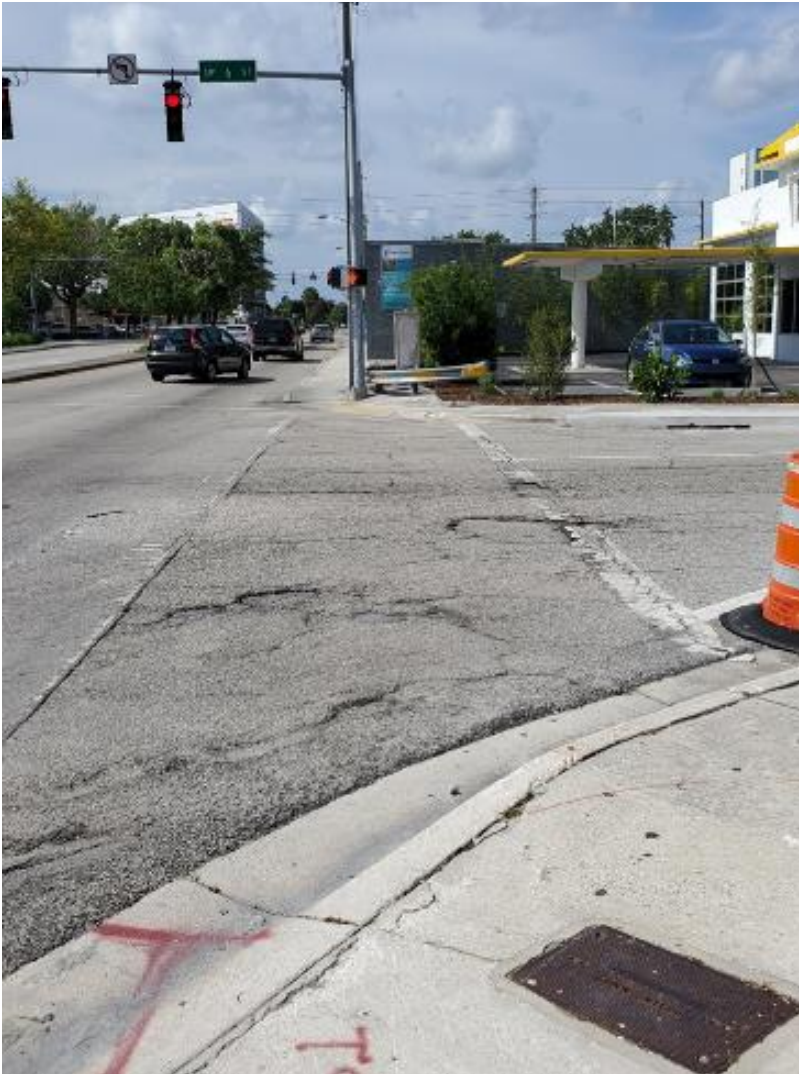
**Location: SW 22<sup>ND</sup> AVENUE AND SW 6<sup>TH</sup> STREET INTERSECTION****Issue #8: Pedestrian Facility**

The crosswalk on the west side of SW 22<sup>nd</sup> Avenue, crossing SW 6<sup>th</sup> Street does not have truncated domes at both ends and stop bar/crosswalk pavement markings are worn out / faded.

- Near-Term Project –  
Install truncated domes. Re-paint the crosswalks and stop bars at the intersection.

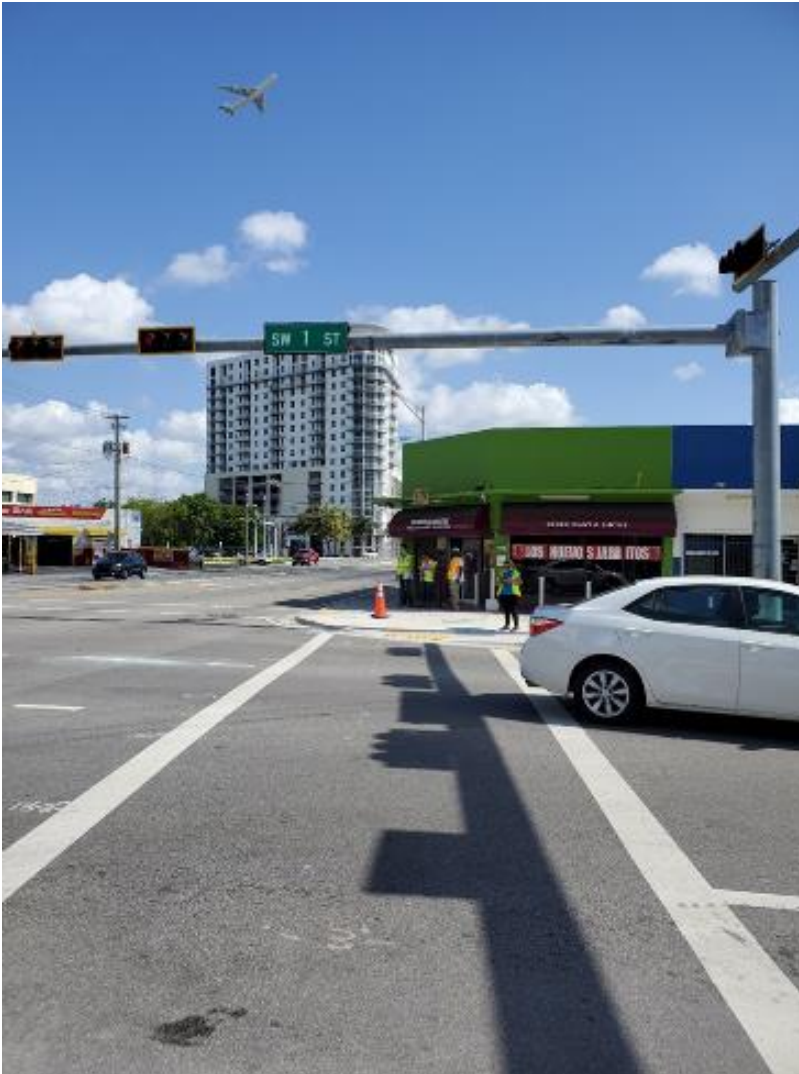
**Location: SW 22<sup>ND</sup> AVENUE AND SW 1<sup>ST</sup> STREET INTERSECTION****Issue #9: Pedestrian Facility**

Intersection is missing a pedestrian crossing signal on the northeast corner of SW 22<sup>nd</sup> Avenue and SW 3<sup>rd</sup> Street, facing northbound pedestrians.

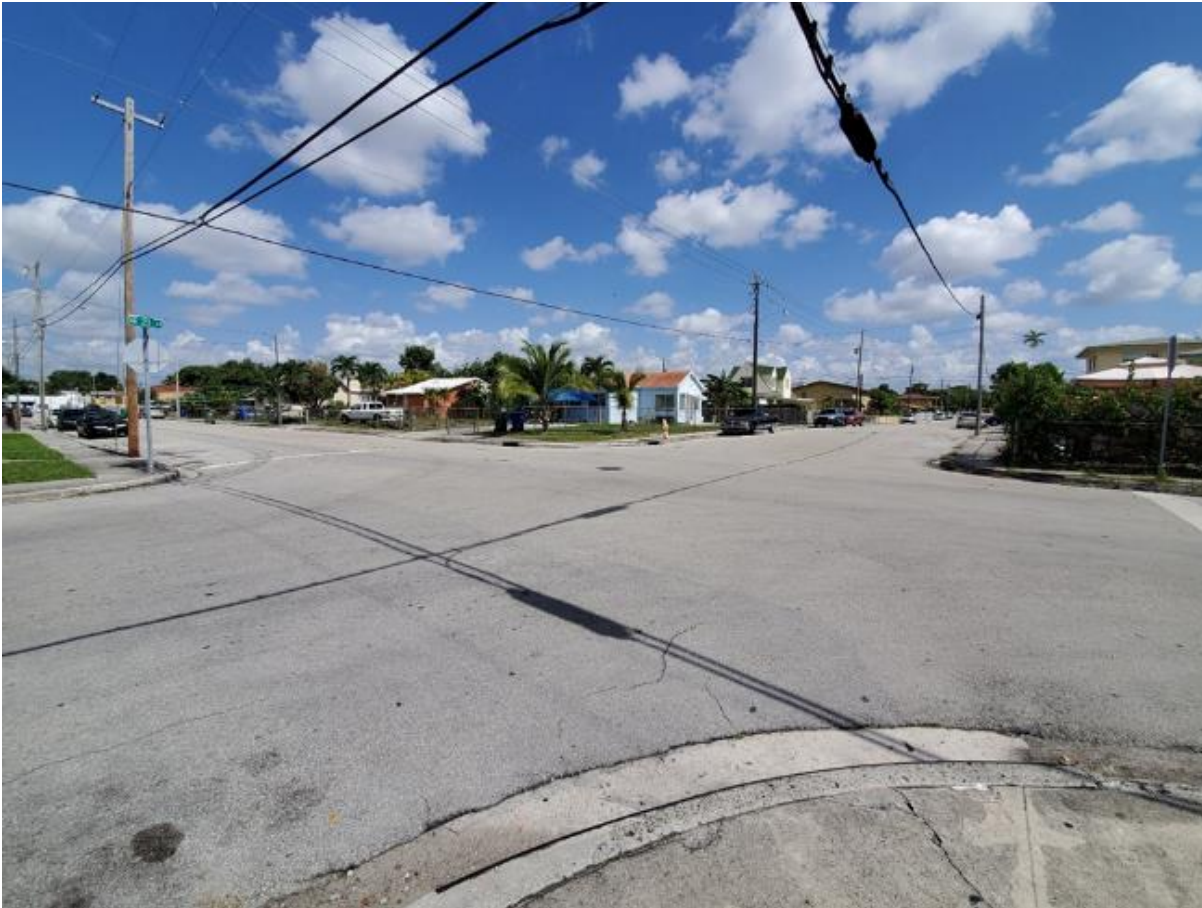
**Location: NW 21<sup>ST</sup> AVENUE AND NW FLAGLER TERRACE INTERSECTION****Issue #11: Pedestrian Facility**

The intersection is missing crosswalks the east and west legs of the intersection. All four corners of the intersection have high curb with no transition for pedestrians or wheelchairs to transition from the sidewalks to the street.

- Near-Term Project –  
Install curb ramps all four corners with truncated domes and provide crosswalks running parallel to NW Flagler Terrace.  
Consider adding bulb-outs at the intersection to reduce the pedestrian crossing distance and increase pedestrian visibility.

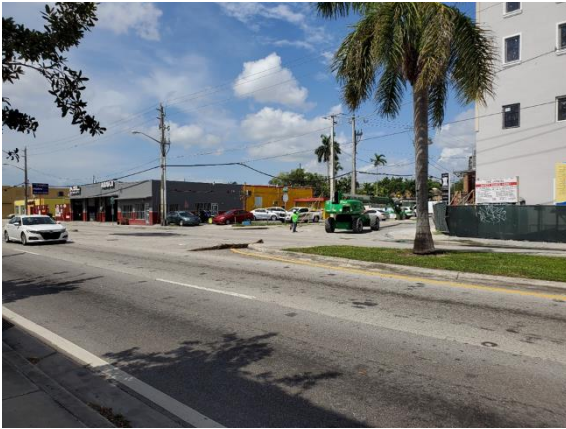
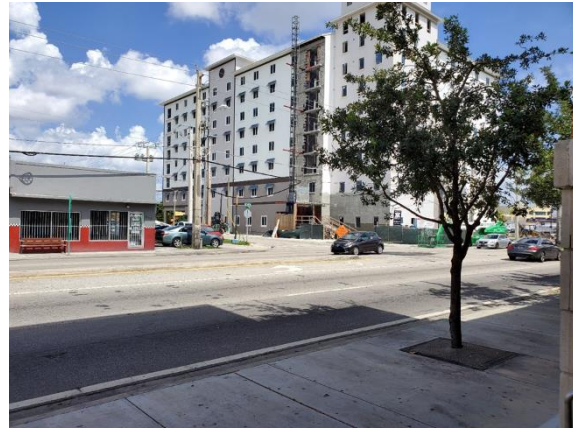
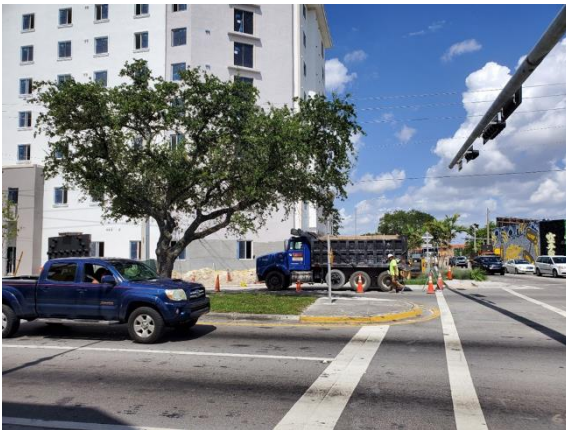
**Location: SW 22<sup>ND</sup> AVENUE AND SW 2<sup>ND</sup> STREET INTERSECTION****Issue #12: Pedestrian Facility**

The Jasmine assisted living facility is under construction on the northwest corner of SW 22<sup>nd</sup> Avenue and SW 2<sup>nd</sup> Street. The main development entrance is along SW 2<sup>nd</sup> Street, on the south side of the building. The potential safety issue at this intersection is the latent demand that Jasmine residents will create to cross SW 22<sup>nd</sup> Avenue to access Publix on the east side. It is unlikely residents will walk north to the SW 22<sup>nd</sup> Avenue and SW 1<sup>st</sup> Street intersection to cross at the signal and then head back south again to the Publix entrance on SW 22<sup>nd</sup> Avenue, south of SW 2<sup>nd</sup> Street. Residents will likely cross SW 22<sup>nd</sup> Avenue diagonally to/from the Publix entrance by SW 2<sup>nd</sup> Street. Pedestrians were observed performing this walking route.

- Long-Term Projects –  
Conduct a study to evaluate the need for a designated mid-block pedestrian crossing near SW 2<sup>nd</sup> Street.

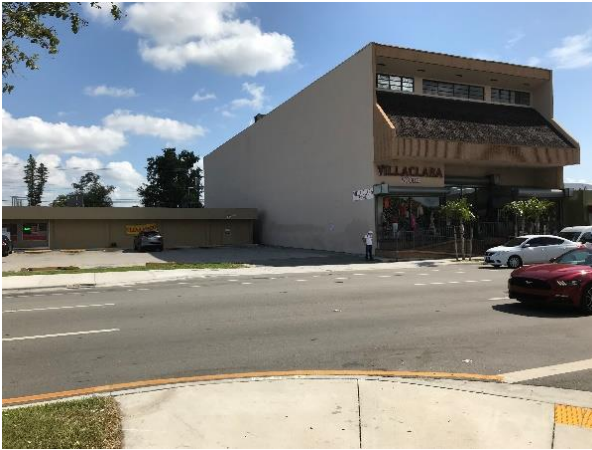
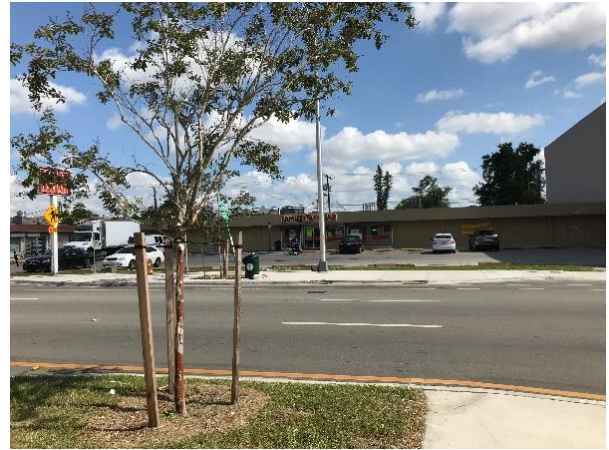
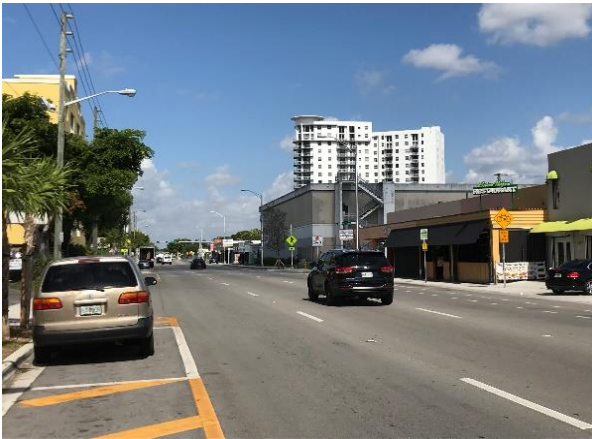
**Location: WEST FLAGLER STREET BETWEEN SW 22<sup>ND</sup> AVENUE AND SW 20<sup>TH</sup> AVENUE****Issue #13: Pedestrian Facility**

There is a midblock crossing immediately east of NW 21<sup>st</sup> Avenue to cross West Flagler Street which is equipped with rectangular rapid flashing beacons (RRFBs) on both sides of the crosswalk; however, vehicles are not compliant when pedestrians activate the RRFBs. In addition, there is a bus and trolley stop and Family Dollar Store east of the midblock crossing near SW 20<sup>th</sup> Avenue where pedestrians were observed crossing.

- Long-Term Project –  
Conduct a study to determine if the pedestrian crossing should be relocated or modified.

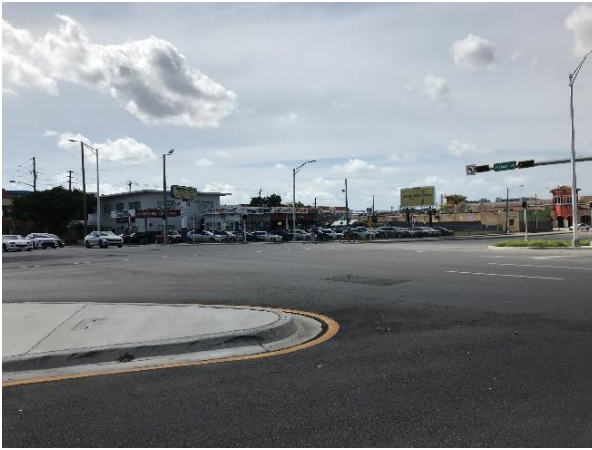
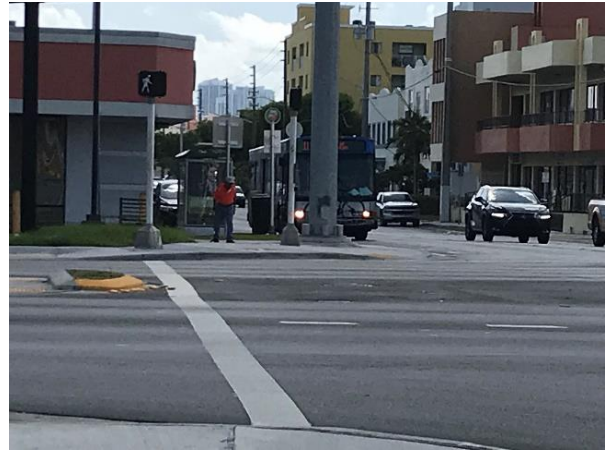
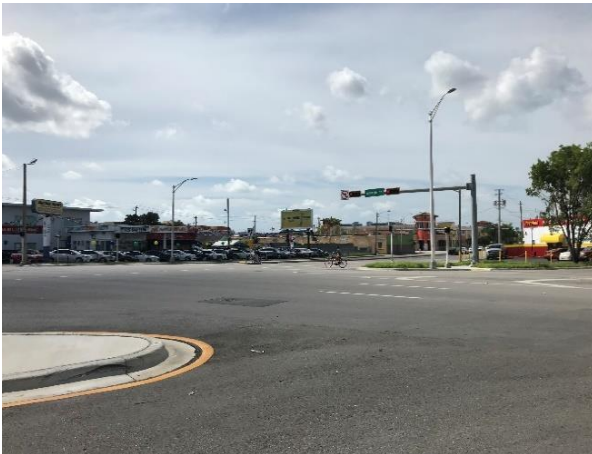
**Location: SW 22<sup>ND</sup> AVENUE / BEACOM BOULEVARD AND WEST FLAGLER STREET INTERSECTION****Issue #14: Signal Timing**

Westbound traffic on West Flagler Street making a slight left onto Beacom Boulevard has a green light during the same time that the pedestrian signal instructs pedestrian to walk on the Beacom Boulevard leg. Conflicts between pedestrians and westbound left turning vehicles onto Beacom Boulevard were observed.

- Long-Term Project –  
Conduct a study to determine if intersection improvements are needed to raise awareness in drivers of pedestrians crossing Beacom Boulevard and inform vehicles to yield the right-of-way. Improvements could include additional signage, median extension, or crosswalk realignment for increased visibility.

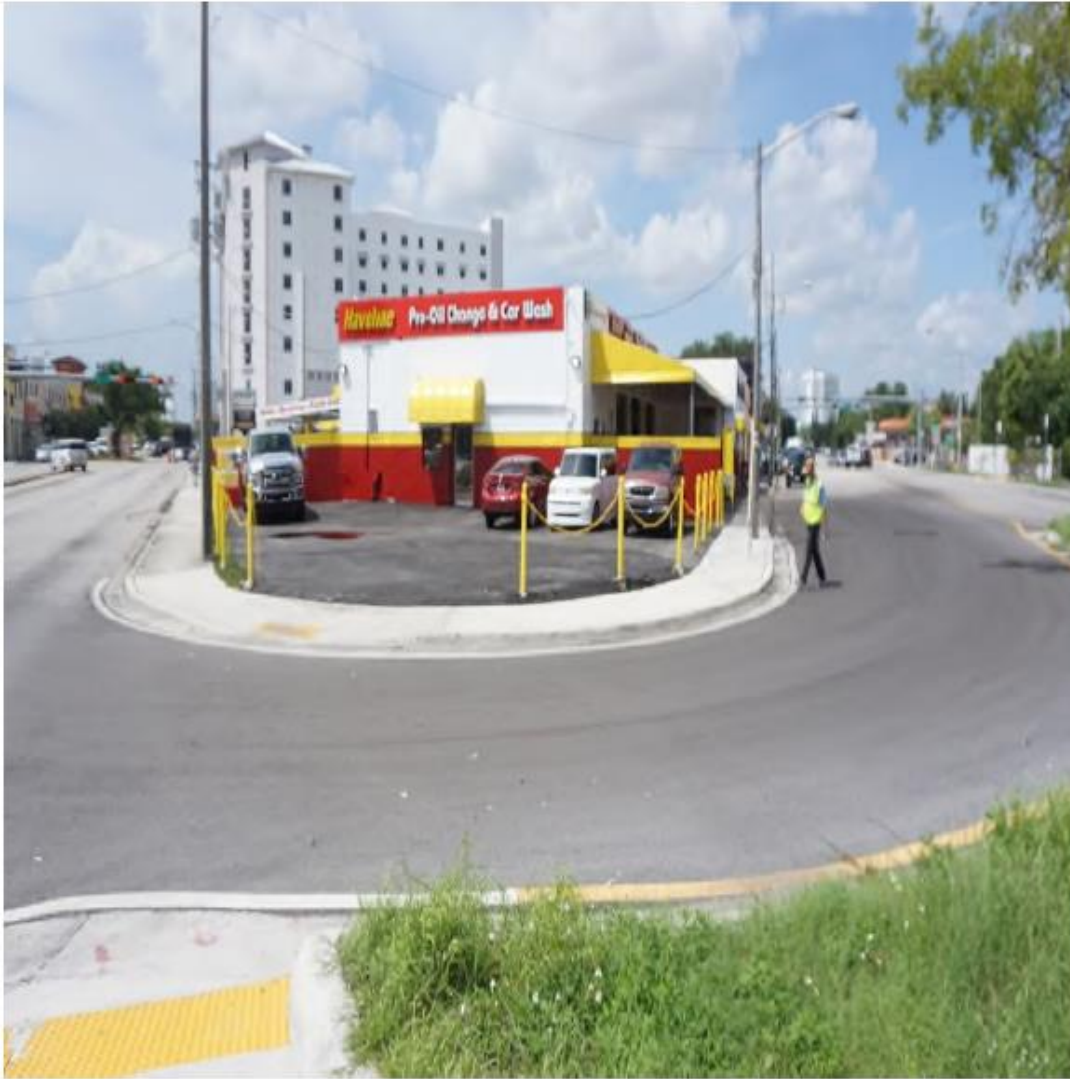
**Location: SW 22<sup>ND</sup> AVENUE / BEACOM BOULEVARD AND WEST FLAGLER STREET INTERSECTION****Issue #15: Pedestrian Crossing**

There is no marked pedestrian crosswalk on the southwest leg of the SW 22<sup>nd</sup> Avenue / Beacom Boulevard and West Flagler Street intersection. The northbound traffic on Beacom Boulevard are forced to turn right to head southbound on SW 22<sup>nd</sup> Avenue. However, the approach has no traffic control device and conflicts with potential pedestrian patterns encourage by the curb ramps adjacent to the movement.

- Near-Term Project –  
Install a stop sign at the Beacom Boulevard northbound approach where it intersects with SW 22<sup>nd</sup> Avenue. In addition, install a marked pedestrian crosswalk on this intersection leg.

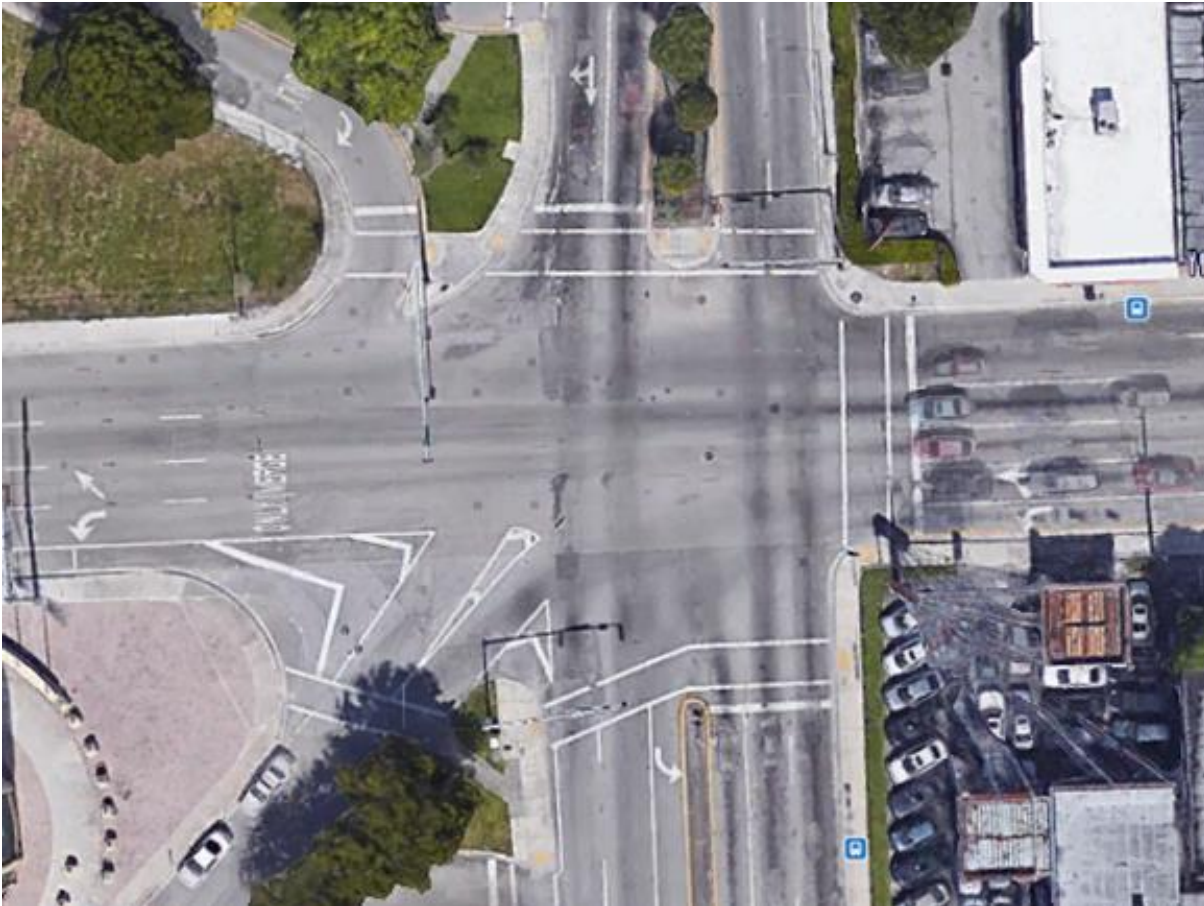
**Location: SW 22<sup>ND</sup> AVENUE / BEACOM BOULEVARD AND WEST FLAGLER STREET INTERSECTION****Issue #16: Pedestrian Crossing**

There is no crosswalk across the west leg of the intersection. Pedestrians wanting to travel south to Beacom Boulevard must cross Flagler Street on the east side of the intersection and then cross SW 22<sup>nd</sup> Avenue.

- Near-Term Project –  
Install a marked pedestrian crosswalk on the west leg of SW 22<sup>nd</sup> Avenue / Beacom Boulevard and West Flagler Street.

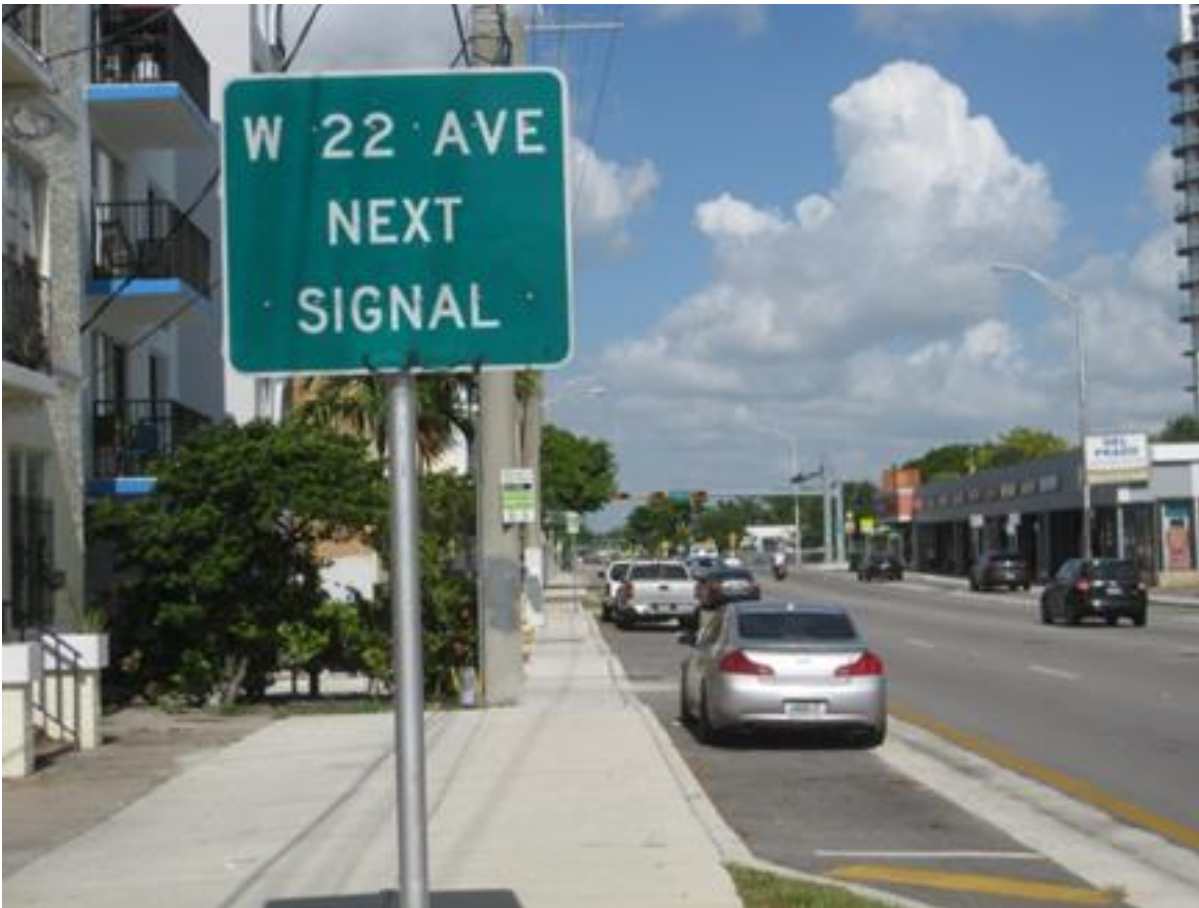
**Location: SW 22<sup>ND</sup> AVENUE / BEACOM BOULEVARD AND WEST FLAGLER STREET INTERSECTION****Issue #17: Lane Geometry and Signing**

The intersection of Flagler Street and SW 22<sup>nd</sup> Avenue and Beacom Boulevard is a confusing geometry for drivers. Unfamiliar drivers may not perceive and comprehend the left turn options until they are within the intersection. This may be influencing the high number of crashes at the intersection.

- Long-Term Project –  
Conduct intersection study to determine if intersection geometry or signing can be improved to increase safety for all roadway users.

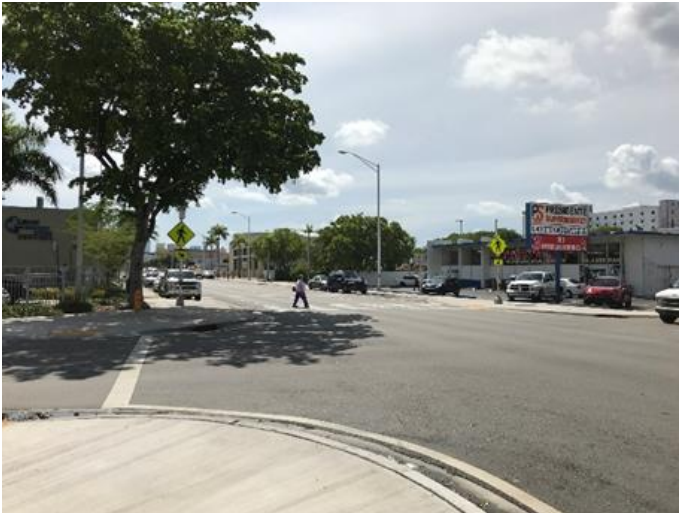
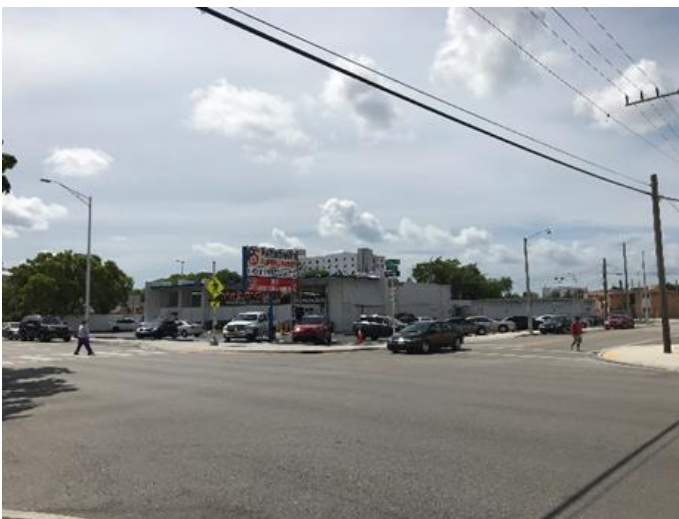
**Location: SW 23<sup>RD</sup> AVENUE AND WEST FLAGLER STREET INTERSECTION****Issue #18: Pedestrian Facility**

There are two medical centers on the north side of West Flagler Street in the vicinity of the SW 23<sup>rd</sup> Avenue intersection and a supermarket on the southeast corner of the intersection. A marked pedestrian crossing with RRFBs is provided on the east leg of the intersection; however, vehicles were observed to neglect stopping for pedestrians during the flashing RRFBs. Most pedestrians observed at this location were seniors. Pedestrians informed the study team that they do not press the push button anymore since vehicles do not stop.

- Long-Term Project –  
Conduct a study to determine if the pedestrian crossing on the east leg should be modified to a full signal.

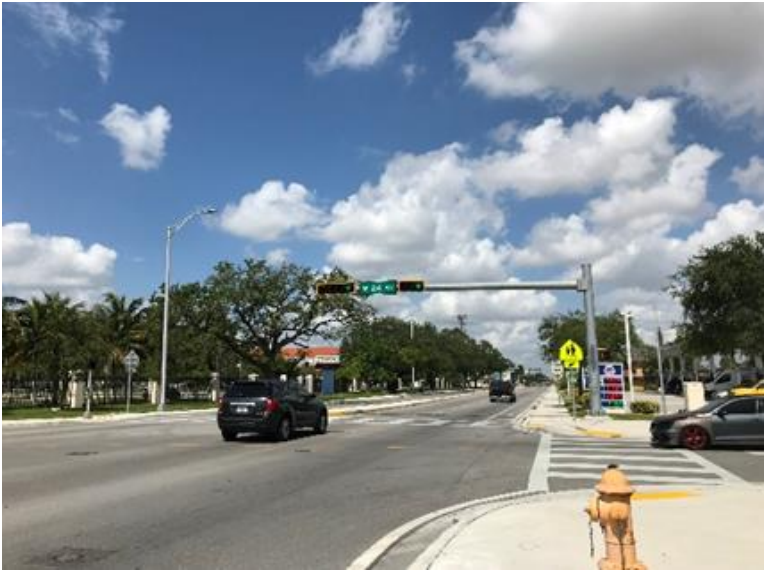
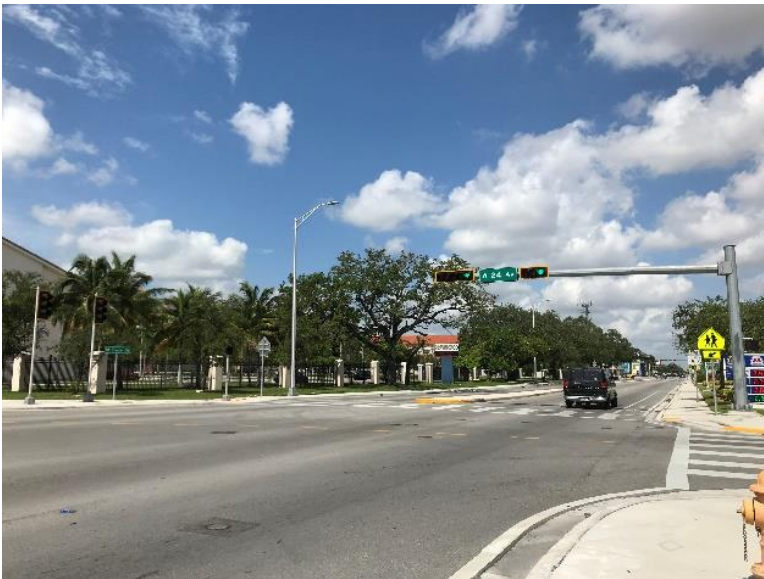
**Location: SW 24<sup>TH</sup> AVENUE AND WEST FLAGLER STREET INTERSECTION****Issue #19: Pedestrian Facility**

The pedestrian signal heads for the east-west pedestrian crossings are not showing a WALK interval.

- Short-Term or Maintenance Project –  
Conduct maintenance on the pedestrian signals and program WALK time in the controller.

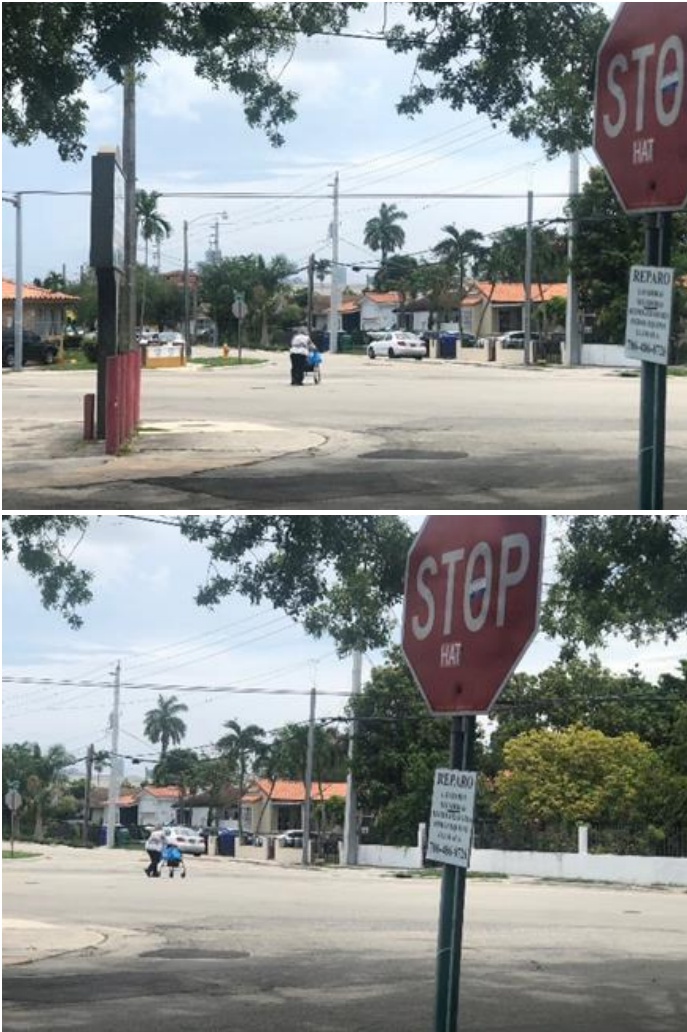
**Location: SW 23<sup>RD</sup> AVENUE AND BEACOM BOULEVARD INTERSECTION****Issue #20: Pedestrian Facility**

There are no marked pedestrian crossings along Beacom Boulevard between SW 1<sup>st</sup> Street and SW 6<sup>th</sup> Street (approximately 0.4 miles) with at least four bus stops along this segment. At the SW 23<sup>rd</sup> Avenue intersection, multiple residents were observed walking from the neighborhood southeast of Beacom Boulevard to the supermarket on West Flagler Street. The bus stop on the southeast corner of the SW 23<sup>rd</sup> Avenue and Beacom Boulevard was observed to be active during the field observations.

- Long-Term Project –  
Conduct a study to evaluate the feasibility of an alternative intersection design (e.g., roundabout) at Beacom Boulevard/SW 2<sup>nd</sup> Street/SW 23<sup>rd</sup> Avenue. In addition, evaluate the need for traffic calming measures along Beacom Boulevard.

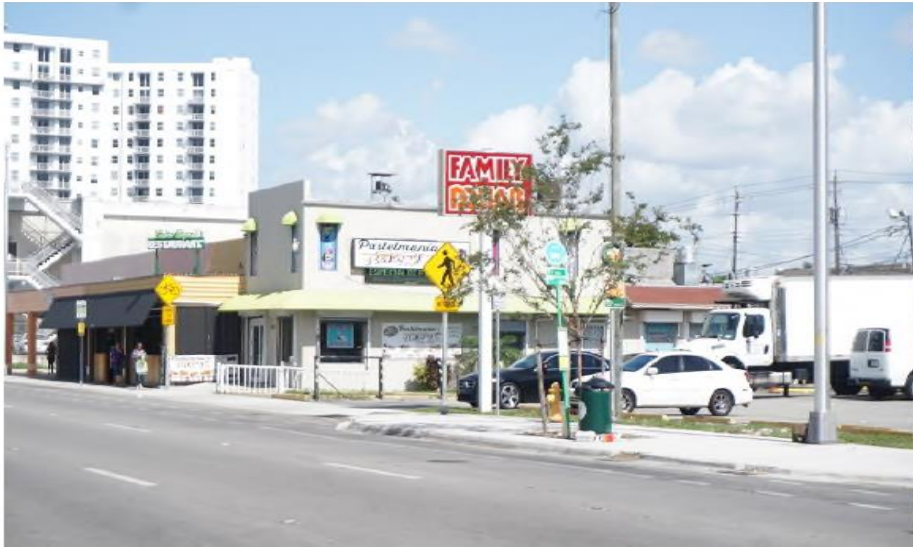
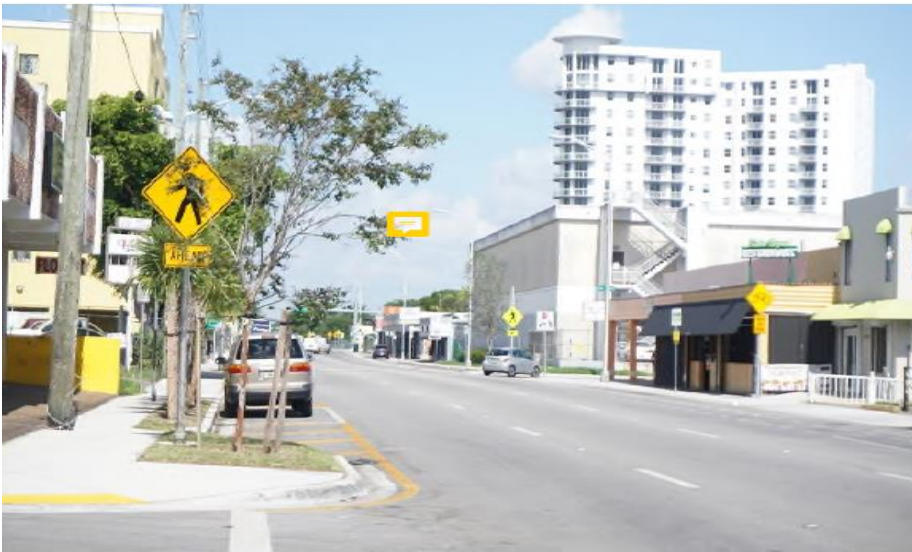
**Location: SW 20<sup>TH</sup> AVENUE AND WEST FLAGLER STREET INTERSECTION****Issue #21: Pedestrian Facility**

Pedestrian warning signs facing westbound traffic on both sides of Flagler Street, west of SW 20<sup>th</sup> Avenue, are blocked by landscaping.

- Short-Term or Maintenance Project –  
Conduct maintenance to trim landscaping or potentially relocate behind the signs.
