# SENIOR LIVING FACILITIES ROAD SAFETY AUDIT

## WORK ORDER # GPC VII-02

OCTOBER  
2019

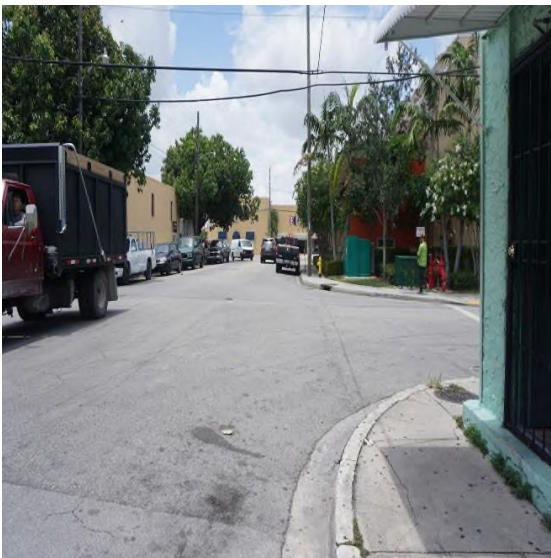
**Location: SW 21<sup>ST</sup> COURT AND SW 3<sup>RD</sup> STREET INTERSECTION****Issue #22: Pedestrian Facility**

Pedestrian crosswalk on the north leg of the SW 21<sup>st</sup> Court and SW 3<sup>rd</sup> Street intersection is offset to the north out of the line of sight of oncoming traffic. The offset creates difficulty for pedestrians and vehicles to see each other.

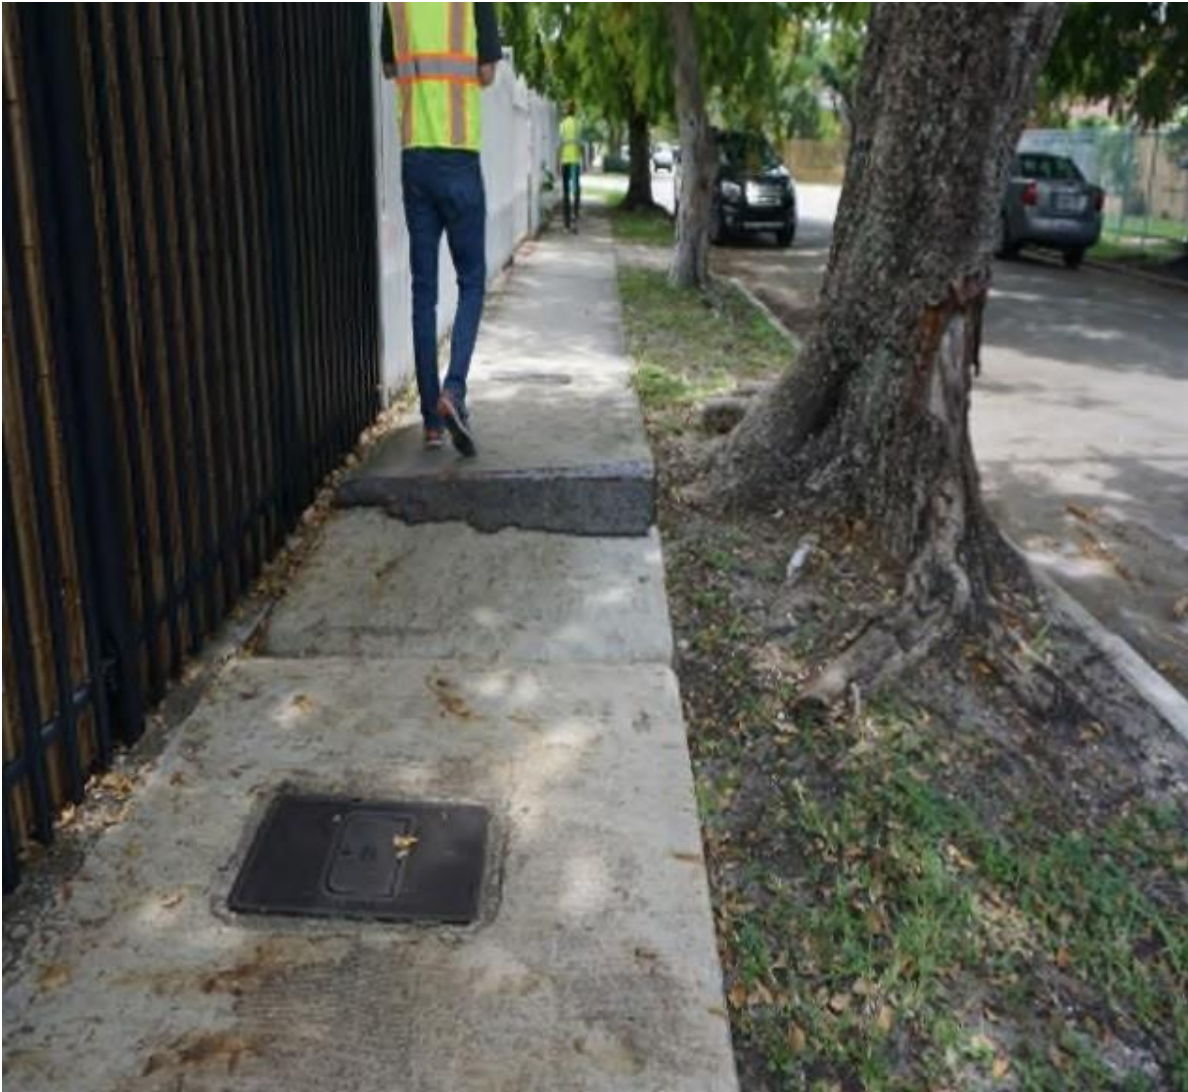
**Issue #24: Pedestrian Facility**

The sidewalk on the east side of SW 23<sup>rd</sup> Avenue between SW 5<sup>th</sup> Street and SW 4<sup>th</sup> Street is uneven due to tree roots.

- Near-Term Project –  
Level the sidewalk.

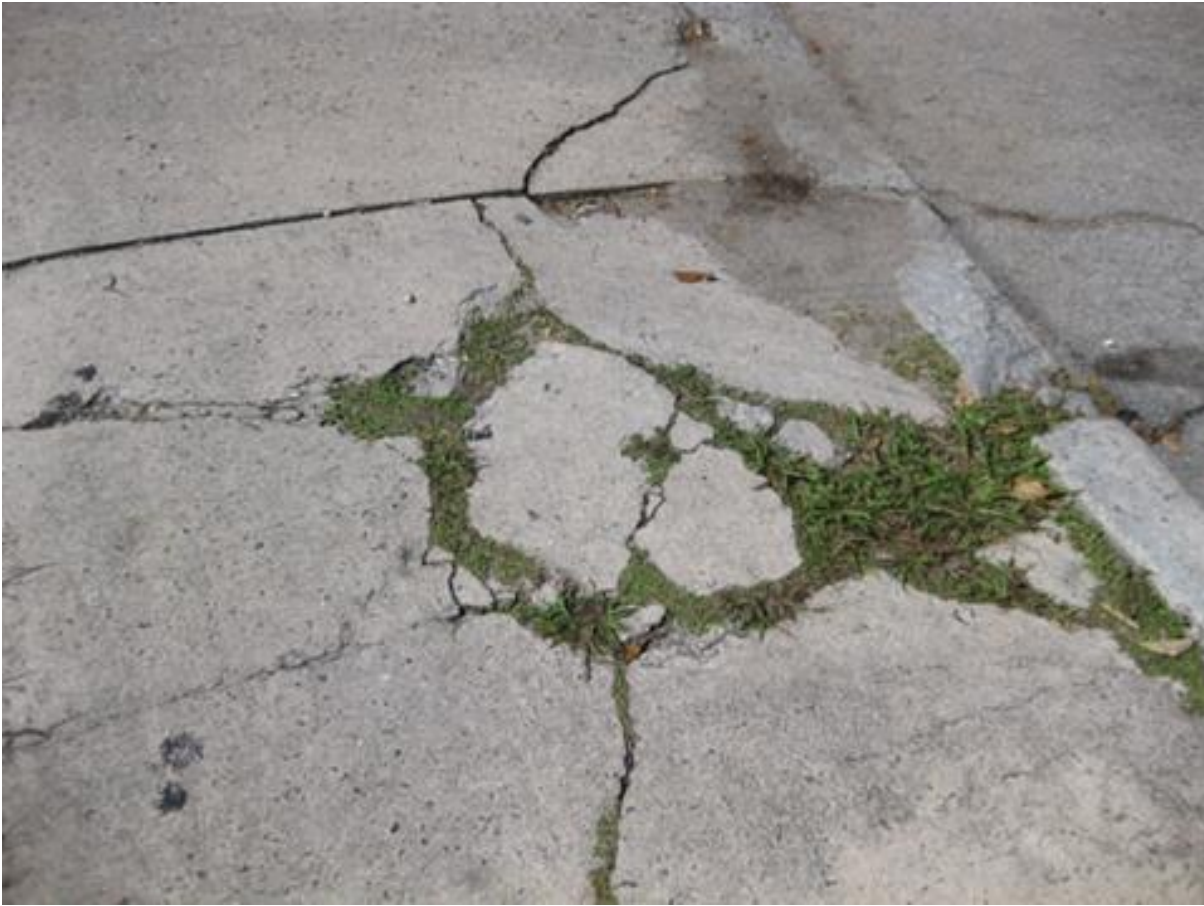
**Location: NW 21<sup>ST</sup> AVENUE NORTH OF WEST FLAGLER STREET****Issue #25: Pedestrian Facility**

The sidewalk along both sides of NW 21<sup>st</sup> Avenue between West Flagler Street and NW Flagler Terrace is fractured in multiple places.

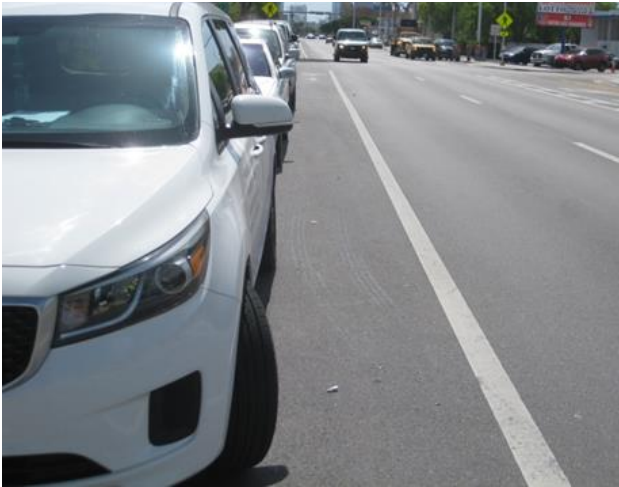
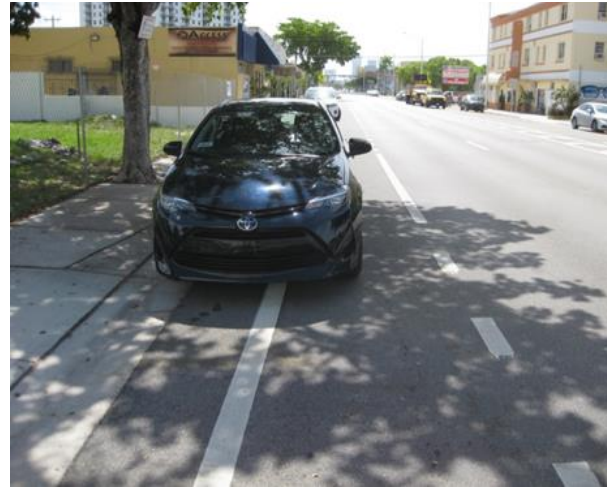
**Location: WEST FLAGLER STREET WEST OF W 23<sup>RD</sup> AVENUE****Issue #26: Parking**

Vehicles illegally parked along the north side curb of West Flagler Street west of W 23<sup>rd</sup> Avenue encroach significantly upon the westbound marked bicycle lane. A bicyclist encountering these parked vehicles might swerve into a through traffic lane in front of trailing vehicles.

- Short-Term or Maintenance Project –  
Install NO PARKING signs (R7-1) along this commercial section according to the MUTCD Section 2B.47.  
Conduct enforcement activities to prevent illegally parked vehicles on the north side of West Flagler Street.

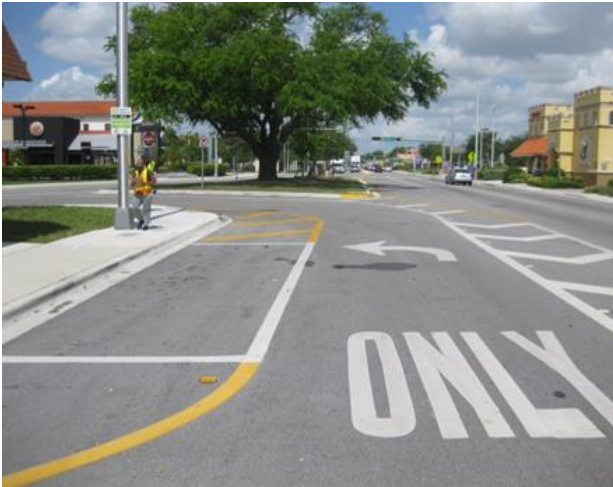
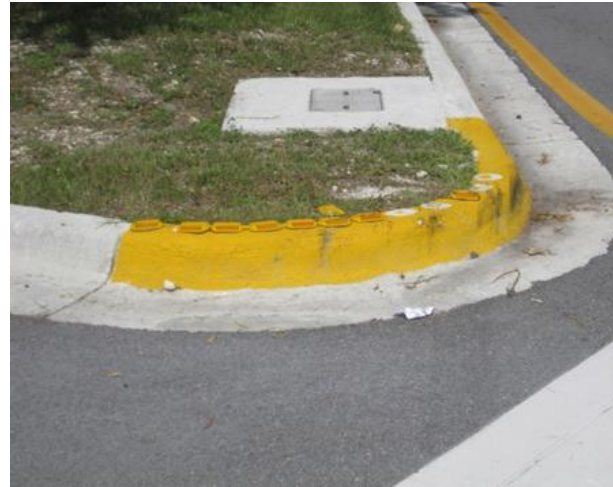
**Location: WEST FLAGLER STREET AND THE U-TURN TO SW 1<sup>ST</sup> STREET****Issue #27: Curb Visibility**

The leftmost lane of West Flagler Street is designated as an exclusive left turn lane as it approaches a triangular island where West Flagler transitions from a one-way to a two-way configuration. There is evidence that vehicles have impacted the nose of the curbed, landscaped island. The maintaining agency has installed yellow raised pavement markers on top of the painted island nose to increase nighttime visibility, which is diminished by a large oak tree within the island.

- Near-Term Project –  
Install several chevrons (W1-8) according to the MUTCD Section 2C.09 within the island to enhance driver's perception of the obstruction and to emphasize the need to turn.

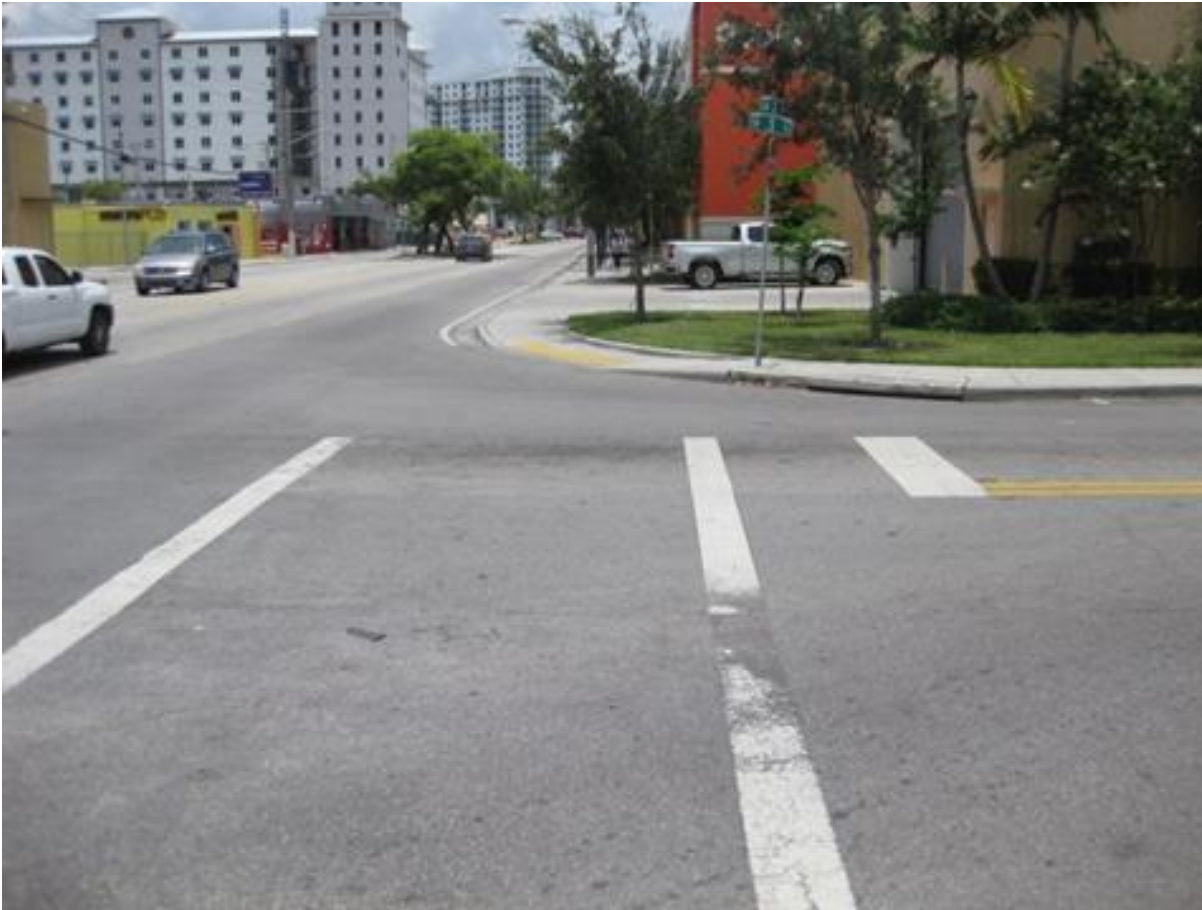
**Location: SW 22<sup>ND</sup> AVENUE AND SW 3<sup>RD</sup> STREET INTERSECTION****Issue #28: Pedestrian Facility**

The crosswalk and stop bar pavement markings on the east leg of SW 22<sup>nd</sup> Avenue and SW 3<sup>rd</sup> Street are worn out. In addition, half of the westbound lane has been repaved and no longer shows the pavement markings.

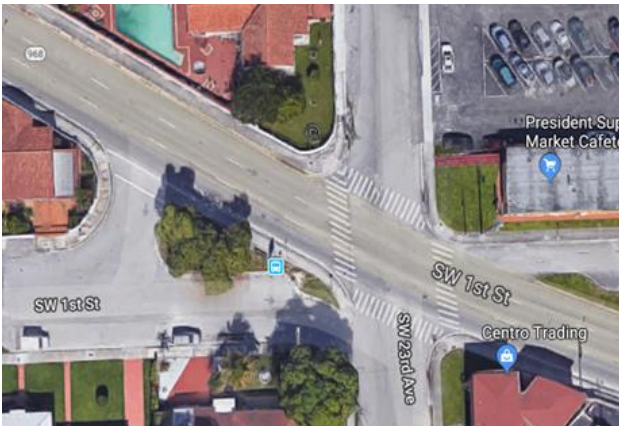
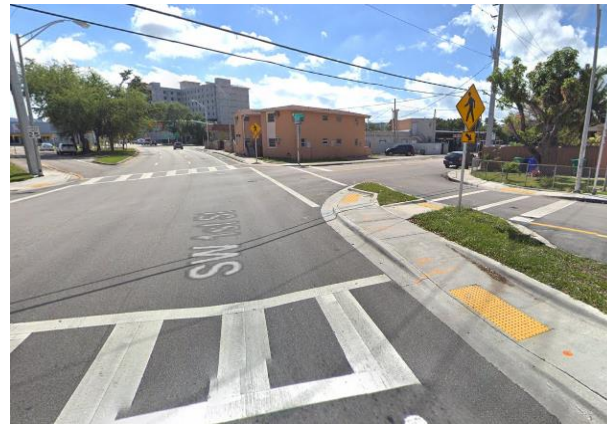
**Issue #29: Pedestrian Facility**

Eastbound traffic on the original alignment of SW 1<sup>st</sup> Street may make right turns onto SW 23<sup>rd</sup> Avenue from a short, one-way section controlled by a STOP sign. While a driver making this turn can clearly see a vehicle travelling southbound on SW 23<sup>rd</sup> Avenue, that driver would not be aware of a right turning vehicle approaching from SW 1<sup>st</sup> Street. Also, there are uncontrolled, marked crosswalks on both legs of the realigned SW 1<sup>st</sup> Street at the intersection.

- Short-Term or Maintenance Project –  
Replace the standard crosswalk pavement markings on the north and south legs with high emphasis crosswalk pavement markings.  
Install Yield Here To Pedestrians signs (R1-5) per MUTCD Section 2B.11 and yield lines per MUTCD Section 3B.15 in advance of the marked crosswalks for eastbound traffic on SW 1<sup>st</sup> Street.
- Long-Term Project –  
Conduct an intersection study to determine if the right turn access onto SW 23<sup>rd</sup> Avenue from SW 1<sup>st</sup> Street should be closed or reconfigured for improved visibility of oncoming or turning traffic. Also, evaluate the need for all-way stop controlled intersection.

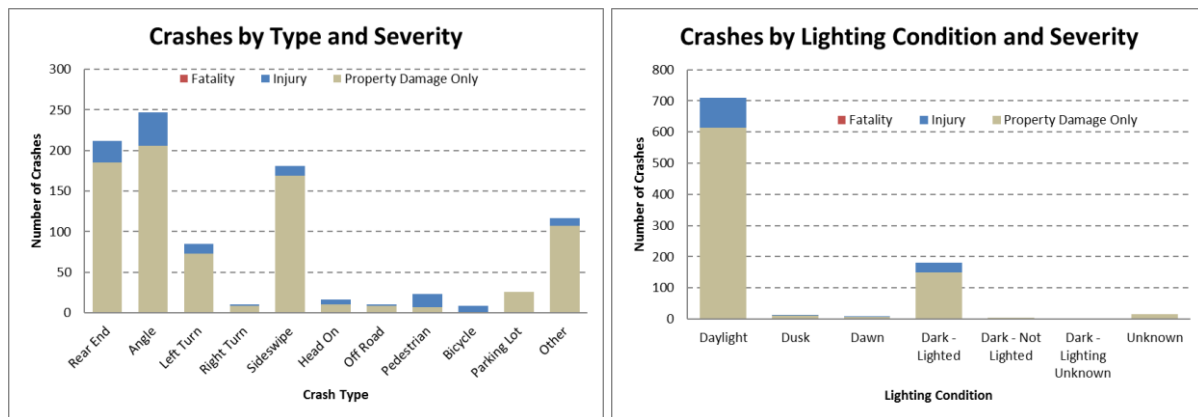
The reported crashes by crash type are displayed below. Twenty-six (26) percent (247 crashes) angle crashes, twenty-three (23) percent (212 crashes) were rear end crashes, and nineteen (19) percent (181 crashes) were sideswipe crashes. Twenty-four (24) percent of crashes occurred under non-daylight conditions.
