# Traffic Calming for Pedestrians at Miami Dade College Wolfson Campus

## Technical Memorandum 3: Final Report

**September 2004**

*Prepared by:*  
HDR Engineering, Inc.  
315 E. Robinson St., Suite 400  
Orlando, FL 32801

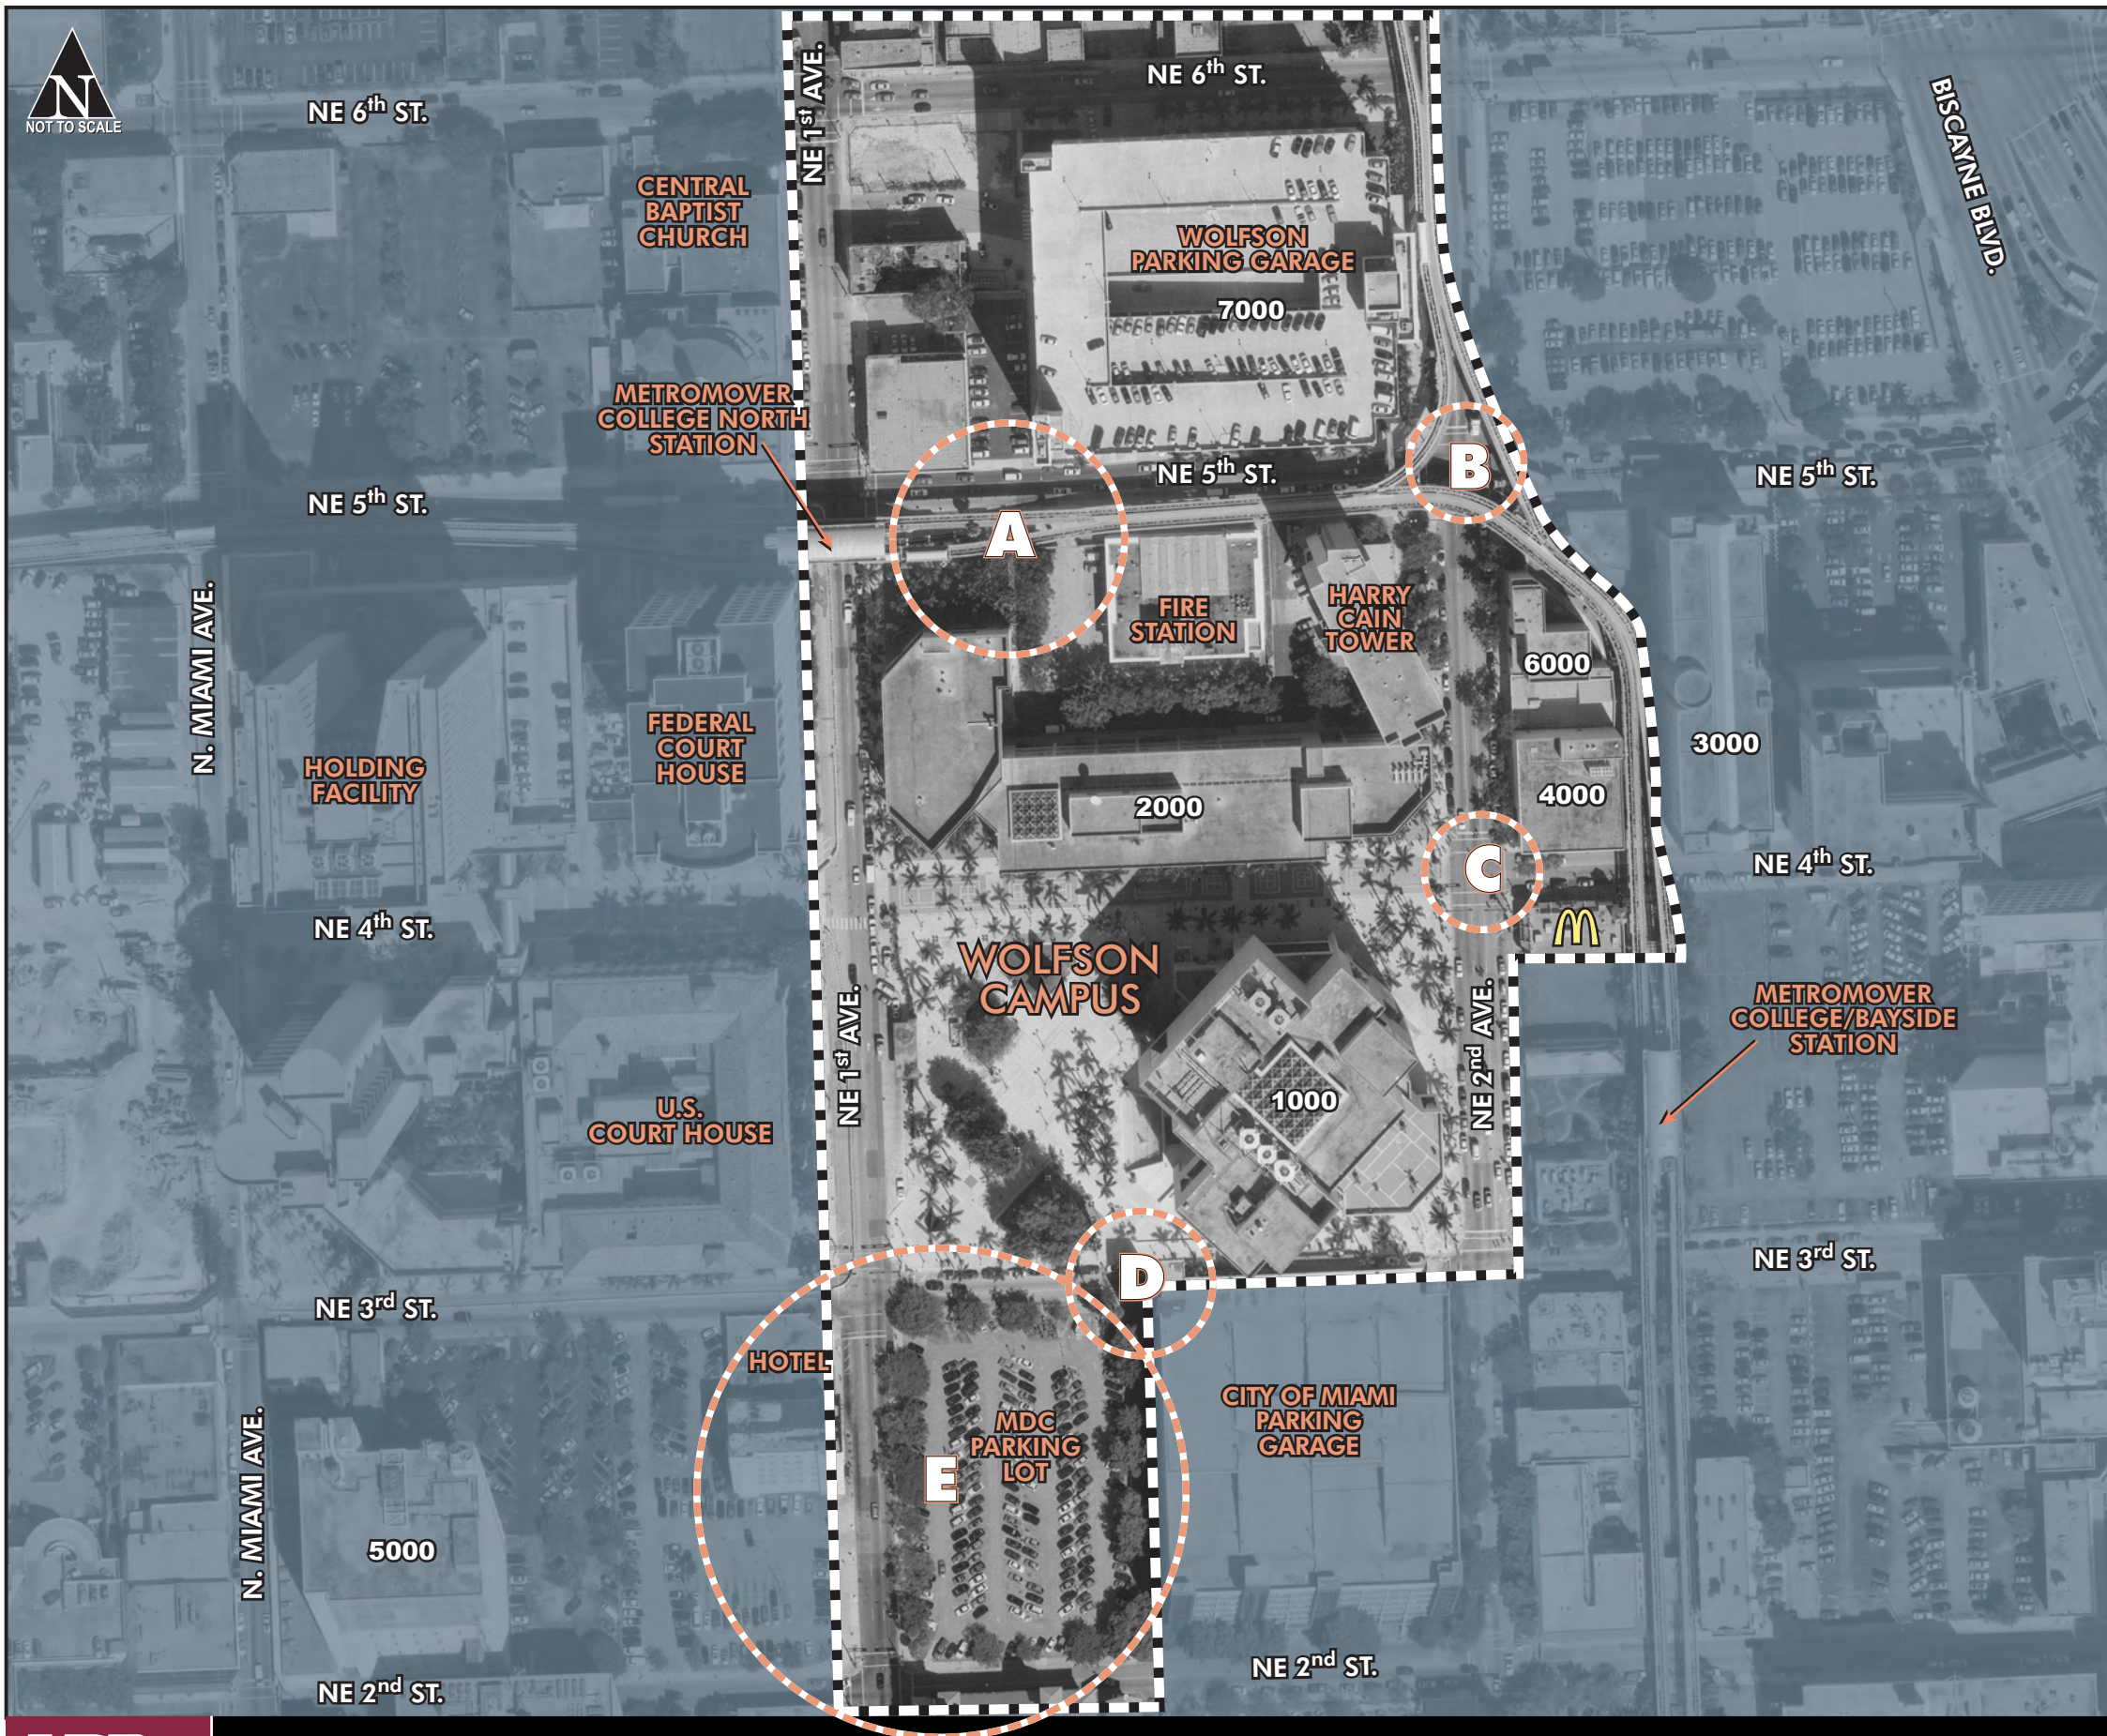
# MDC WOLFSON CAMPUS

## Study Area & Focus Areas

To assist in the development and review of recommendations, a Study Advisory Committee was established, which included representatives from the Miami-Dade Metropolitan Planning Organization (MPO), Miami Dade College, Miami-Dade County Public Works Department, Miami-Dade Seaport Department, and Miami-Dade Transit. Based on input from the Committee at the project kickoff meeting, a project study area was established, along with a list of high priority focus areas. Figure 1 shows the Wolfson Campus layout, the project study area, and the project's specific focus areas.

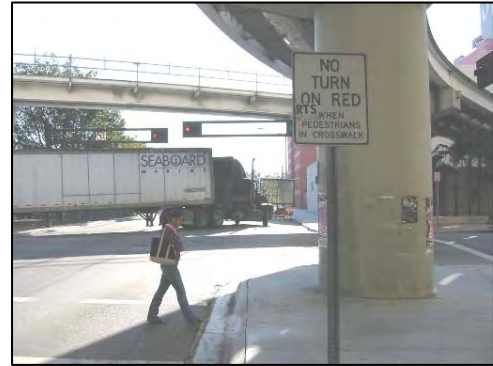
View of 2<sup>nd</sup> Avenue crosswalk as seen from 5<sup>th</sup> Street. Any pedestrians in this crosswalk may be obstructed from motorists' view due to the Metromover support.

Another primary safety problem at this intersection is that vehicles making a right turn from NE 5<sup>th</sup> Street onto NE 2<sup>nd</sup> Avenue have an obstructed view of the southern crosswalk across NE 2<sup>nd</sup> Avenue due to the concrete support for the Metromover. Crash #14 was a direct result of this obstructed view, as the driver reported not seeing the crossing pedestrian.

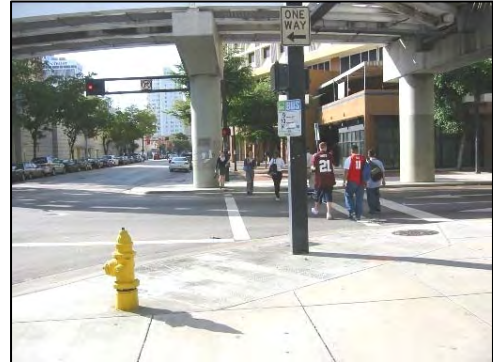
Pedestrians crossing 5<sup>th</sup> Street at 2<sup>nd</sup> Avenue  
(looking south)

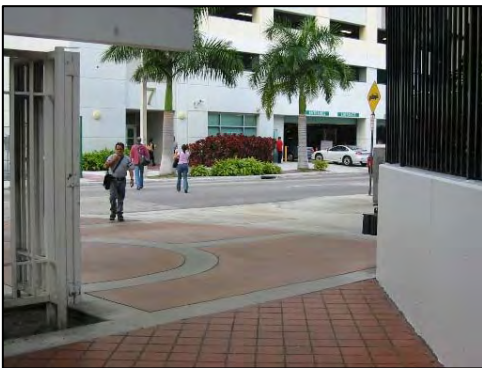
Preferred pedestrian crossing path across  
5<sup>th</sup> Street from the garage

Focus Area A is located on NE 5<sup>th</sup> Street at the west end of the Wolfson parking garage, where a significant amount of pedestrian crossing activity occurs. On this end of the garage, the building entrance/exit used by pedestrians is located about 175 feet east of the signal at 5<sup>th</sup> Street and 1<sup>st</sup> Avenue. However, the vast majority of pedestrians do not cross the street at the signal, but cross the street midblock, often at an angle of preferred path as shown in the adjacent picture. Pedestrian activity is fairly continuous, particularly during peak periods. Counts completed by Miami-Dade County show that the two-way pedestrian crossing volume during the AM peak hour (8:00-9:00 AM) is more than 500, and is more than 600 during the PM peak hour (5:00-6:00 PM).

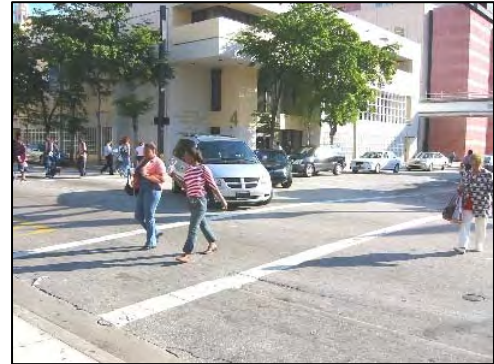
Typical and recurrent pedestrian-vehicle conflict at 2<sup>nd</sup> Avenue & 4<sup>th</sup> Street

More than 1,000 pedestrians cross NE 2<sup>nd</sup> Avenue at the NE 4<sup>th</sup> Street intersection during the AM peak hour (8:00-9:00 AM). Another 650 pedestrians cross NE 2<sup>nd</sup> Avenue at the same intersection during the PM peak hour (5:00-6:00 PM). Because the primary issue at this intersection is the conflict between westbound left turning vehicles and the pedestrians crossing 2<sup>nd</sup> Avenue in the crosswalk on the south side of 4<sup>th</sup> Street, it is important to note the distribution of pedestrians between the crosswalks on the north and south side of the intersection. In the AM peak hour, approximately 70% of the pedestrians crossing 2<sup>nd</sup> Avenue use the north crosswalk, but in the PM peak hour, the distribution is split nearly evenly. In the morning the high percentage of people using the north crosswalk is likely due to the influence of class changes and the location of Wolfson Buildings 3, 4, and 6 on the north side of 4<sup>th</sup> Street. In the afternoon, the more even split in the two crosswalks could be attributed to more students accessing the Metromover station on the south side of 4<sup>th</sup> Street, perhaps to link to the Metrorail system. It is also expected that the location of the McDonald's on the southeast corner of the intersection plays a role in which crosswalk pedestrians may use, particularly during peak lunchtime hours.

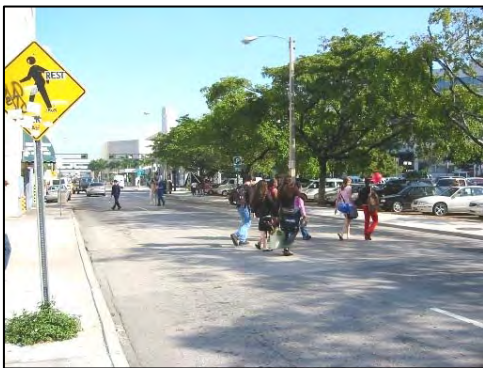
Pedestrians crossing 1<sup>st</sup> Avenue midblock,  
south of 3<sup>rd</sup> Street

Vehicle and pedestrian counts were collected on NE 1<sup>st</sup> Avenue midblock between NE 2<sup>nd</sup> and 3<sup>rd</sup> Streets during the period from 10:00-11:00 AM. Although this time period is outside of the typical morning peak hour, it is representative of conditions during the majority of the morning hours. A significant volume of pedestrians cross this street midblock, primarily during the periods associated with class changes in Building 5, which hosts classes for the New World School of the Arts. Similar to the data collected on NE 3<sup>rd</sup> Street, the number of pedestrians crossing 1<sup>st</sup> Avenue was approximately equal to the number of vehicles traveling northbound on 1<sup>st</sup> Avenue – 399 pedestrians versus 406 vehicles.

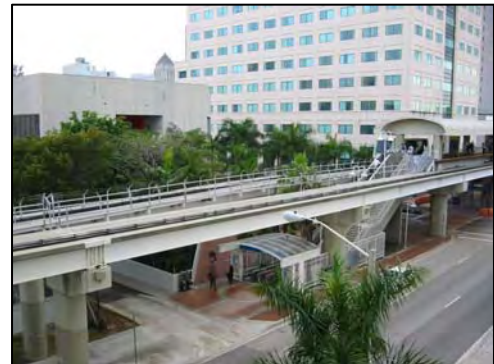
View from the 4<sup>th</sup> floor of the garage across 5<sup>th</sup> Street to Building 2

Tier 4 is the construction of a pedestrian bridge over NE 5<sup>th</sup> Street, which would vertically separate vehicles and pedestrians. In the optimal condition, a pedestrian bridge would connect directly from the parking garage to either Building 2 on the Wolfson Campus or to the Metromover College North Station above the intersection of NE 5<sup>th</sup> Street and NE 1<sup>st</sup> Avenue. However, there are several issues that would need to be addressed in order for the bridge to be constructed – these issues are discussed briefly as follows:

- The bridge would need to connect to the garage on the lowest floor possible (perhaps the third floor) to attract as many people as possible to use it. People parked on the lower floors, especially the first floor, may still cross the street at grade rather than taking the stairs or elevator to access the bridge.
- The bridge would have to be constructed over the top of the Metromover line with adequate clearance for the vehicles. If the bridge connected to the garage at level 3, the bridge would require an uphill grade to clear the Metromover.
