CITY OF SUNNY ISLES BEACH

Feasibility Study Summary of a Bridge to Link a Pedestrian/Bicycle Greenway

**Extension of North Bay Road from 172nd to 174th Street
City of Sunny Isles Beach**

CGA Project No. 04-4567
September 2004

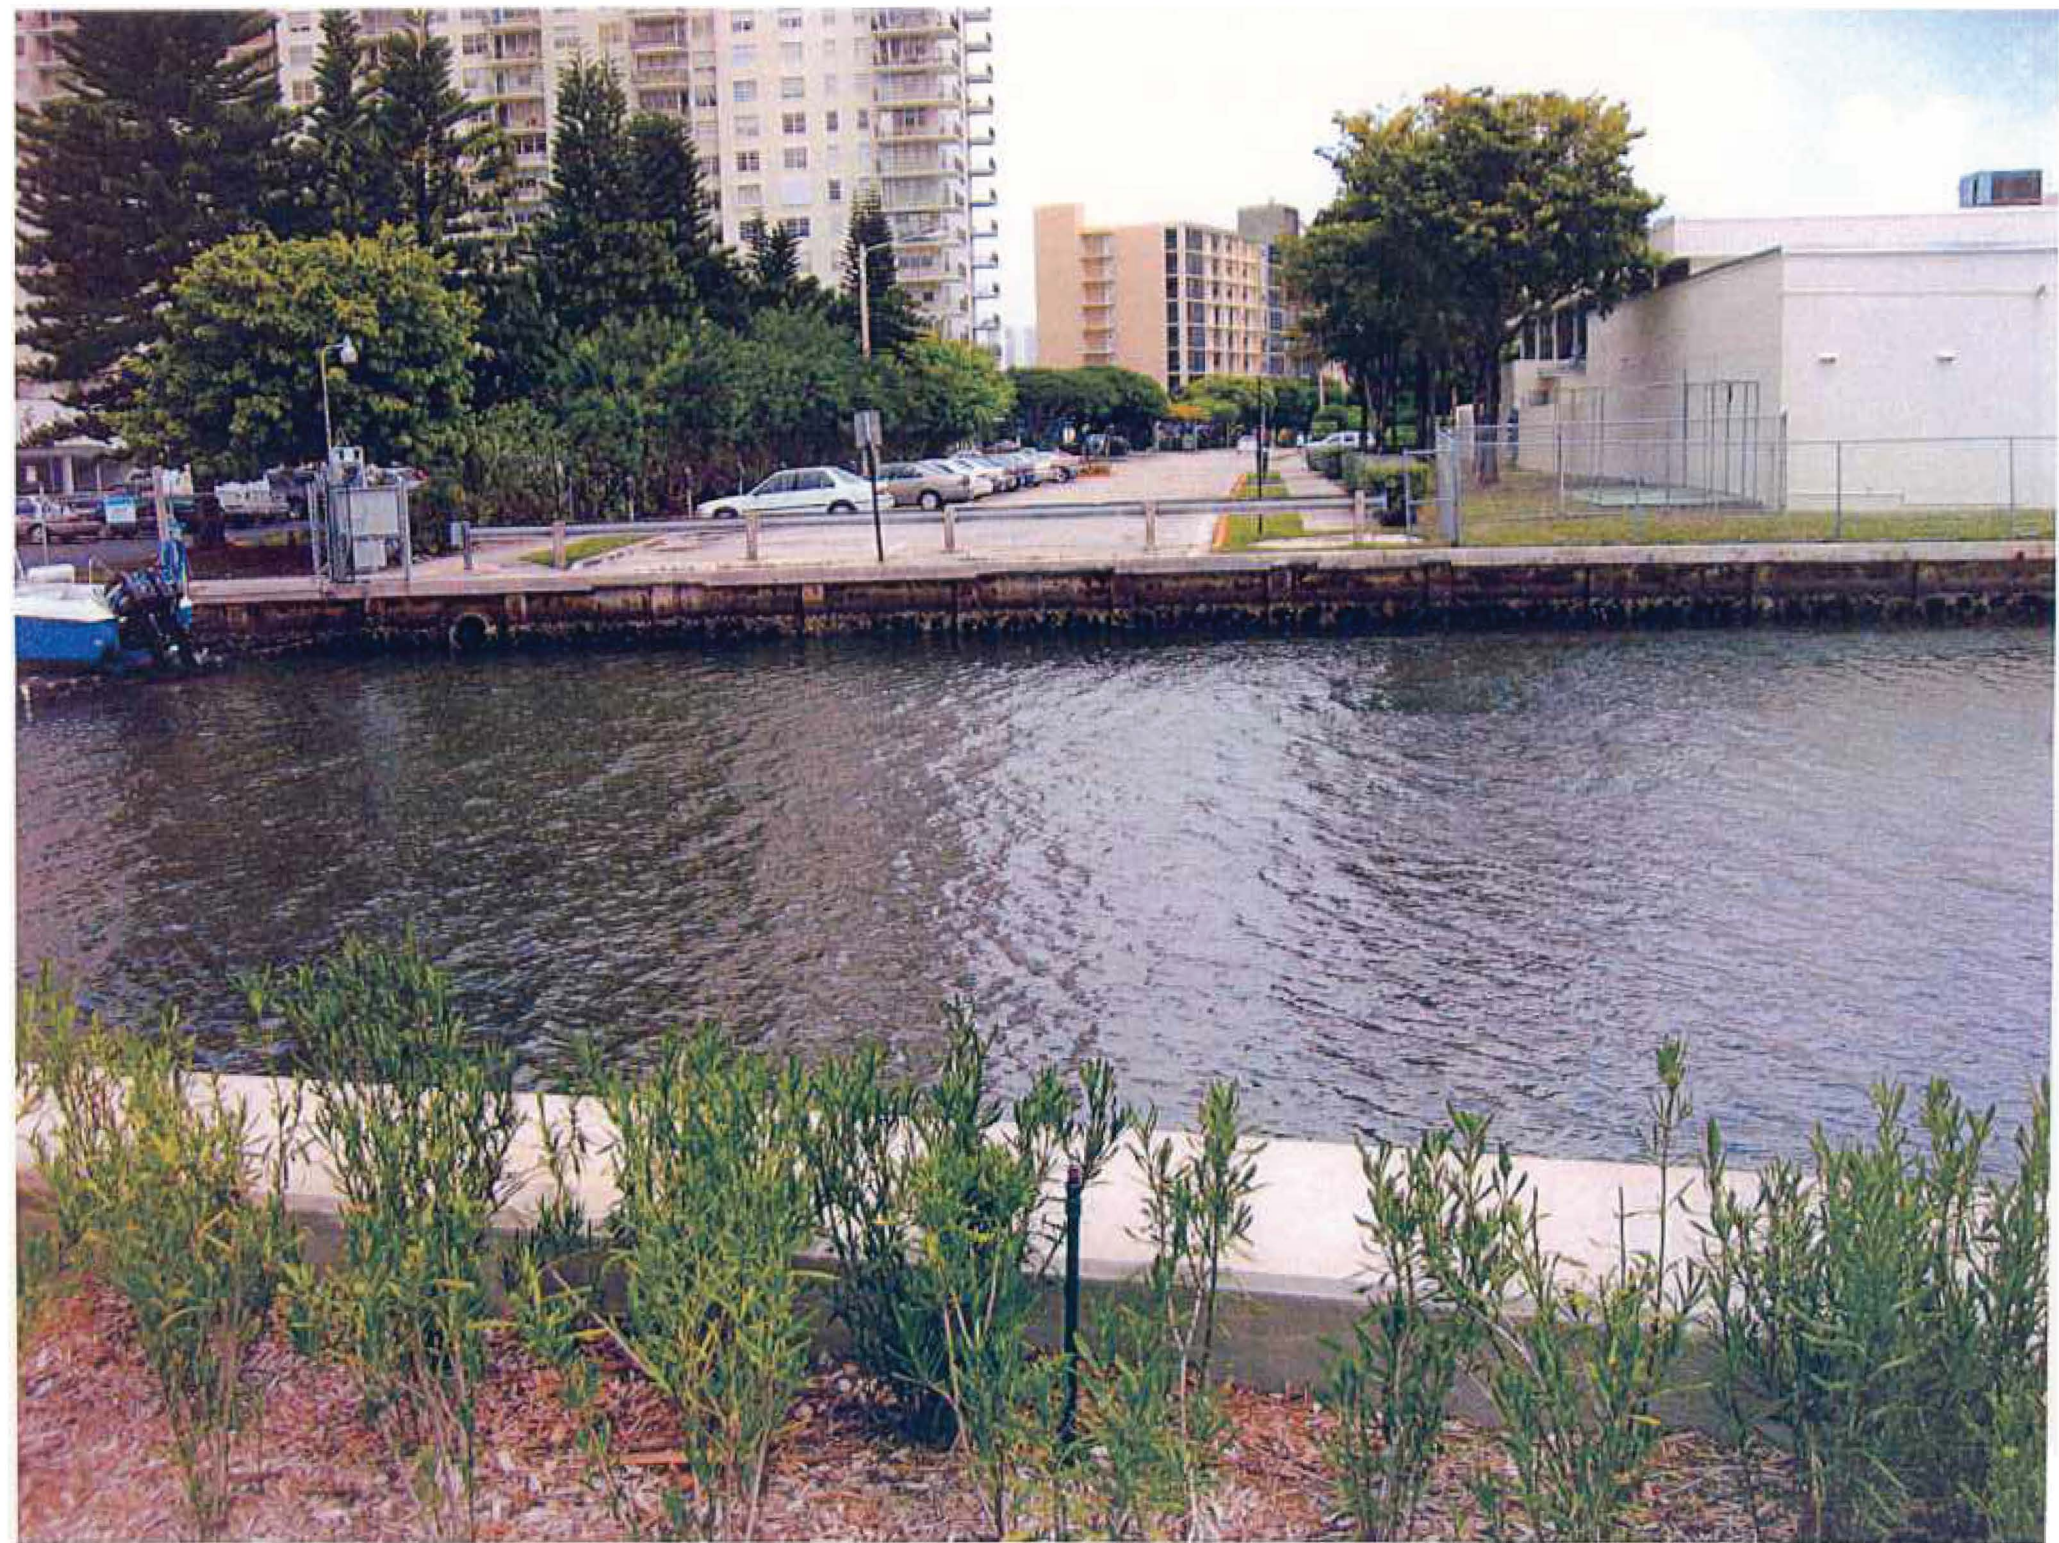
Figure 1

Looking North at North Bay Road

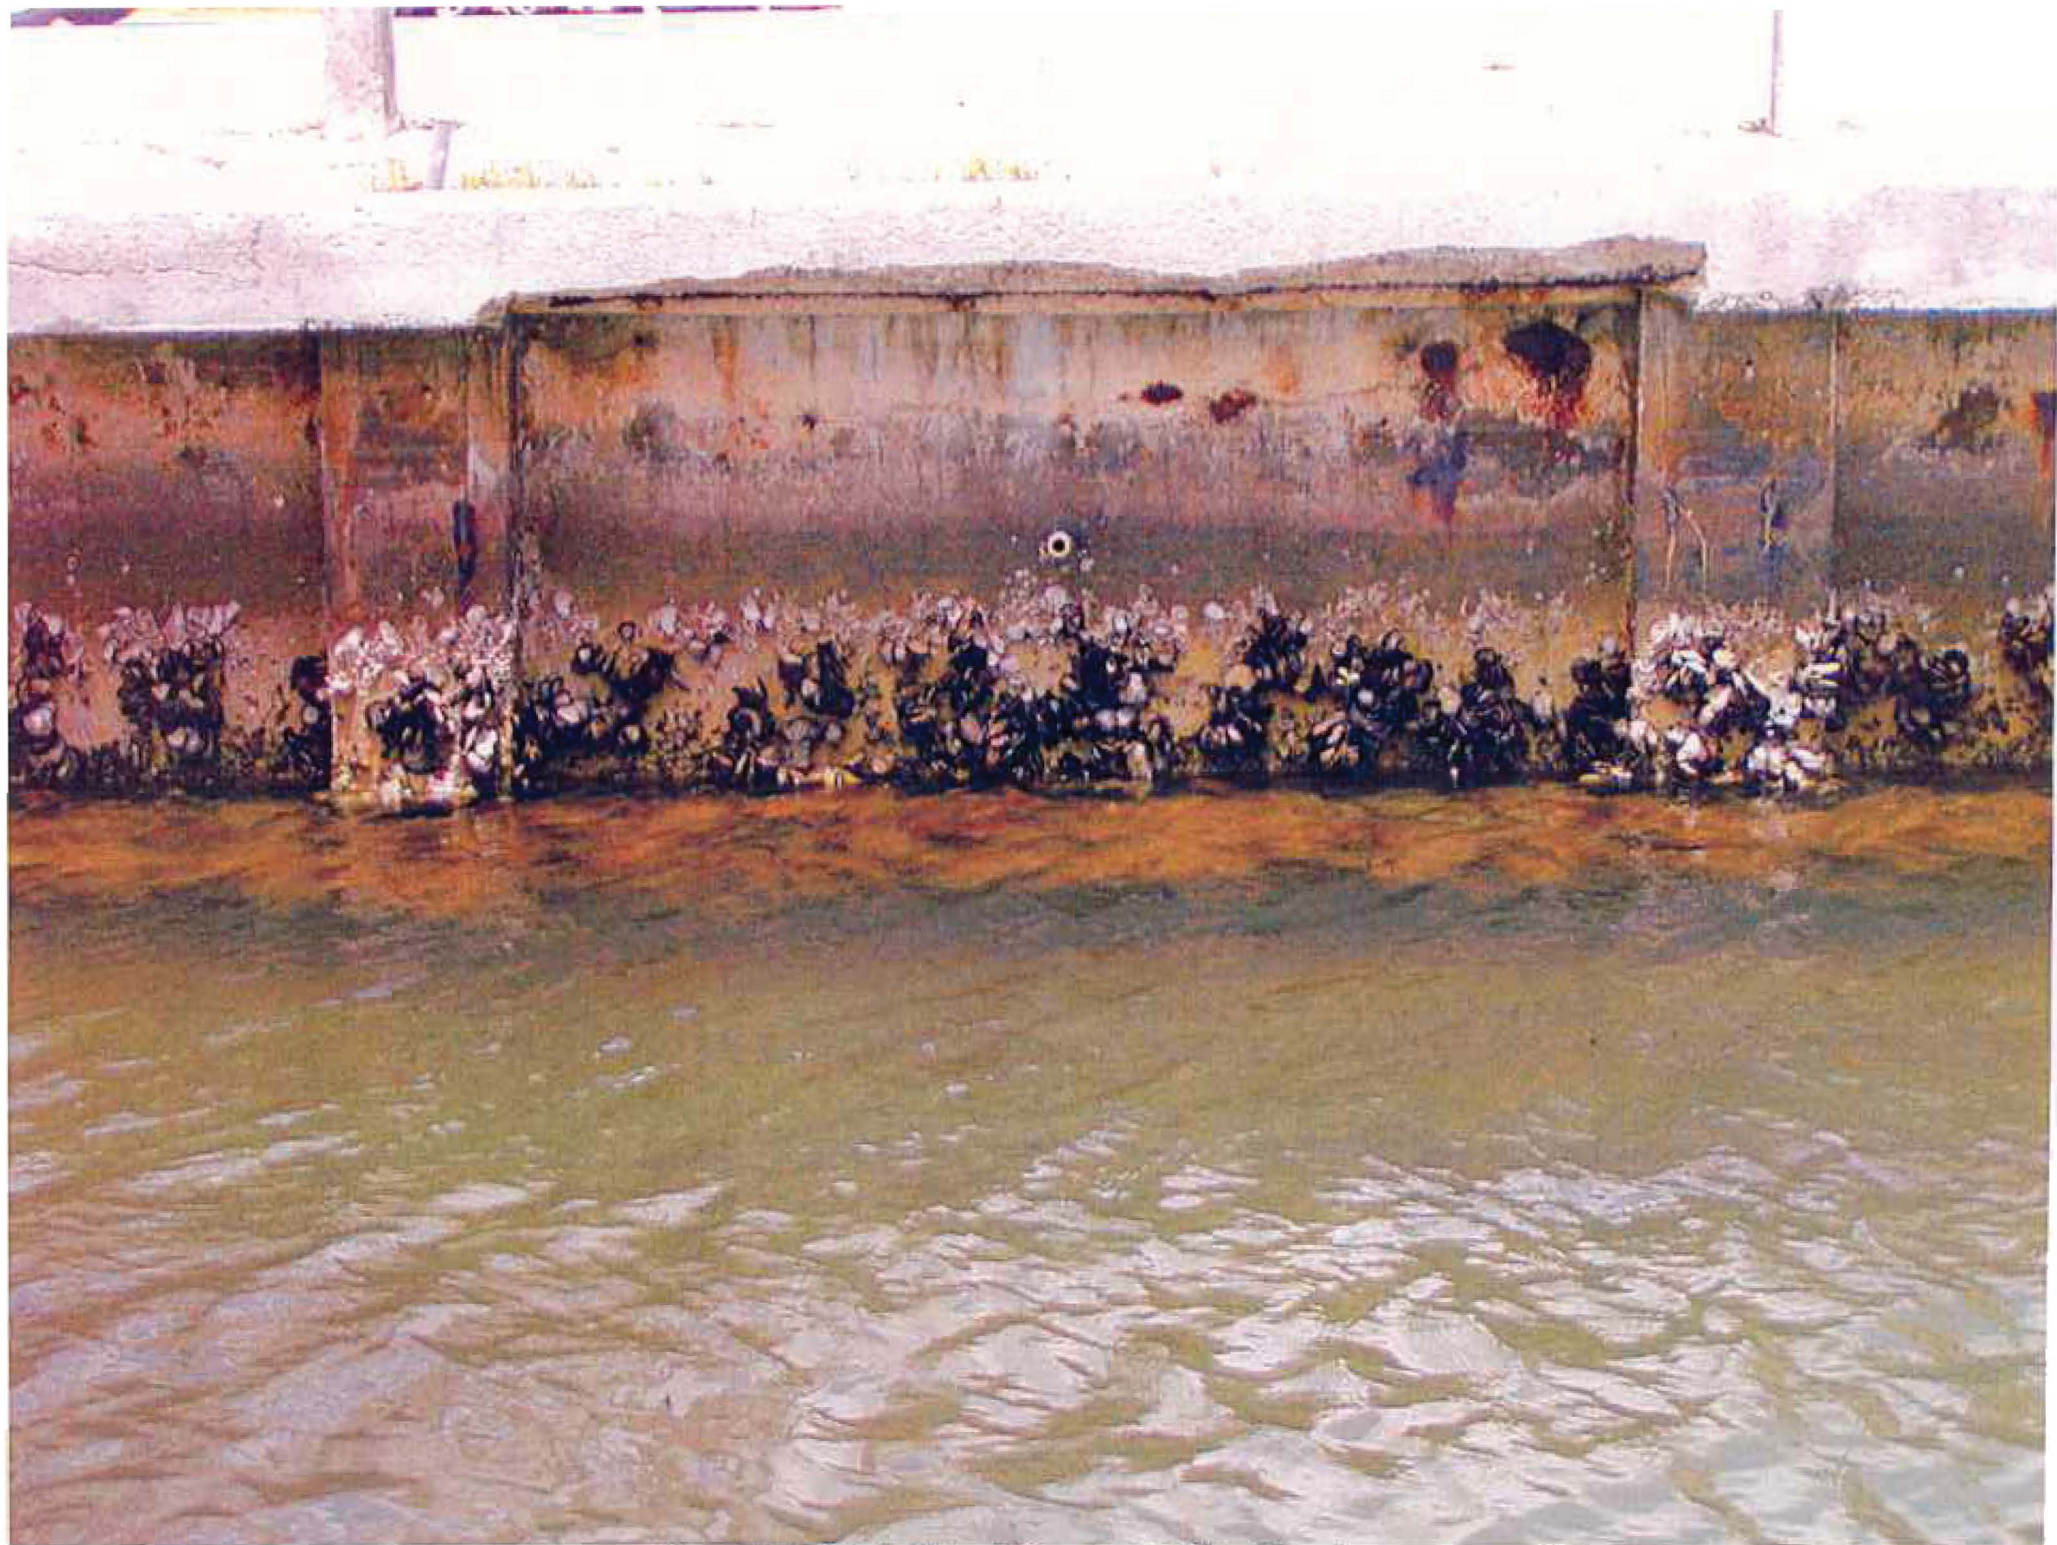
Figure 2

Seawall at North Side of Proposed Bridge Location

The water, at least several feet deep at the bulkhead, was quite turbid. No coral, seagrasses or hardbottom communities were observed in the submerged lands along the north shoreline. The bulkhead had a narrow fringe of algal material and colonies of mollusks along the mean water line. See Figure 2. The bulkhead continued to the east and west of the proposed bridge location.

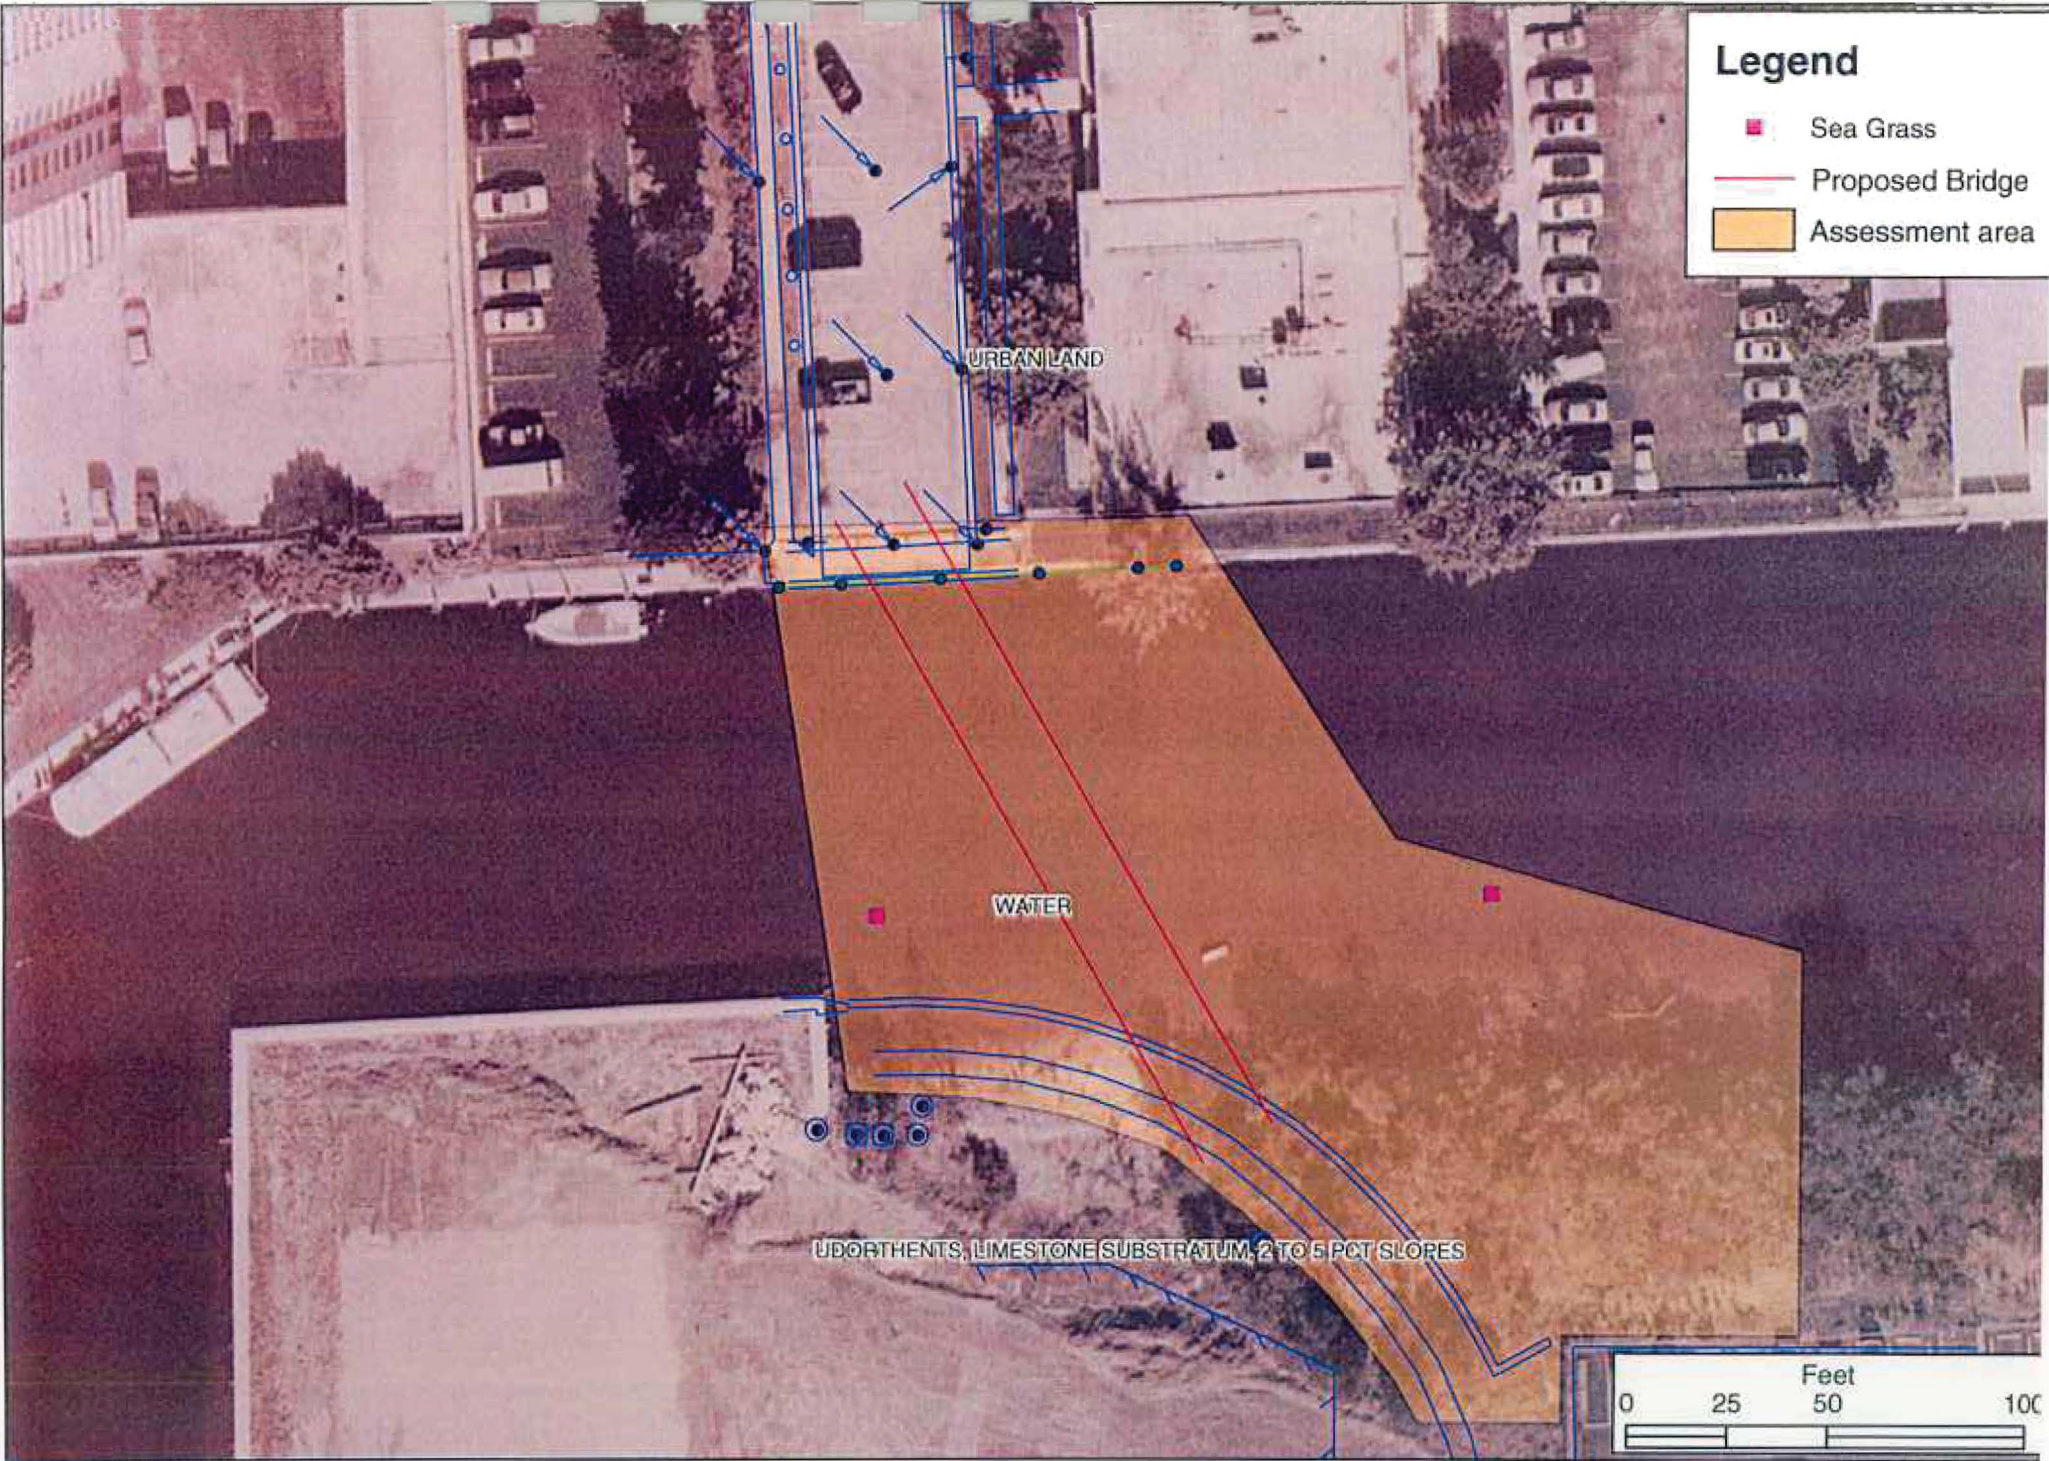
Figure 3

Aerial Overview of Proposed Bridge Location

Calvin, Giordano and Associates, Inc. performed an environmental assessment of the proposed bridge location (see Appendix A, Figure 3). The area on the North side of the canal is a developed urban area that terminates at the concrete bulkhead. Along the north shoreline no jurisdictional wetlands, listed plants species, or exotic plant species were present.

The moderately turbid canal had no sea grasses on the submerged land along the north shoreline, but sparse patches of sea grasses were observed near the proposed bridge connection on the south shoreline. The sparse patches are shown as squares located east and west of the proposed bridge location on the south shoreline in Appendix A, Figure 3.

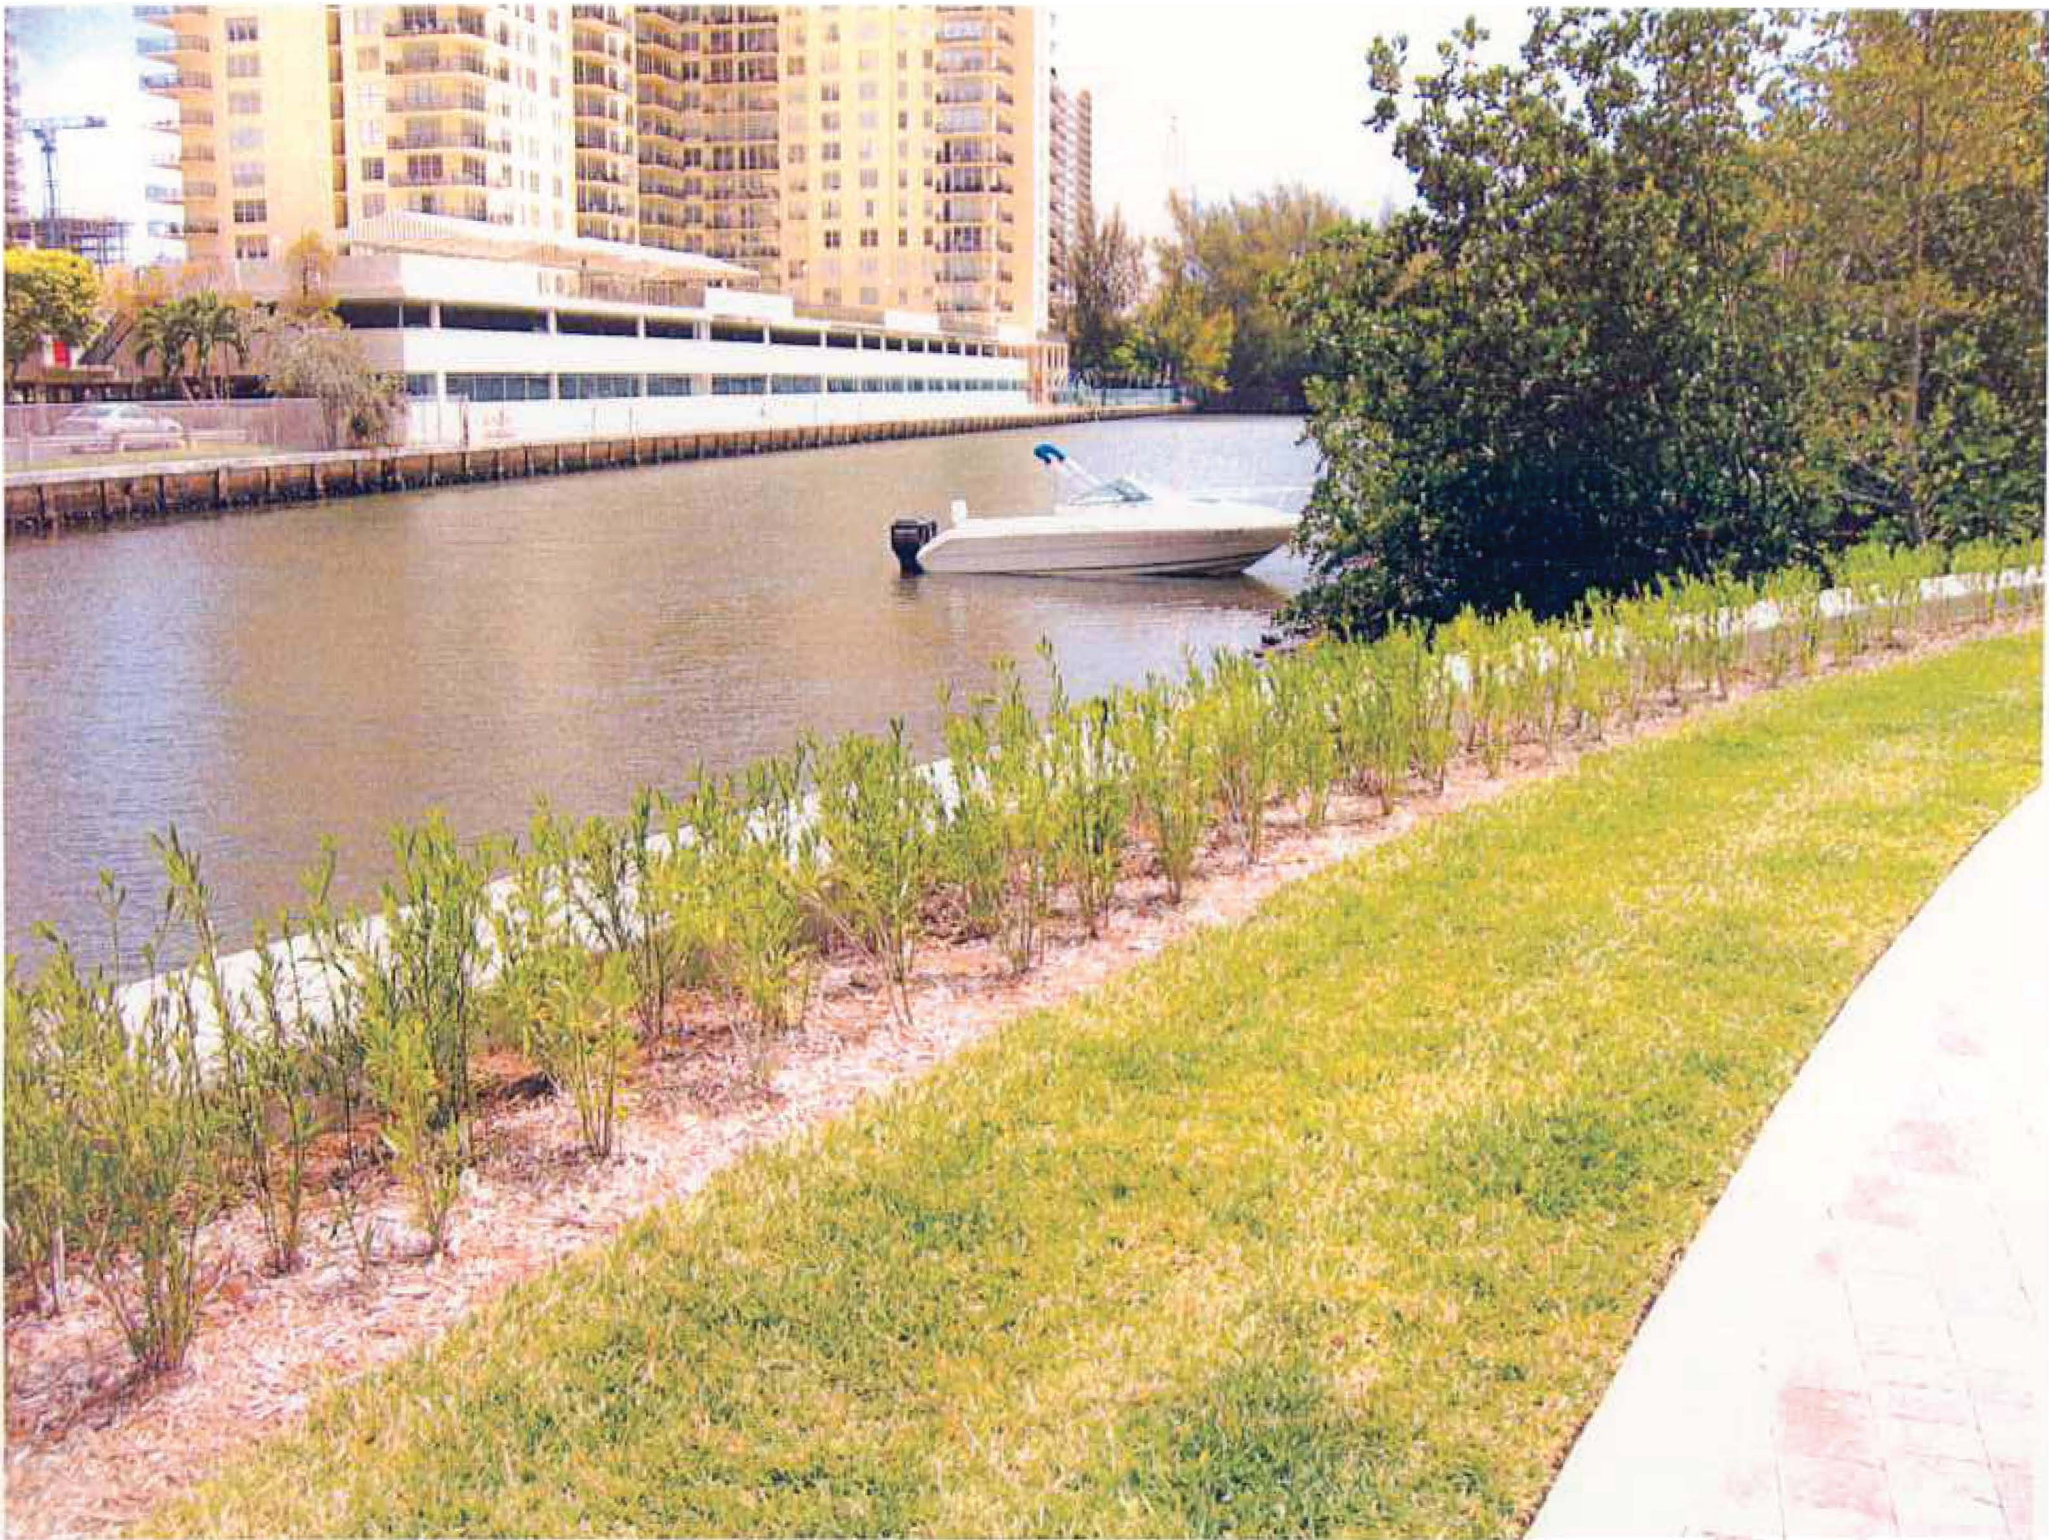
Figure 4

Vegetative Strip Along Seawall on South Side of Canal Looking East

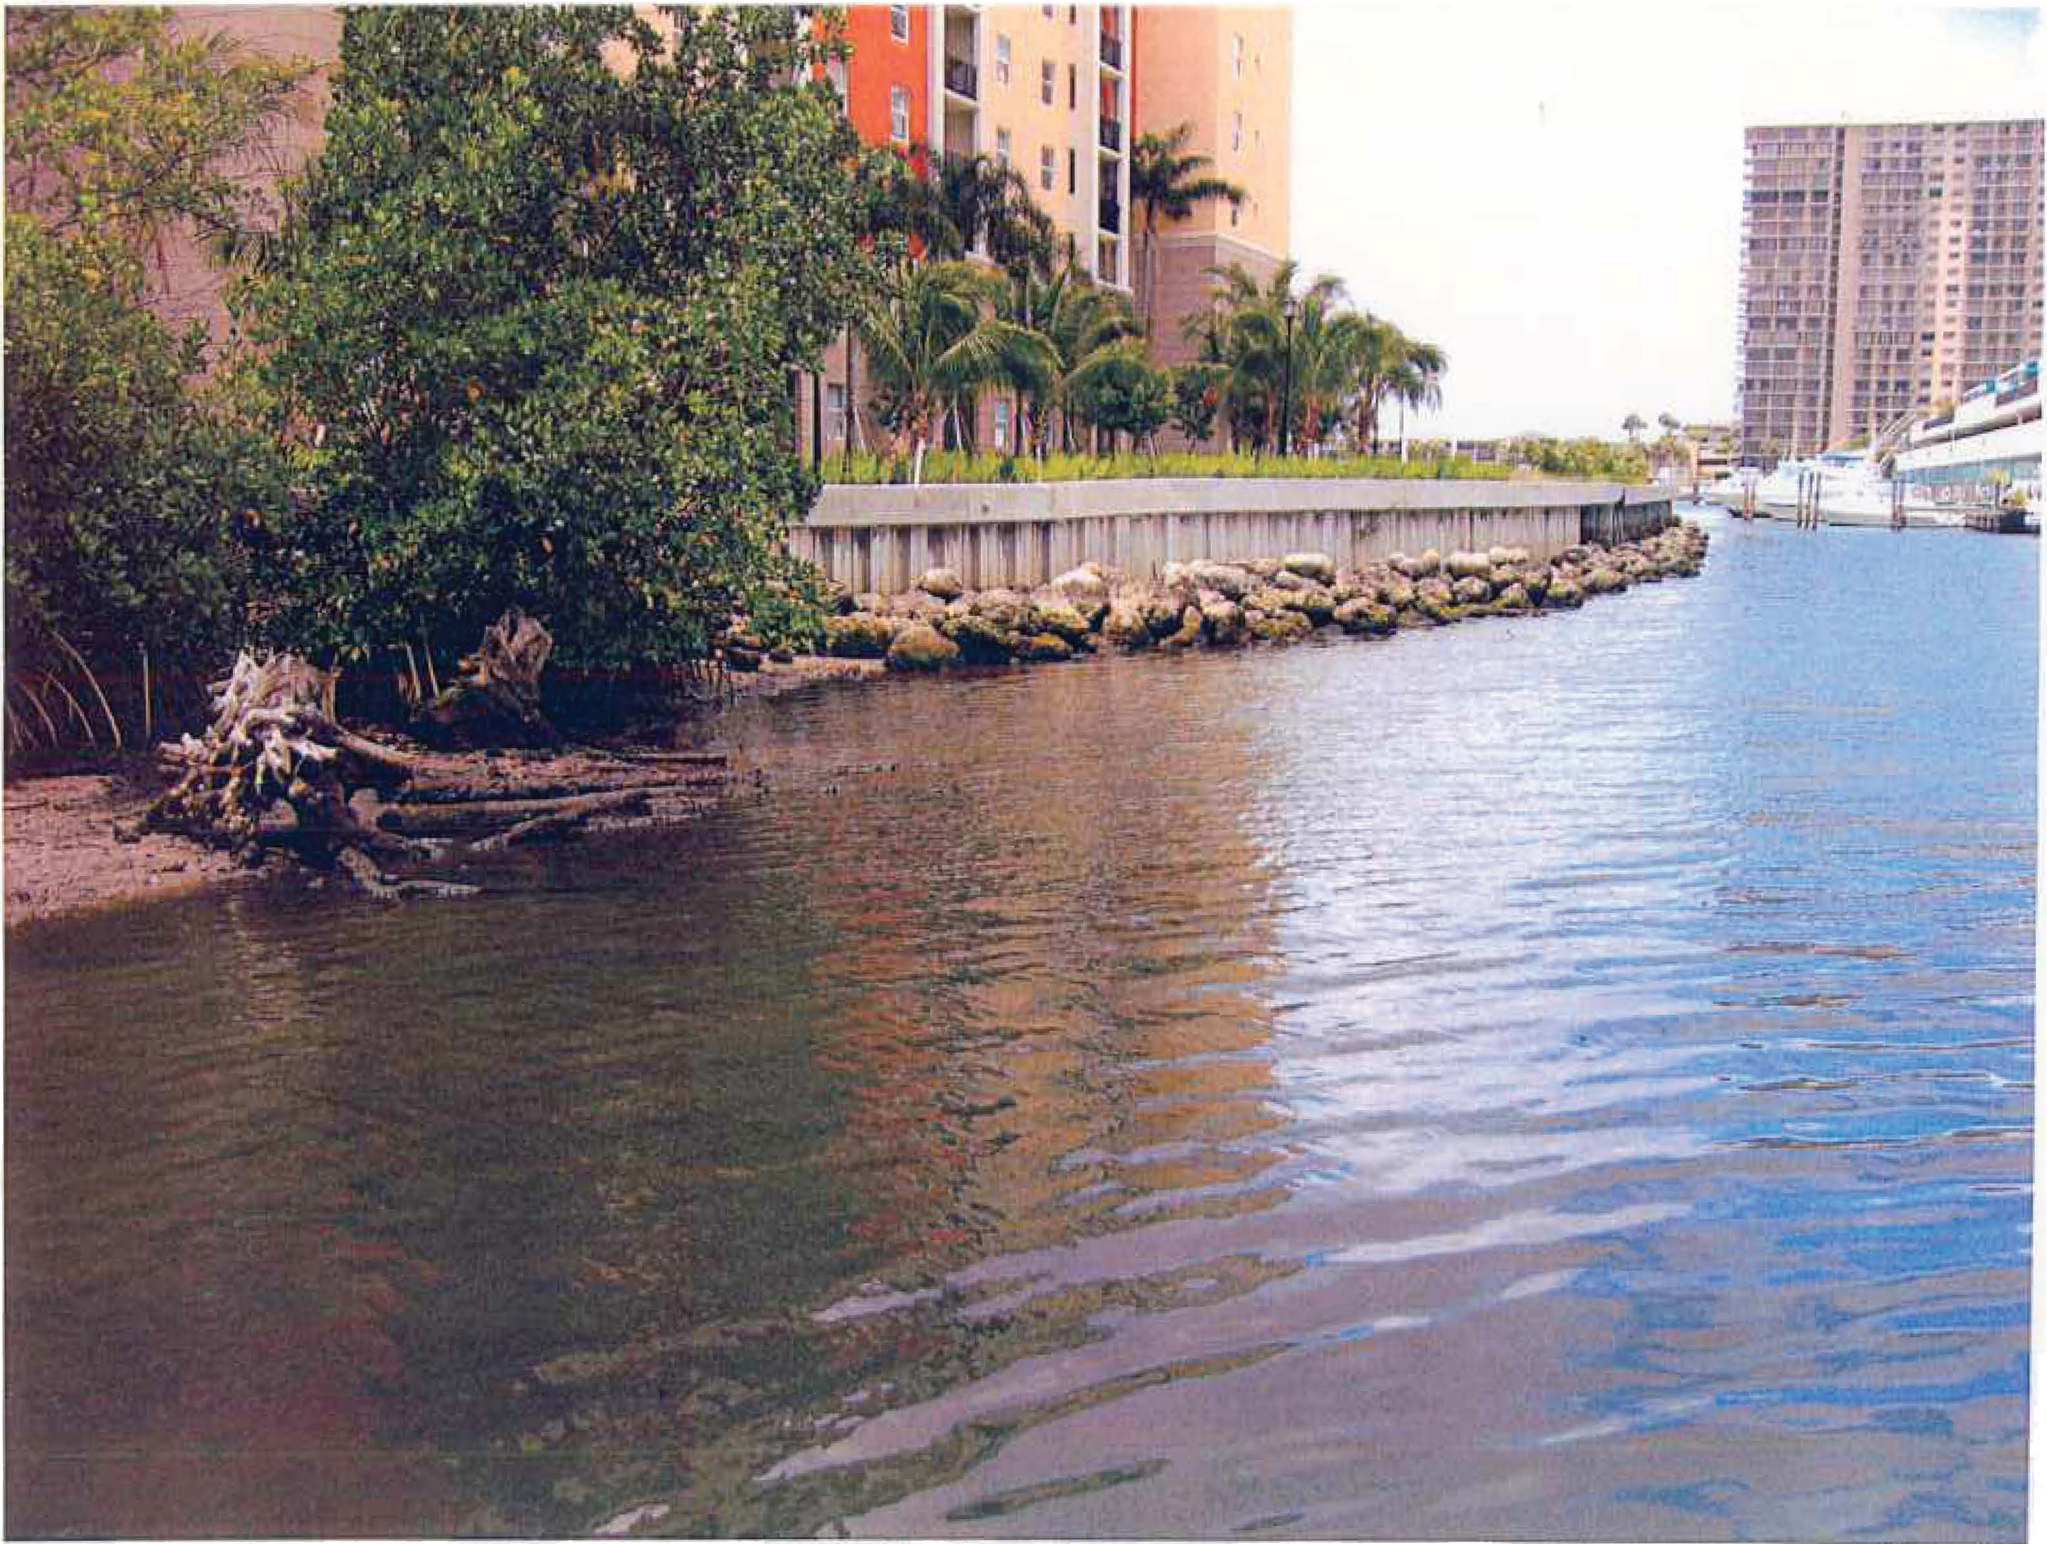
Figure 5

South Side of Canal Looking West

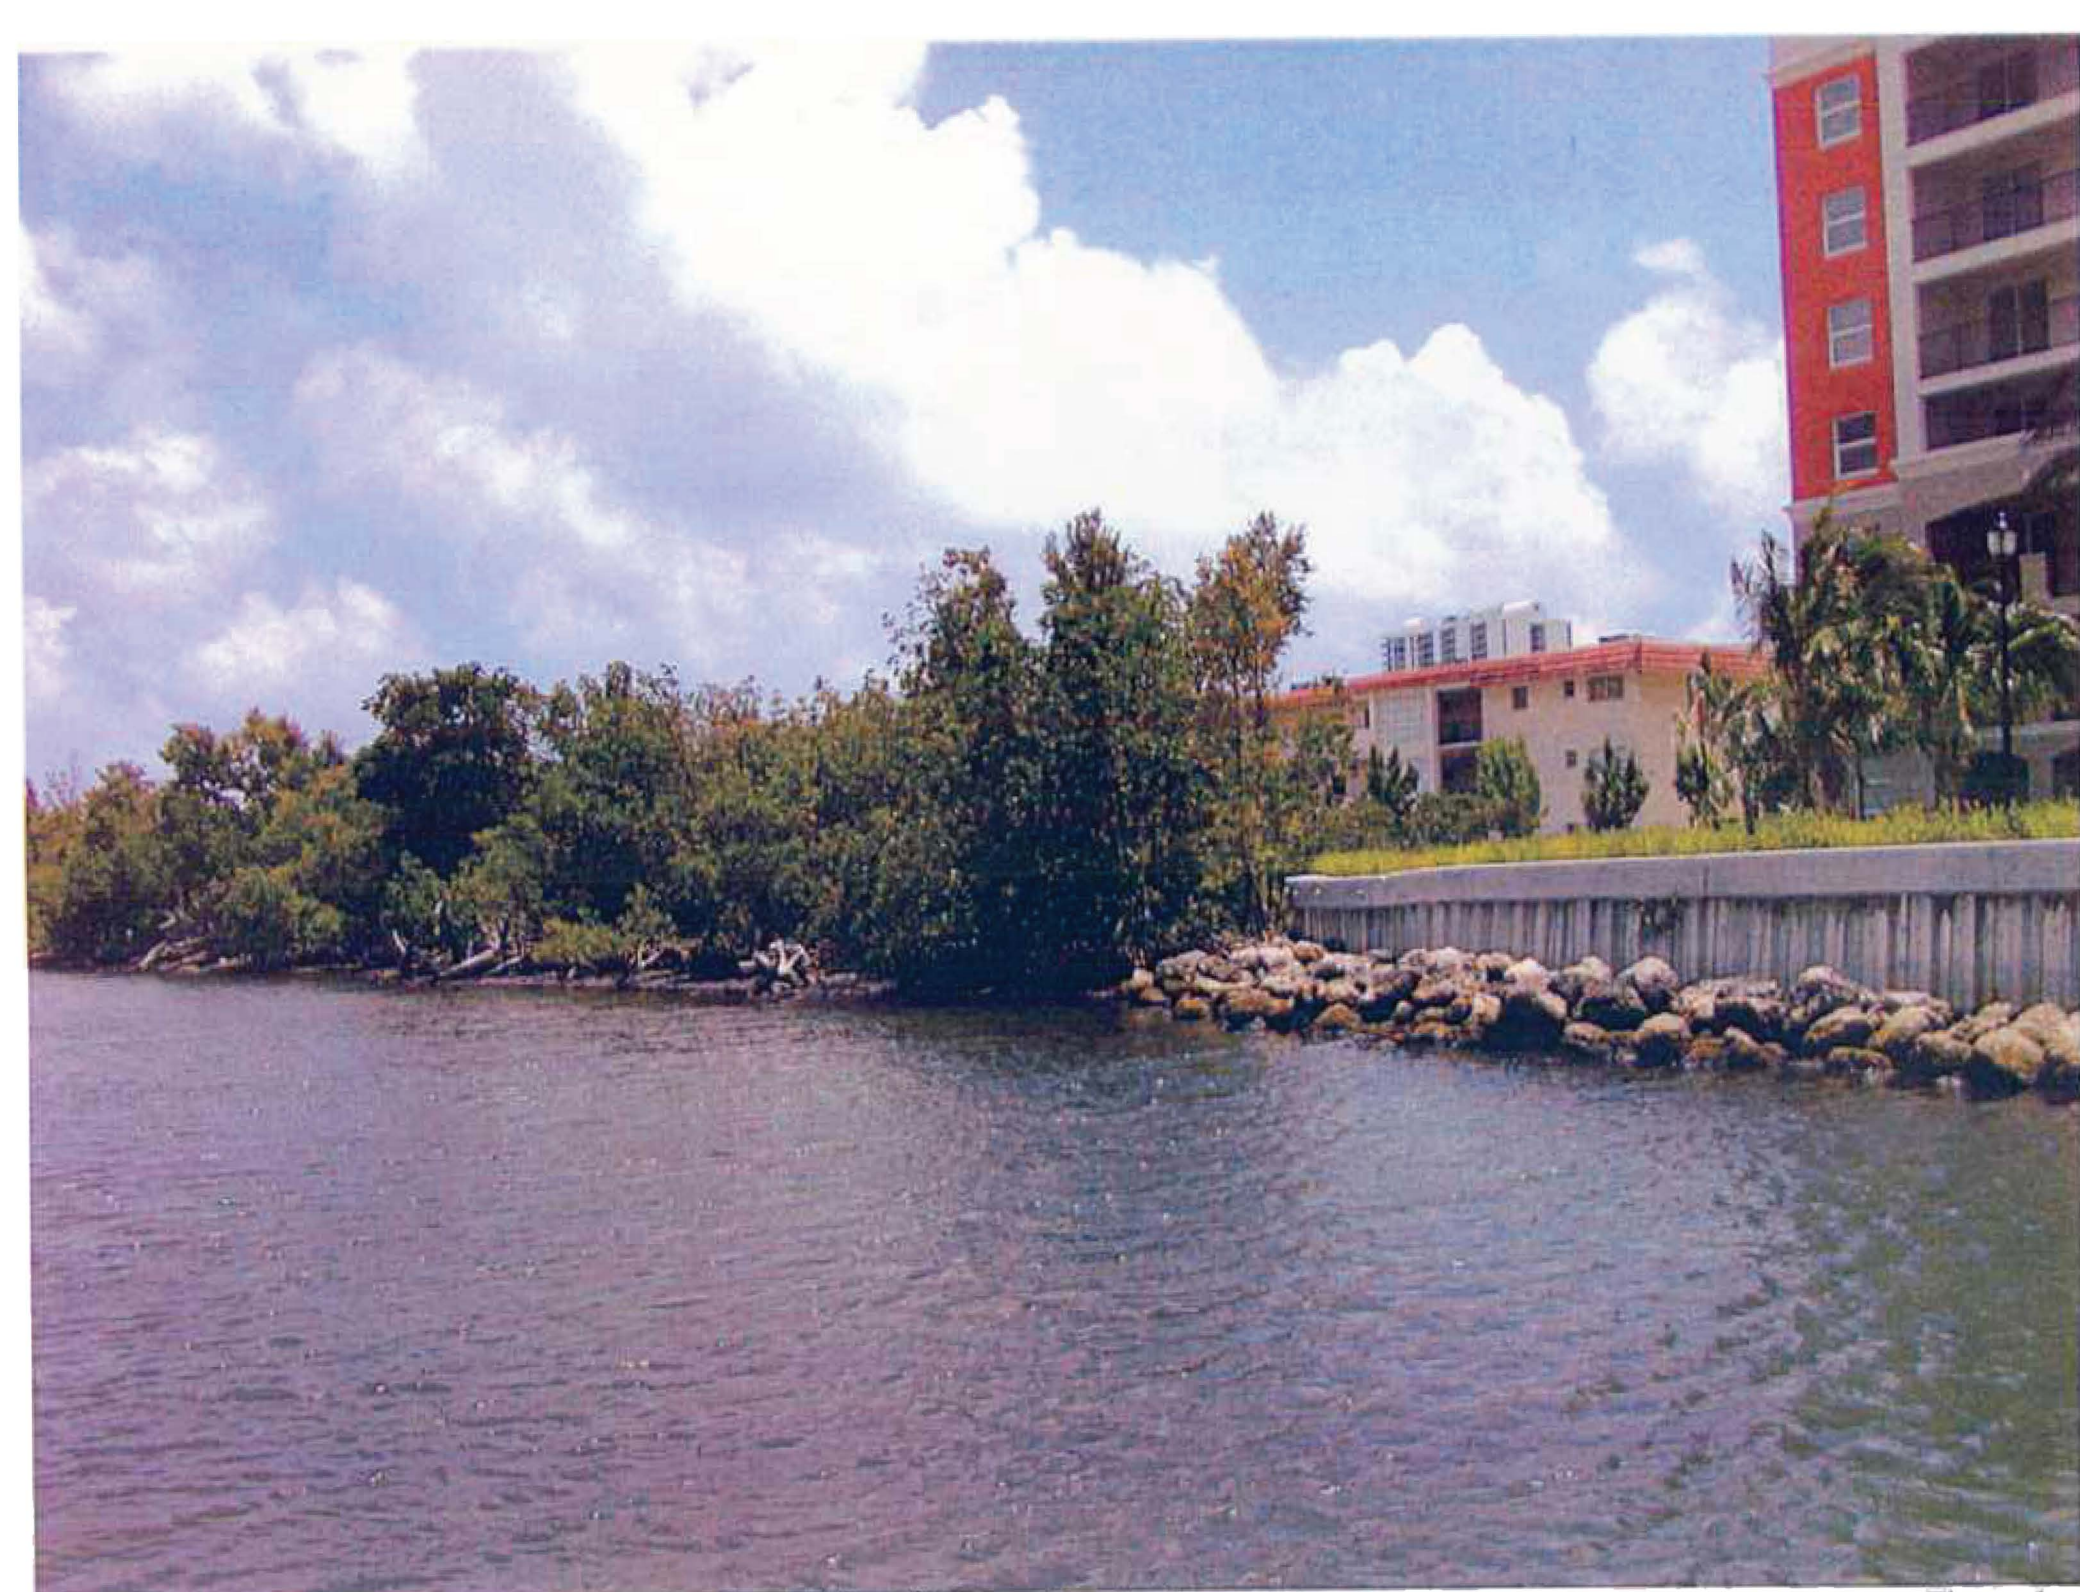
Figure 6

Looking ESE From Canal at Impact Area

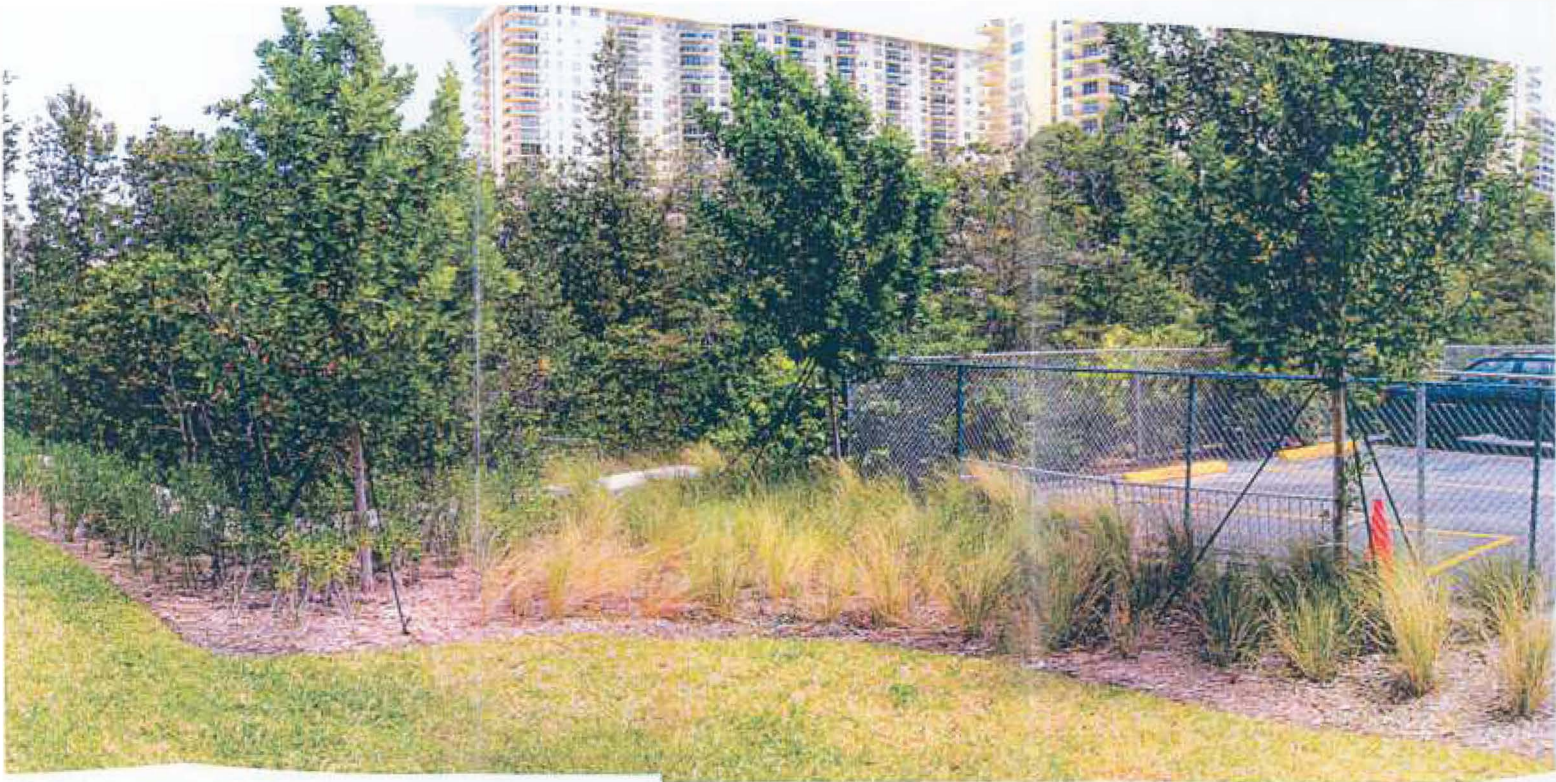
Figure 7

Proposed Bridge Location
