CITY OF SUNNY ISLES BEACH

Feasibility Study Summary of a Bridge to Link a Pedestrian/Bicycle Greenway

**Extension of North Bay Road from 172nd to 174th Street
City of Sunny Isles Beach**

CGA Project No. 04-4567
September 2004

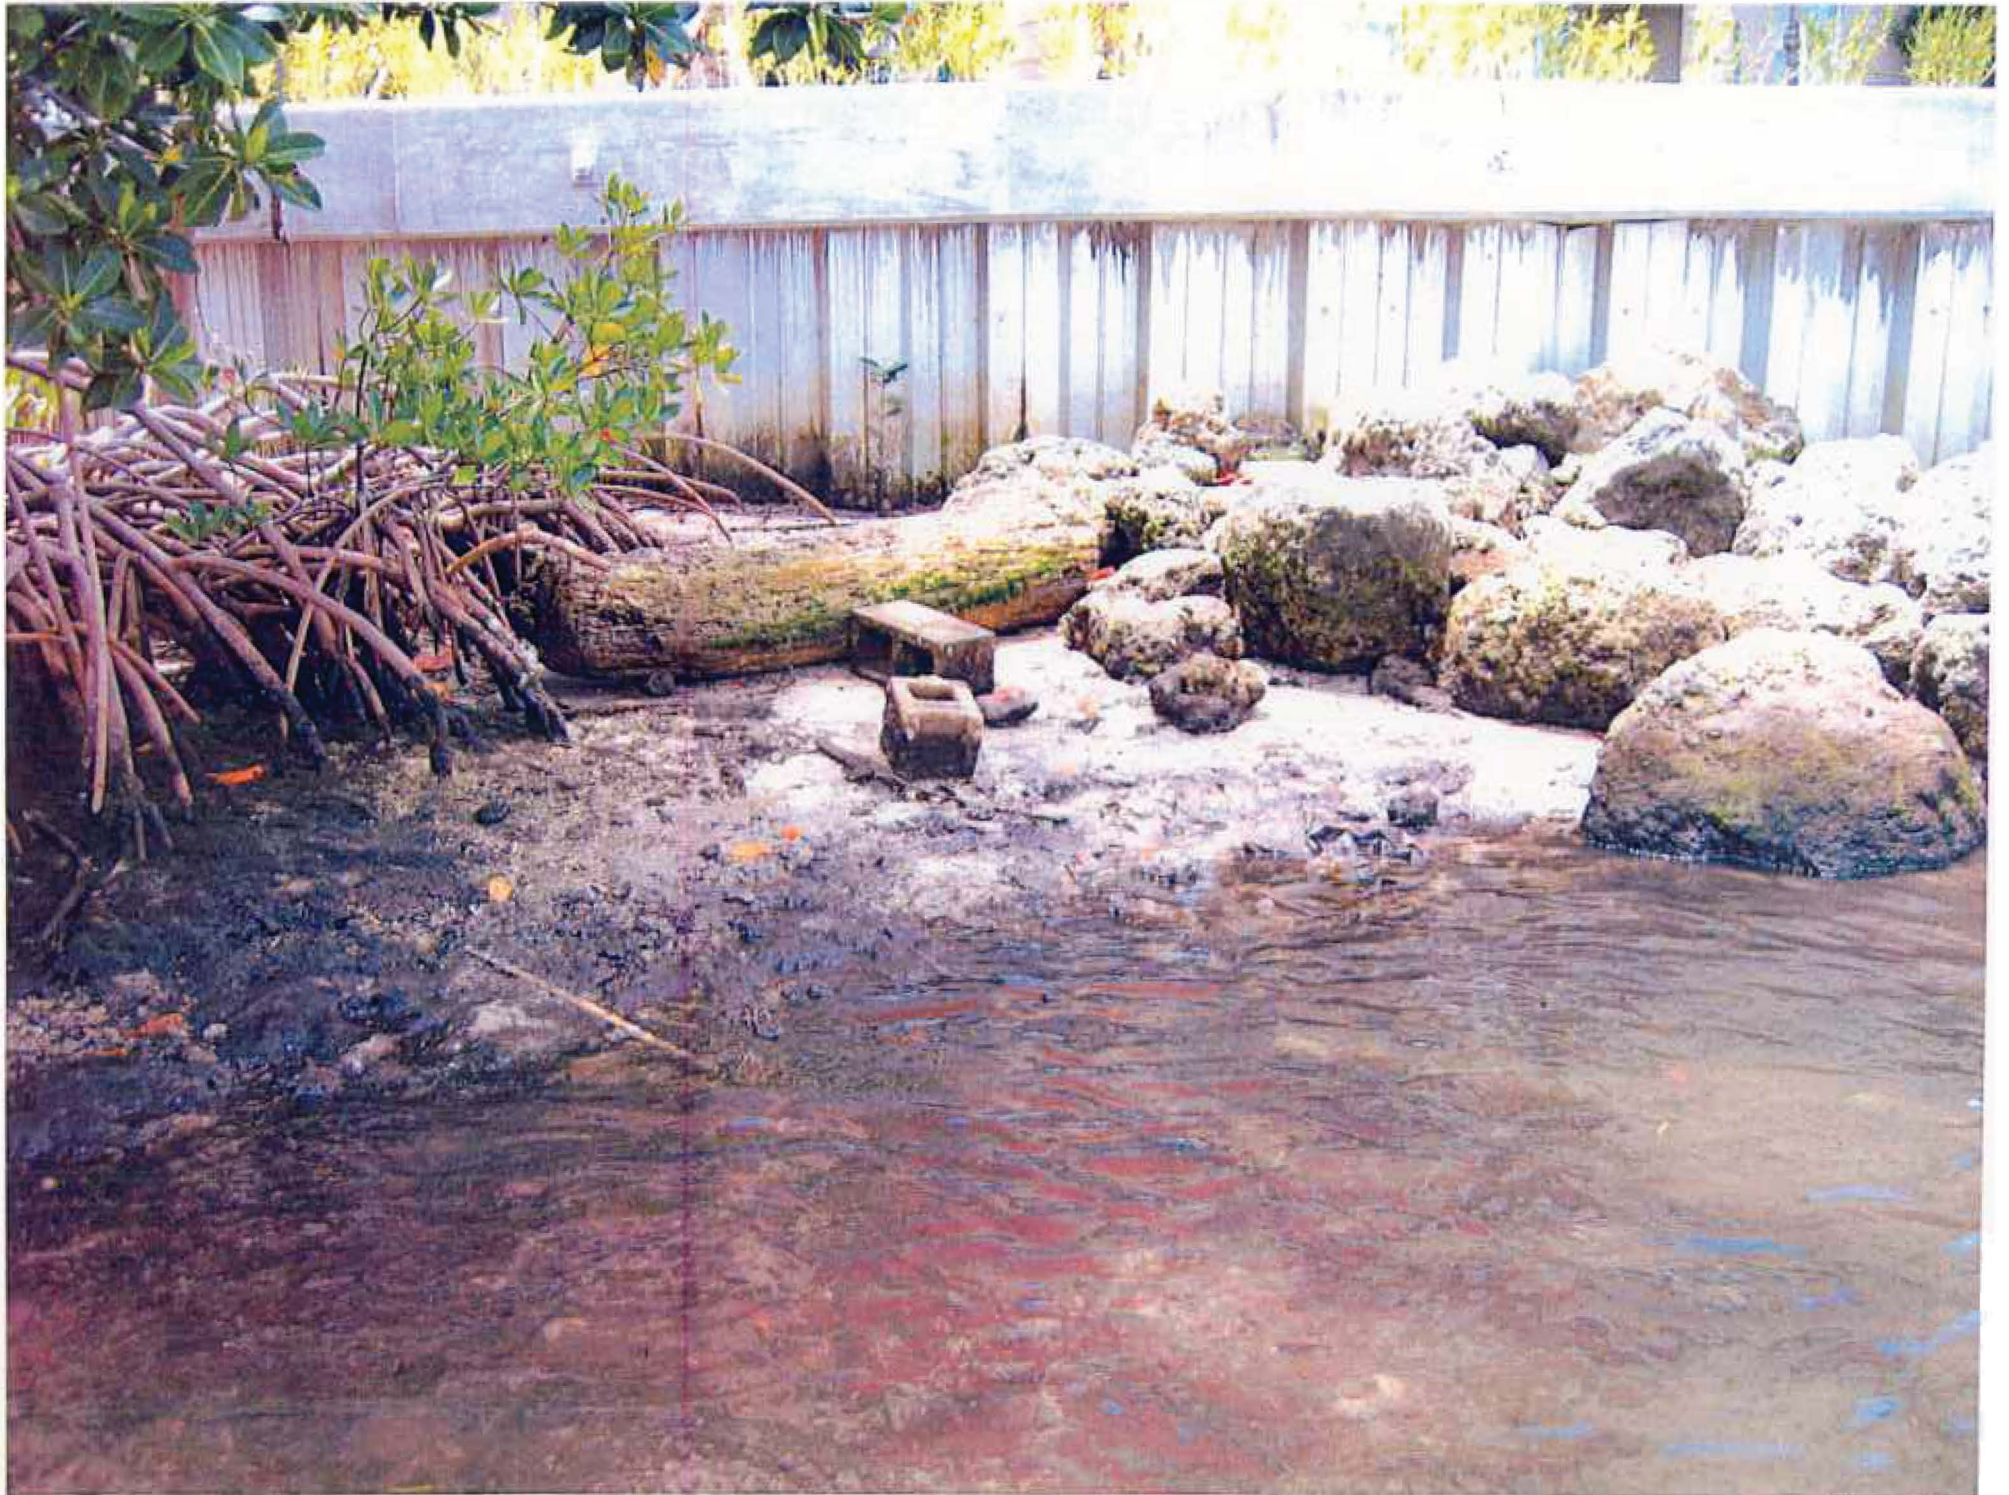
Figure 8

Rip Rap in Front of Seawall on South Side of Canal

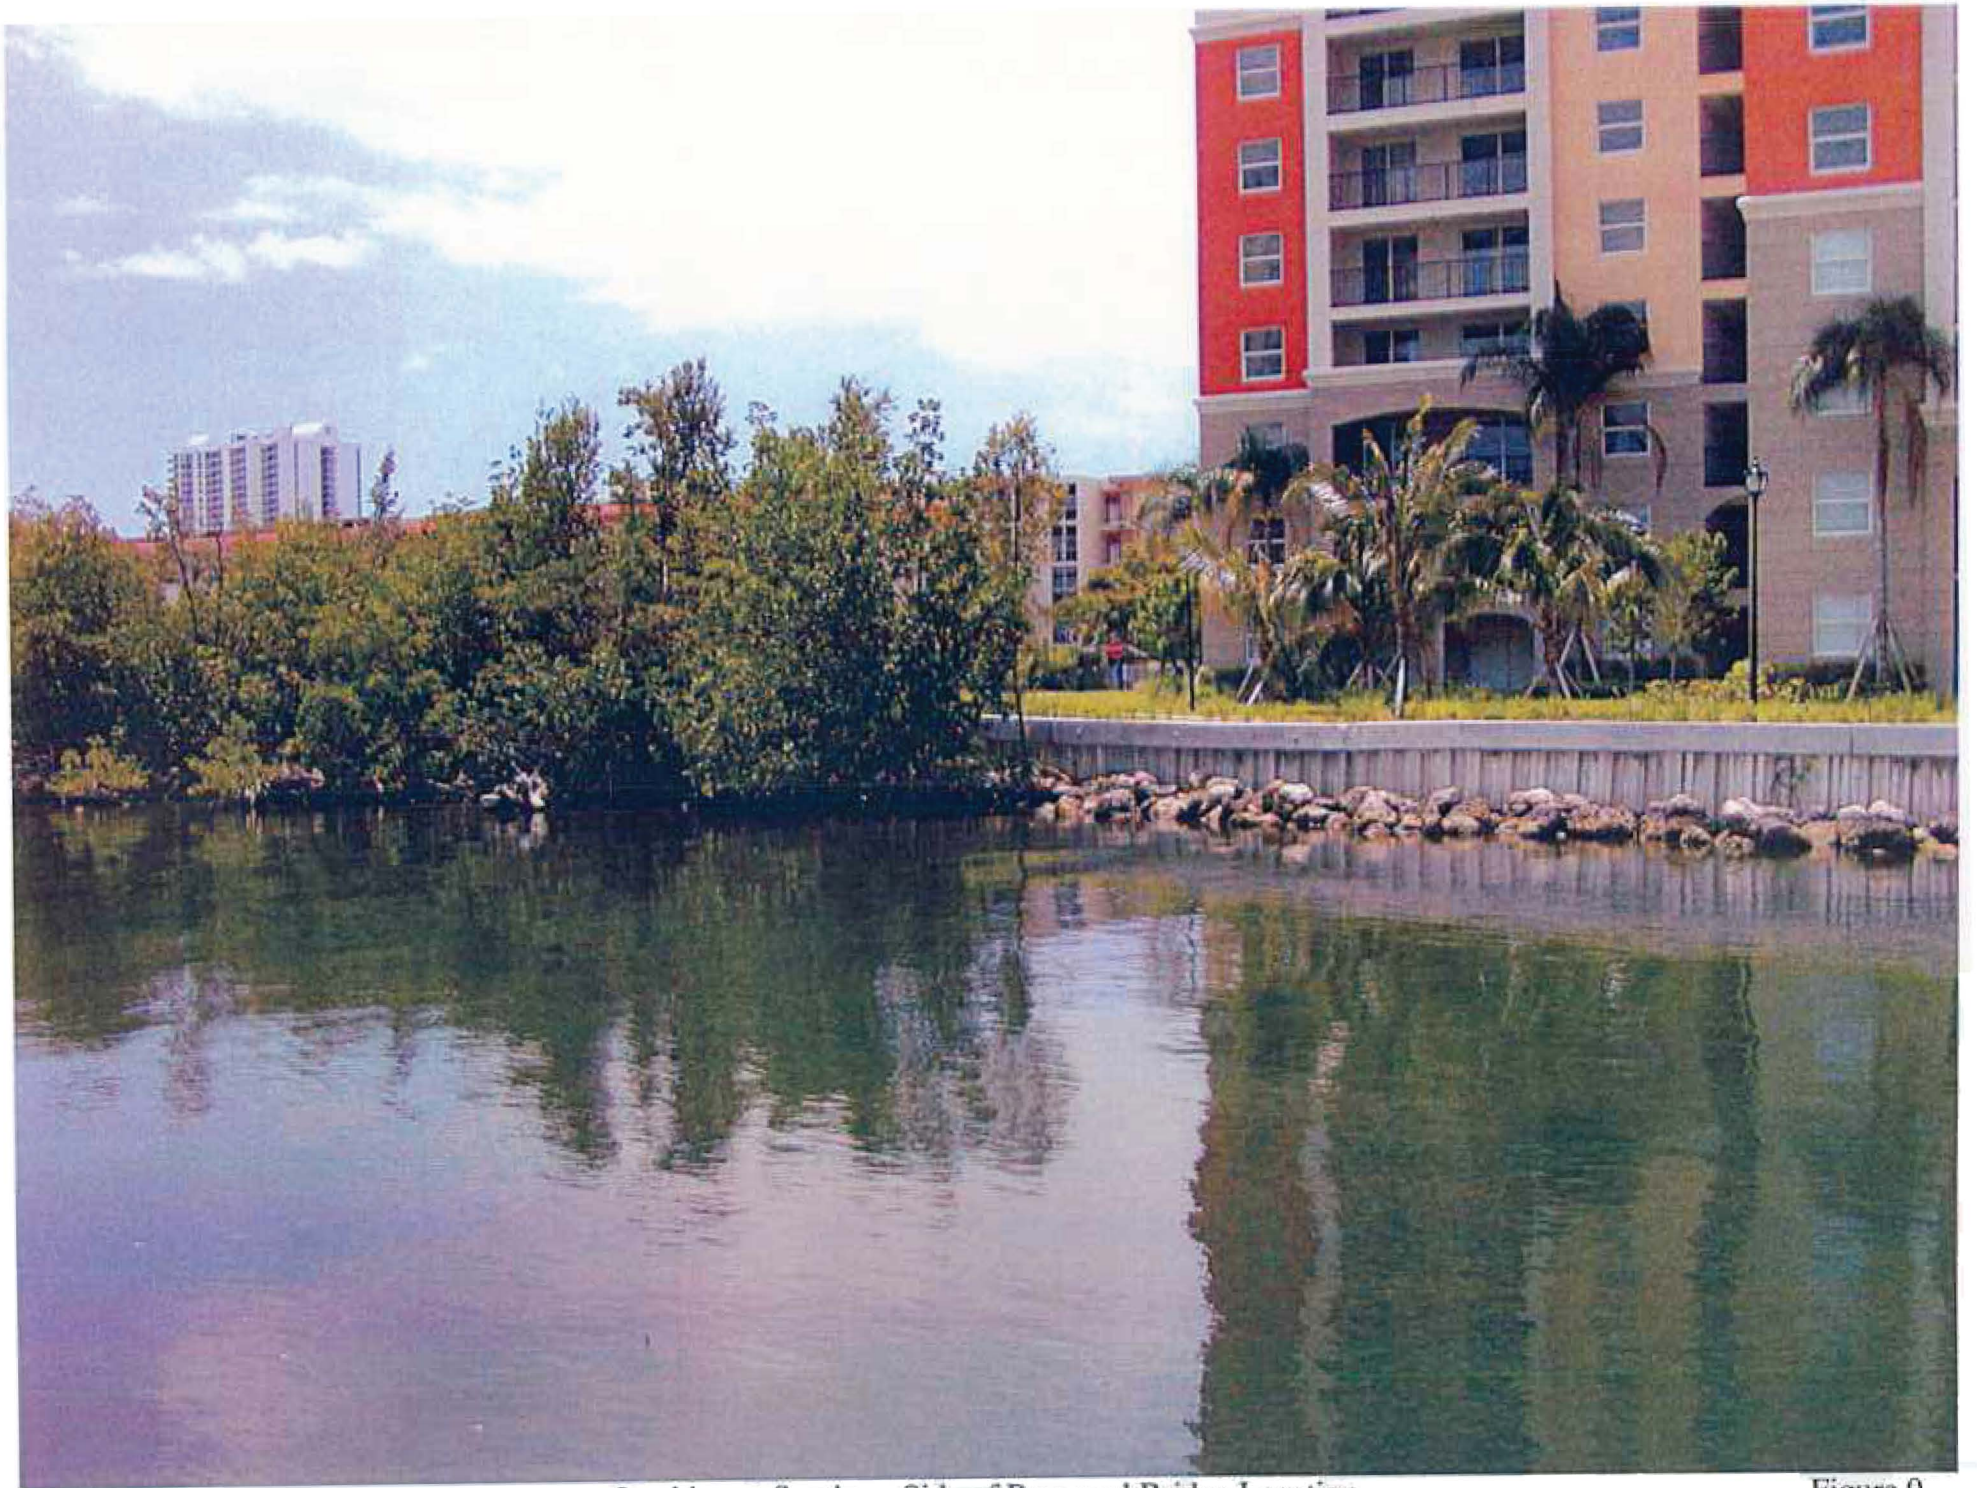
Figure 9

Looking at Southern Side of Proposed Bridge Location

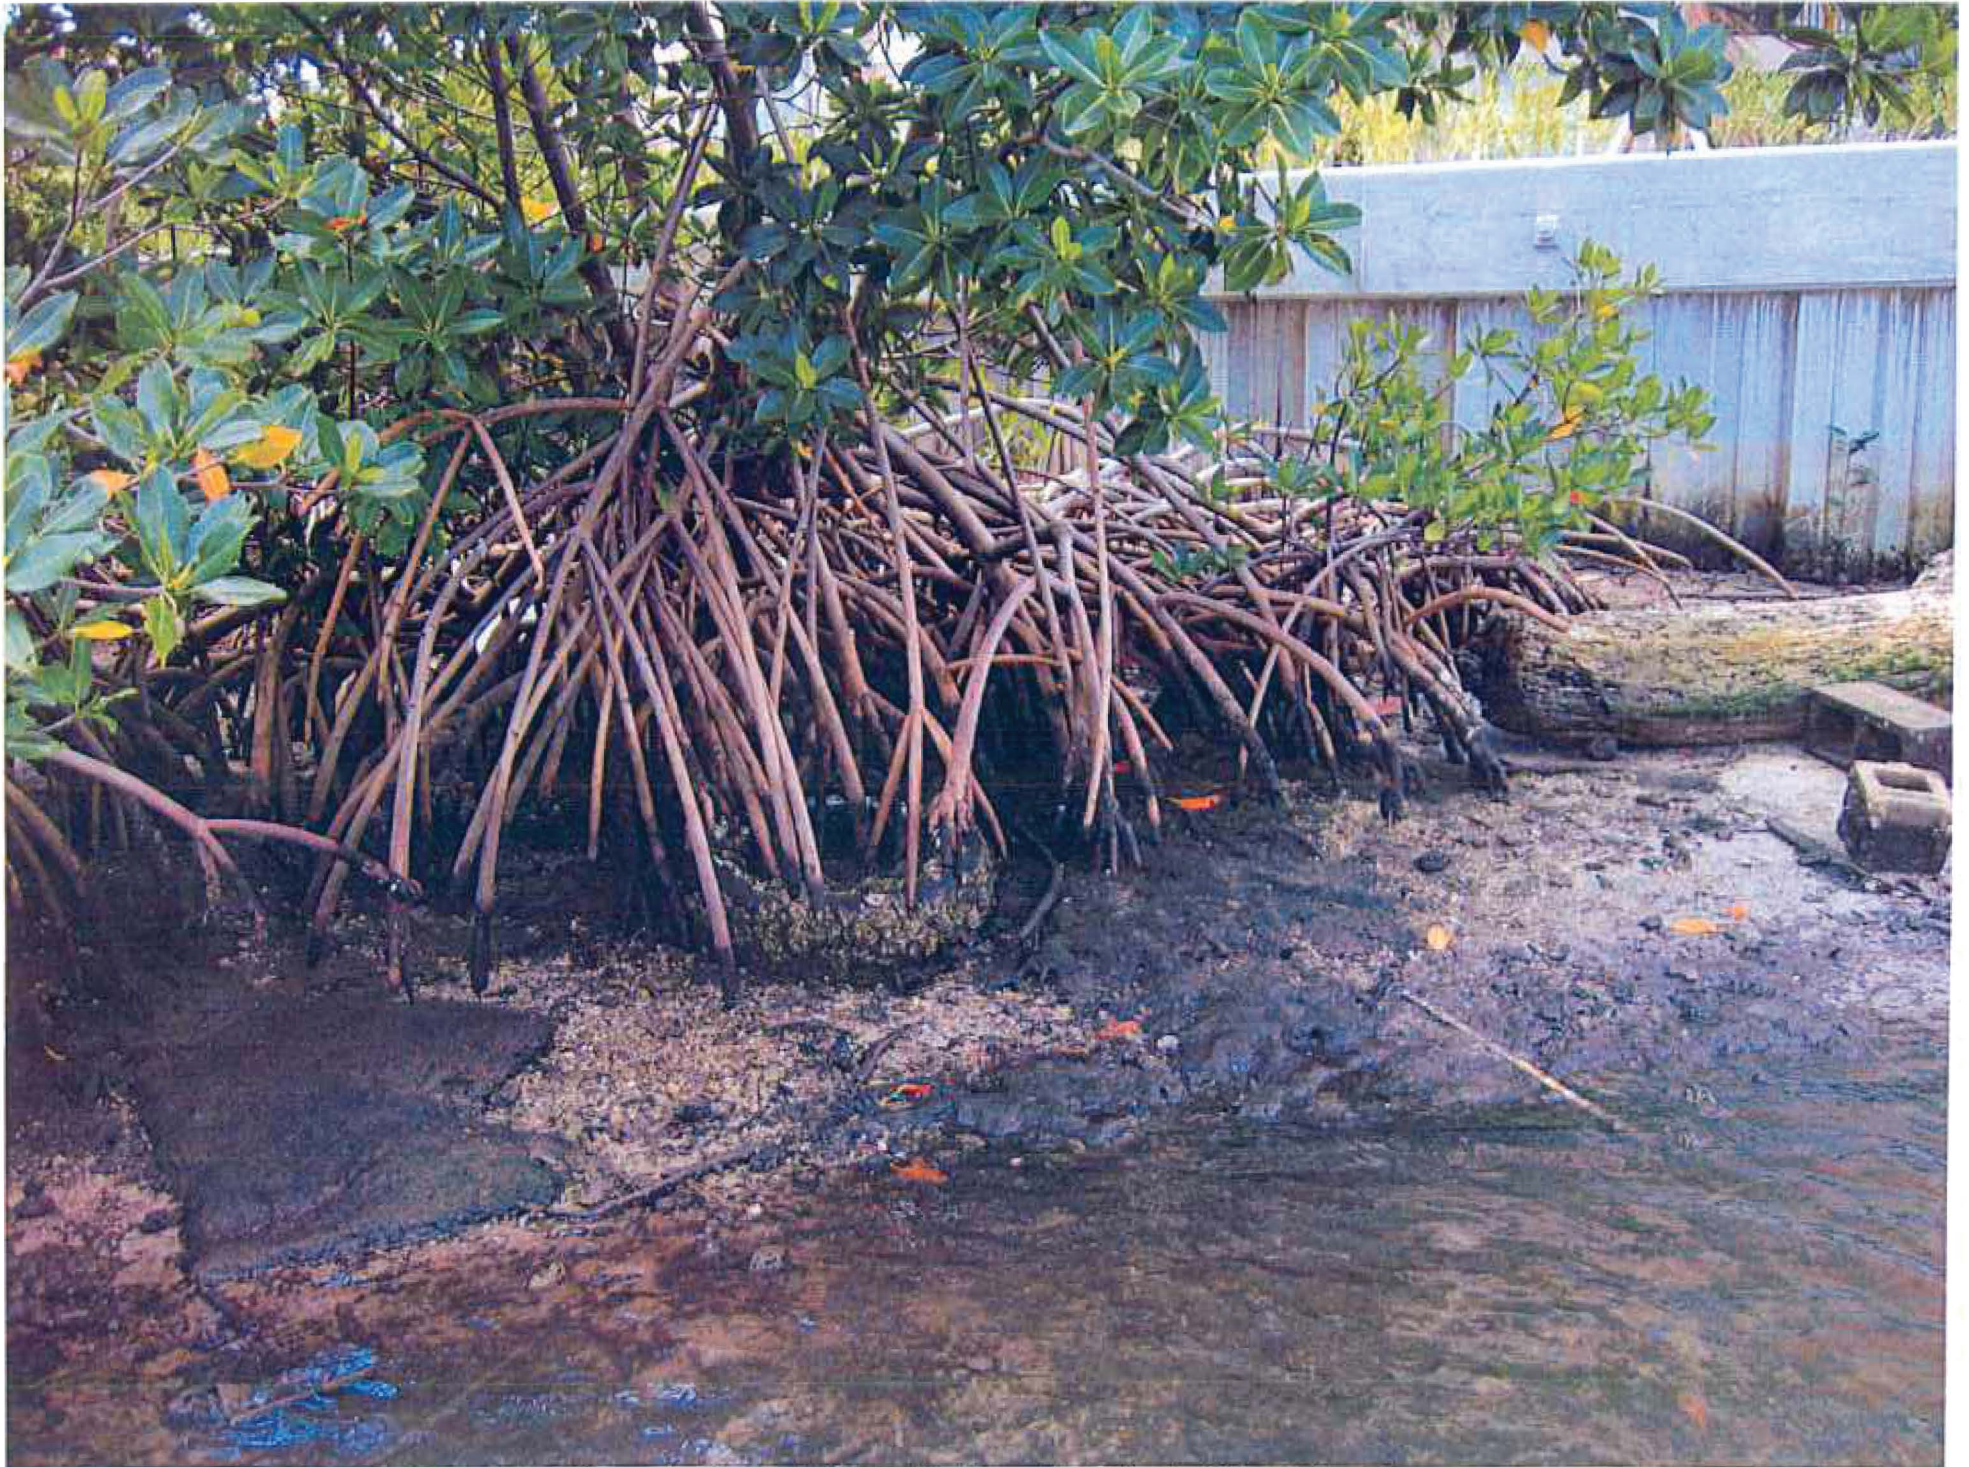
Figure 10

Mangrove Roots Adjacent to Seawall on South Side of Canal

East of the riprap the immediate shoreline is unimproved, consisting of a sandy/mucky substrate vegetated with mangroves. Red Mangroves (*Rhizophora mangle*) dominate closest to the water line with the Black Mangrove (*Avicennia germinans*) and White Mangrove (*Laguncularia racemosa*) dominating closer to the upland development. See Figure 8. Dead tree stumps and washed-up detritus litter the unimproved area of the south shoreline. Sand Cordgrass (*Spartina bakeri*), Beggarticks/Romerillo (*Bidens alba* var. *radiata*), and Ragweed (*Ambrosia artemisiifolia*) plants can be found at the immediate interface of the sheet pile and mangrove fringe near the parking area.

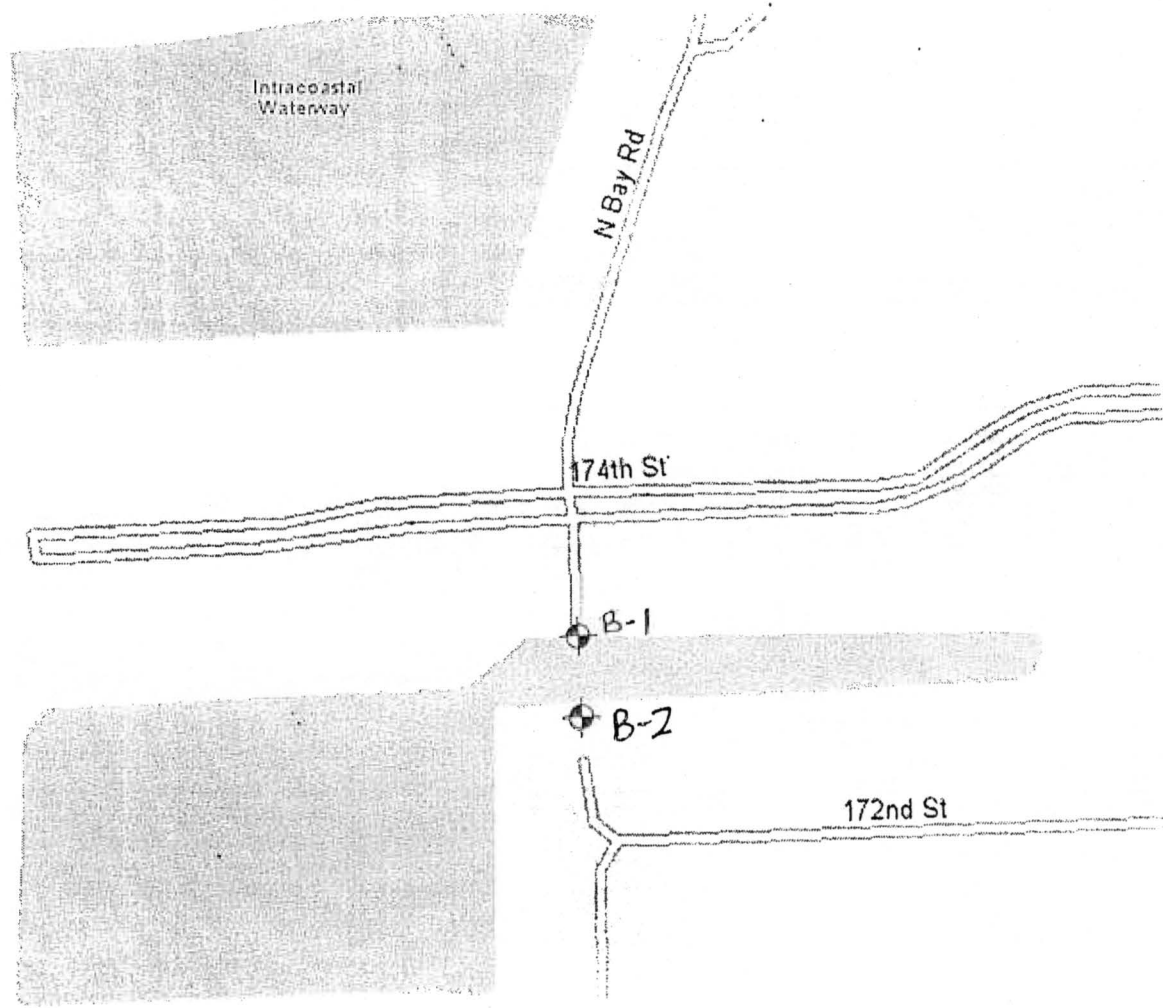
- LEGEND -
⊕ APPROXIMATE TEST BORING (SPT) LOCATION

Nutting Engineers of Florida, Inc. has performed a total of two (2) standard Penetration Test borings (ASTM D-1586) to depths of 50 feet below the existing ground surface in order to evaluate the subsurface soil conditions. The borings were performed along N. Bay Road, one on the north side and on the south side of the canal.

In addition, we performed corrosivity tests on each of the samples. The locations of the test borings are indicated on the attached Test Boring Location Plan. Individual test boring reports are presented in the Appendix of this report. The borings were established in the field using approximate methods; namely, a measuring wheel and available surface controls.

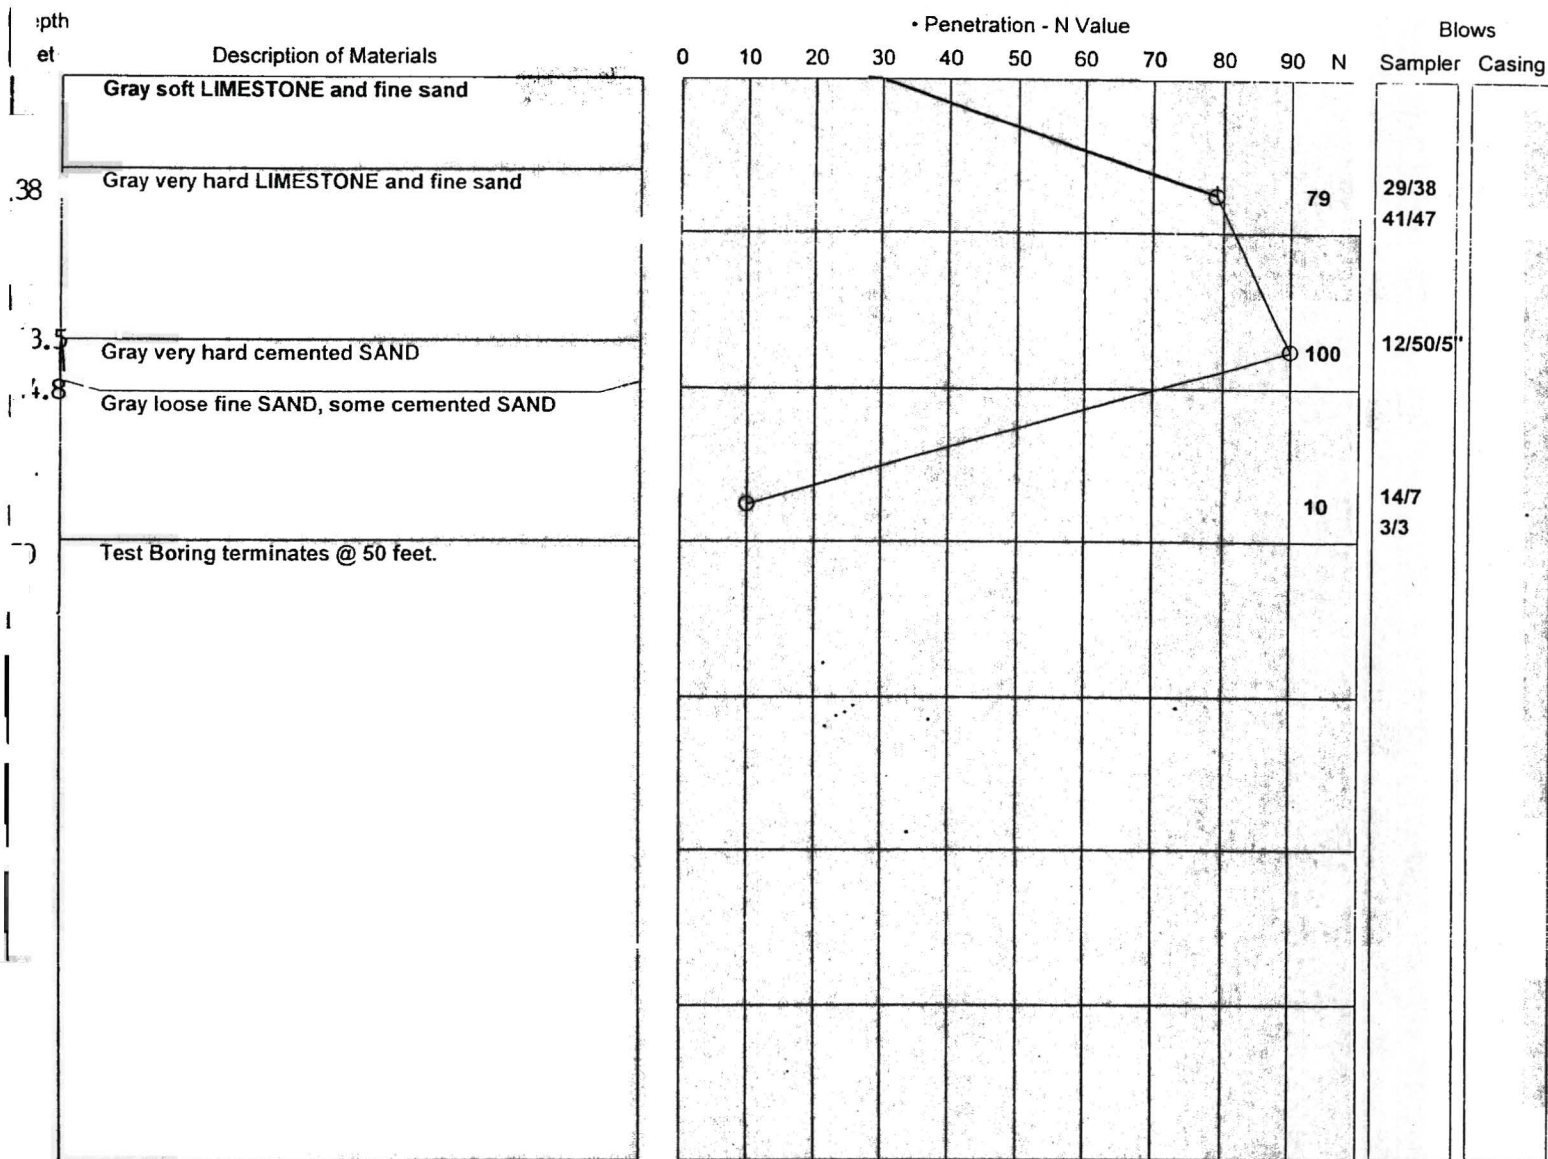
TEST BORING REPORT

Client: Calvin, Giordano & Associates, Inc. Order #: 101.11
 Project Name: Sunny Isles Beach Pedestrian / Emergency Vehicle Bridge Hole #: _____
 Project Location: North Bay Road, Sunny Isles Beach, FL
 Hole Location: Approx. 10' E. of mark on Site
 Driller: T. Simmons Date Started: 2/12/04
 Elevation Reference: Approx. @ Road Crown Date Completed: 2/12/04
 Casing Diameter: 3" OD BX Flush Couple Hammer WT: 280# Fall: 24"
 Sampler Diameter: 2" OD x 2' Split Spoon Hammer WT: 140# Fall: 30"
 Groundwater depth: Immediate: 5'

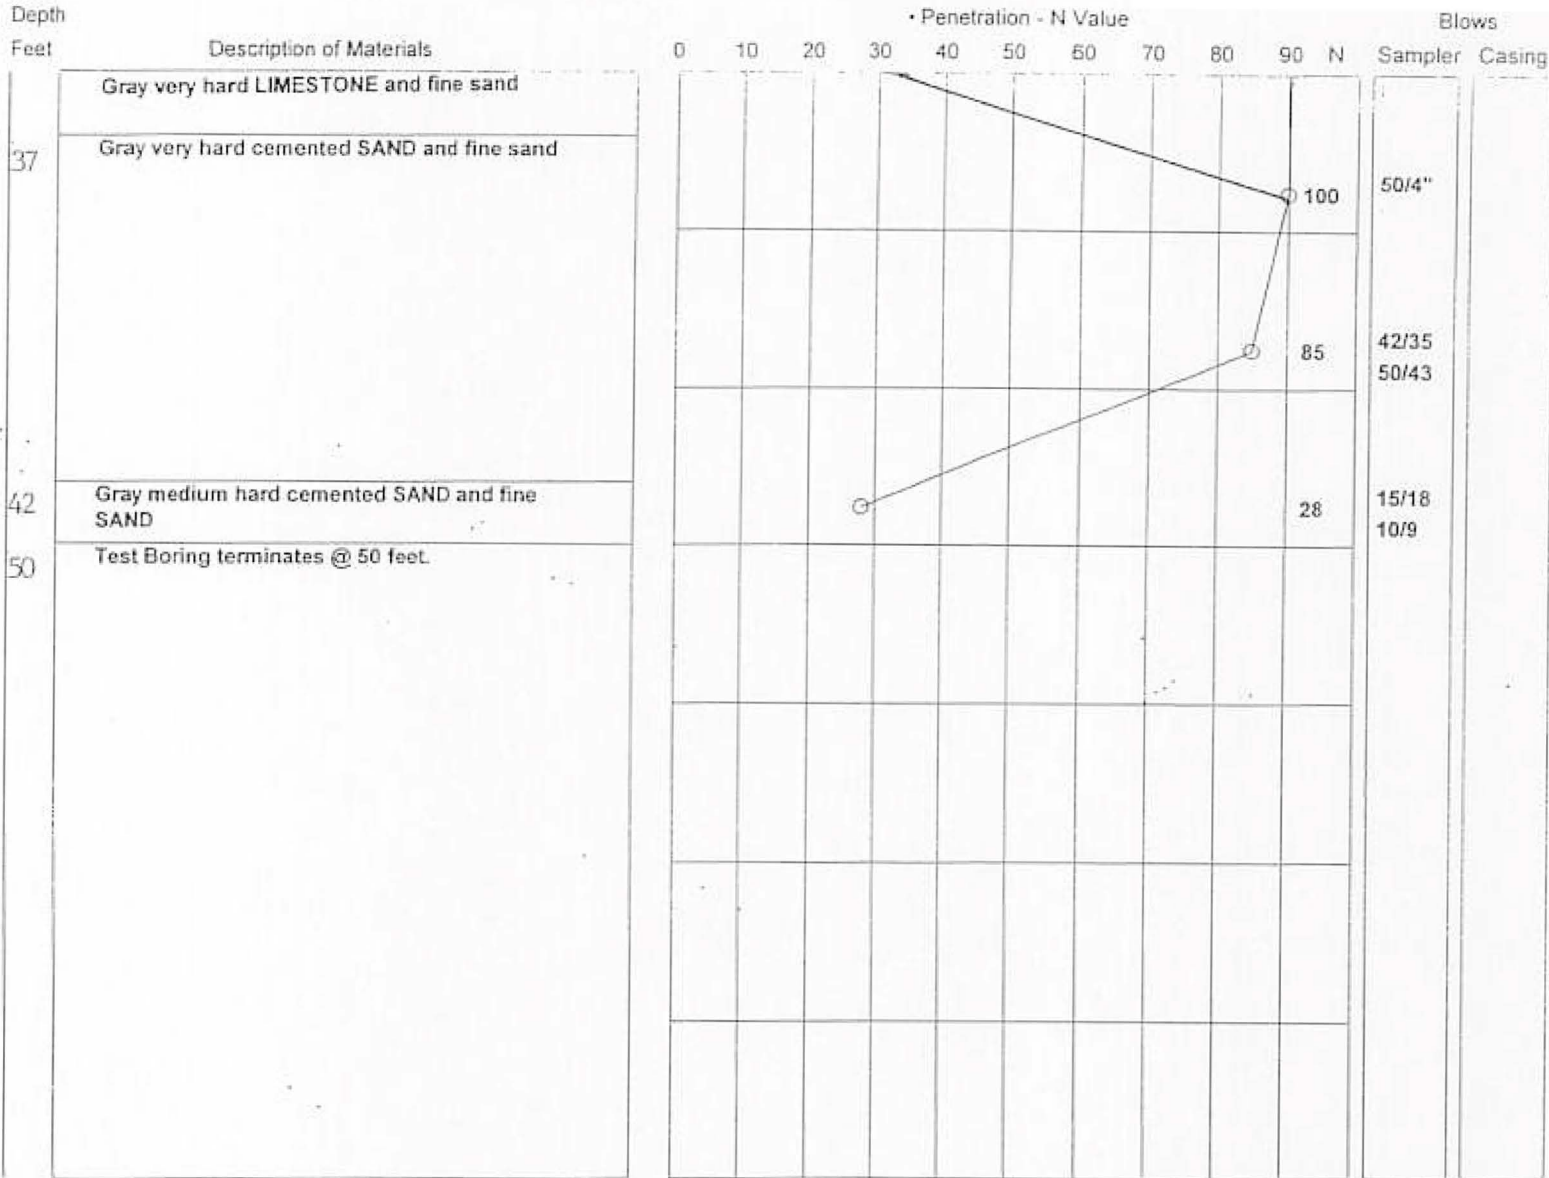
TEST BORING REPORT

Client:	Calvin, Giordano & Associates, Inc.	Order #:	101.11
Project Name:	Sunny Isles Beach Pedestrian / Emergency Vehicle Bridge	Hole #:	2 of 2
Project Location:	North Bay Road, Sunny Isles Beach, FL		
Hole Location:	Approx. 40' N. and 35' W. of the NE Building Corner @ 17150		
Driller:	T. Simmons	Date Started:	2/12/04
Elevation Reference:	Approx. @ Road Crown	Date Completed:	2/12/04
Casing Diameter:	3" OD BX Flush Couple	Hammer WT:	280# Fall: 24"
Sampler Diameter:	2" OD x 2' Split Spoon	Hammer WT:	140# Fall: 30"
Groundwater depth:	Immediate: 5'

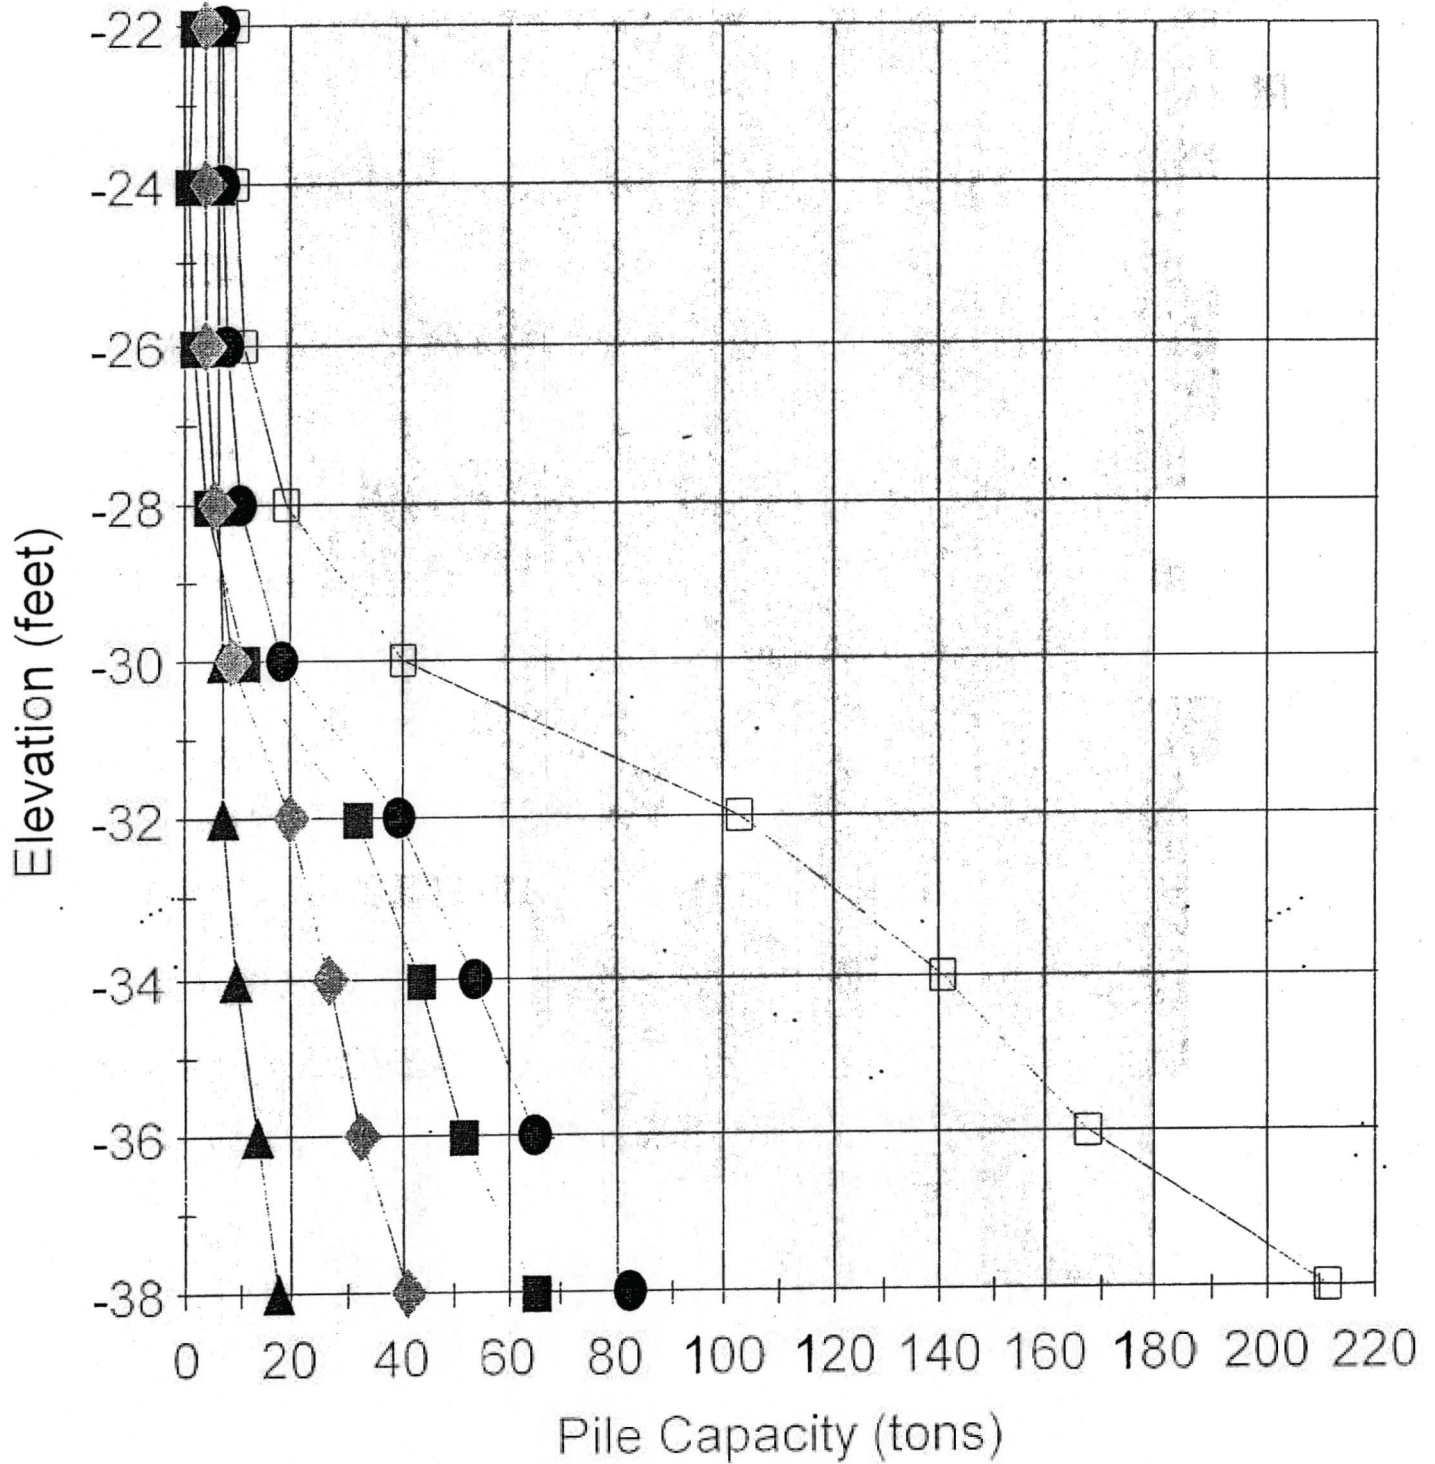
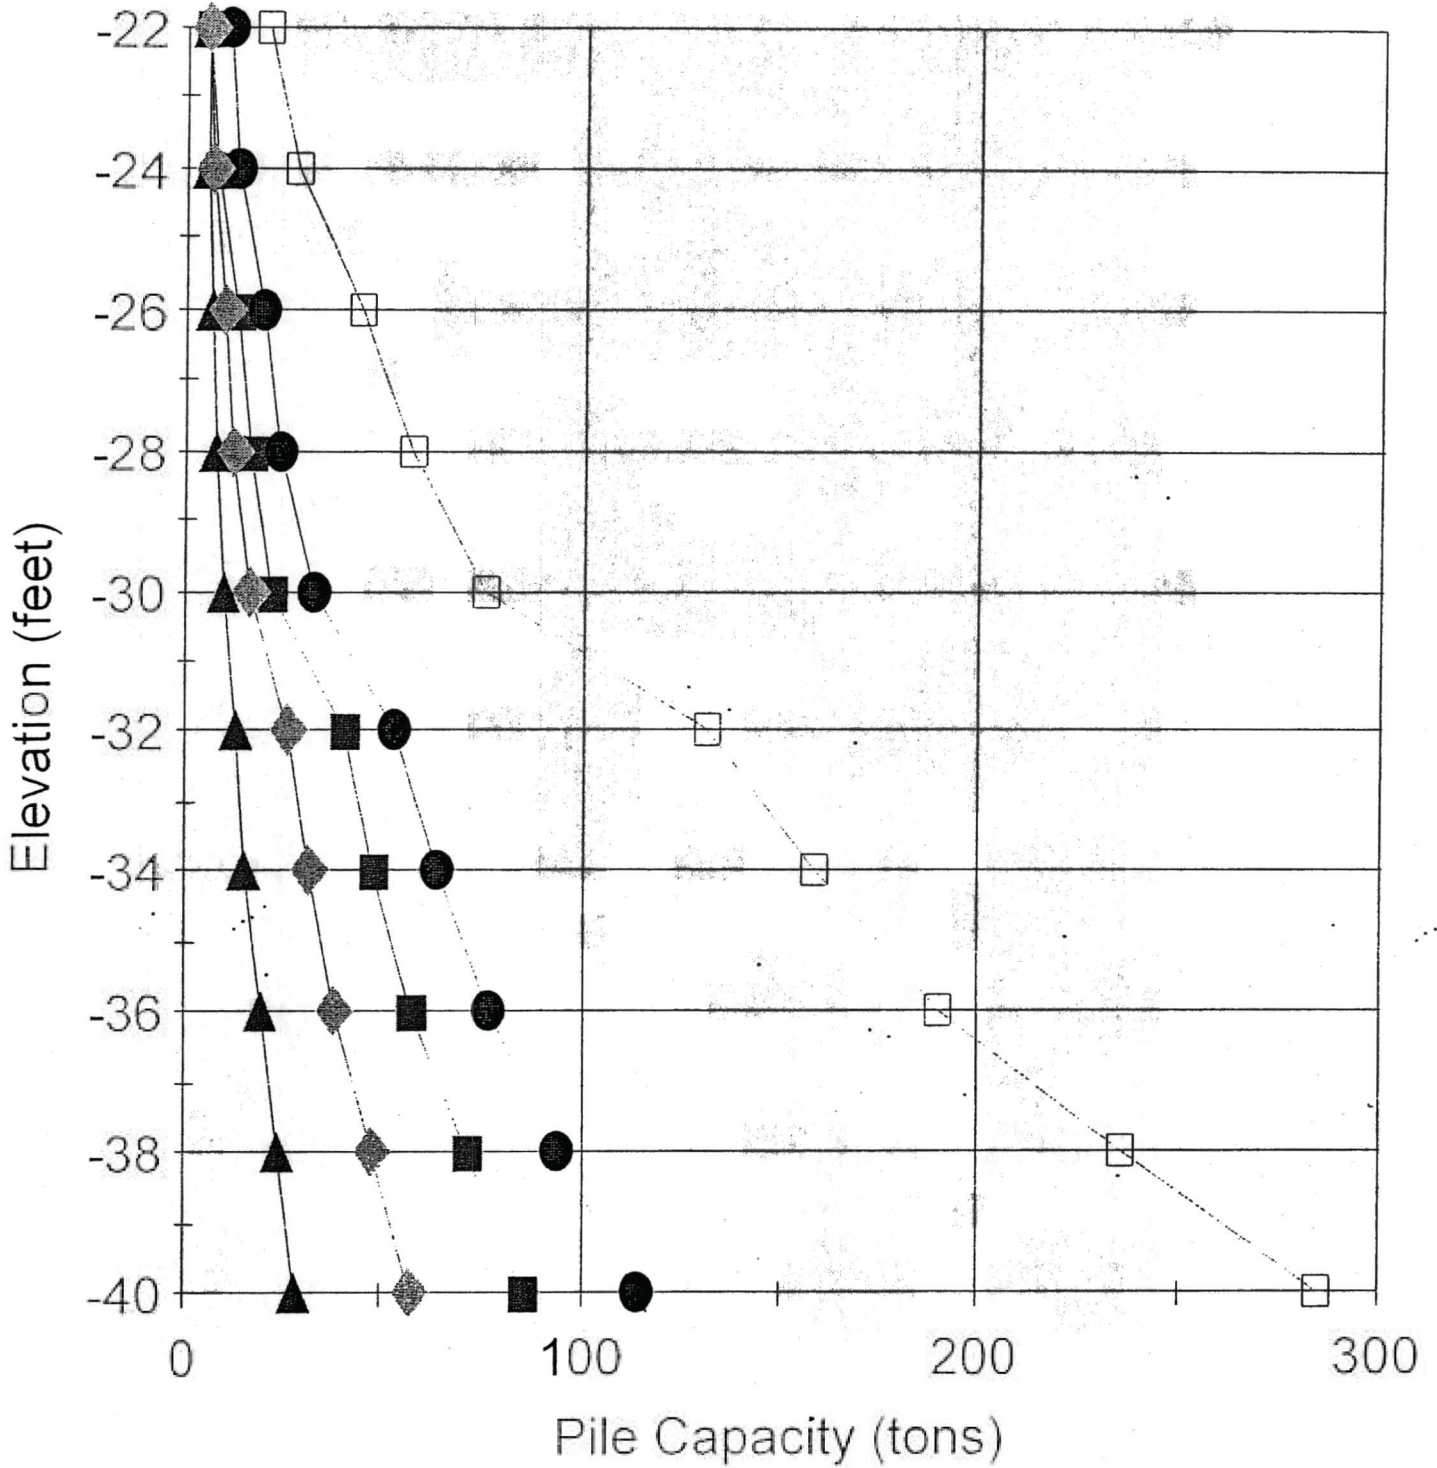
- ▲ Ultimate Side Friction
- Mobilized End Bearing
- Estimated Davisson Capacity
- Allowable Pile Capacity
- Ultimate Pile Capacity

Our analysis indicates that 14 inch by 14 inch square precast concrete piles driven into the well cemented limestone will provide an allowable compressive capacity of 35 tons. This translates to pile lengths ranging from 38 to 39 feet below the existing ground surface. The actual depths should be expected to vary depending on the driving conditions encountered during installation of these piles. This is based on the borings and our experience in the area. If lateral loads are involved, we should be notified to evaluate this condition.

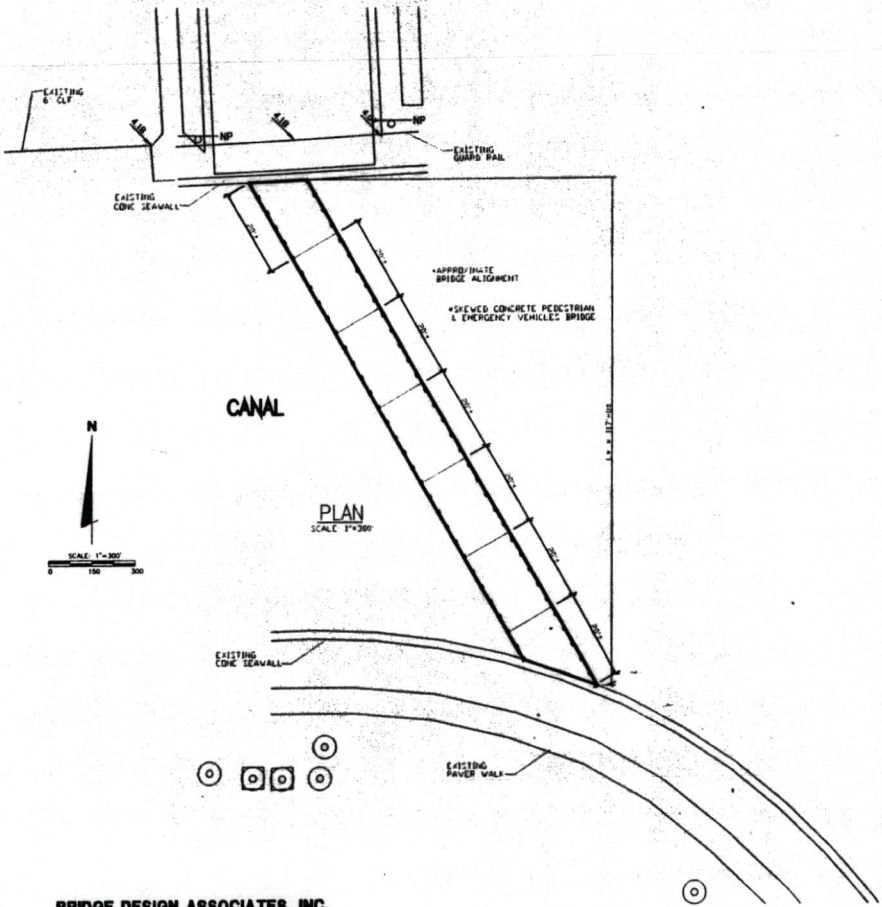
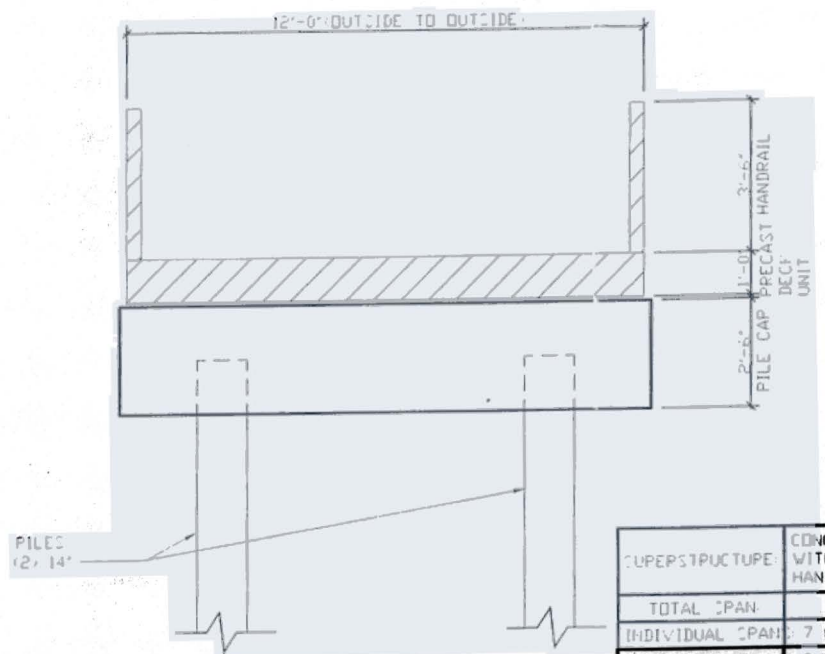
SECTION "A-A"
SCALE 1"=30'

PLAN
SCALE 1"=30'

ELEVATION
LOOKING WEST
SCALE 1"=300'

SUPERSTRUCTURE	CONCRETE DECKS WITH ALUMINUM HANDRAILS
TOTAL SPAN	140 LF.±
INDIVIDUAL SPAN	7 @ 20 LF.±
ORIENTATION	SKEWED 30° ±
BRIDGE WIDTH	12'±
USE	PEDESTRIAN & EMERGENCY VEHICLES

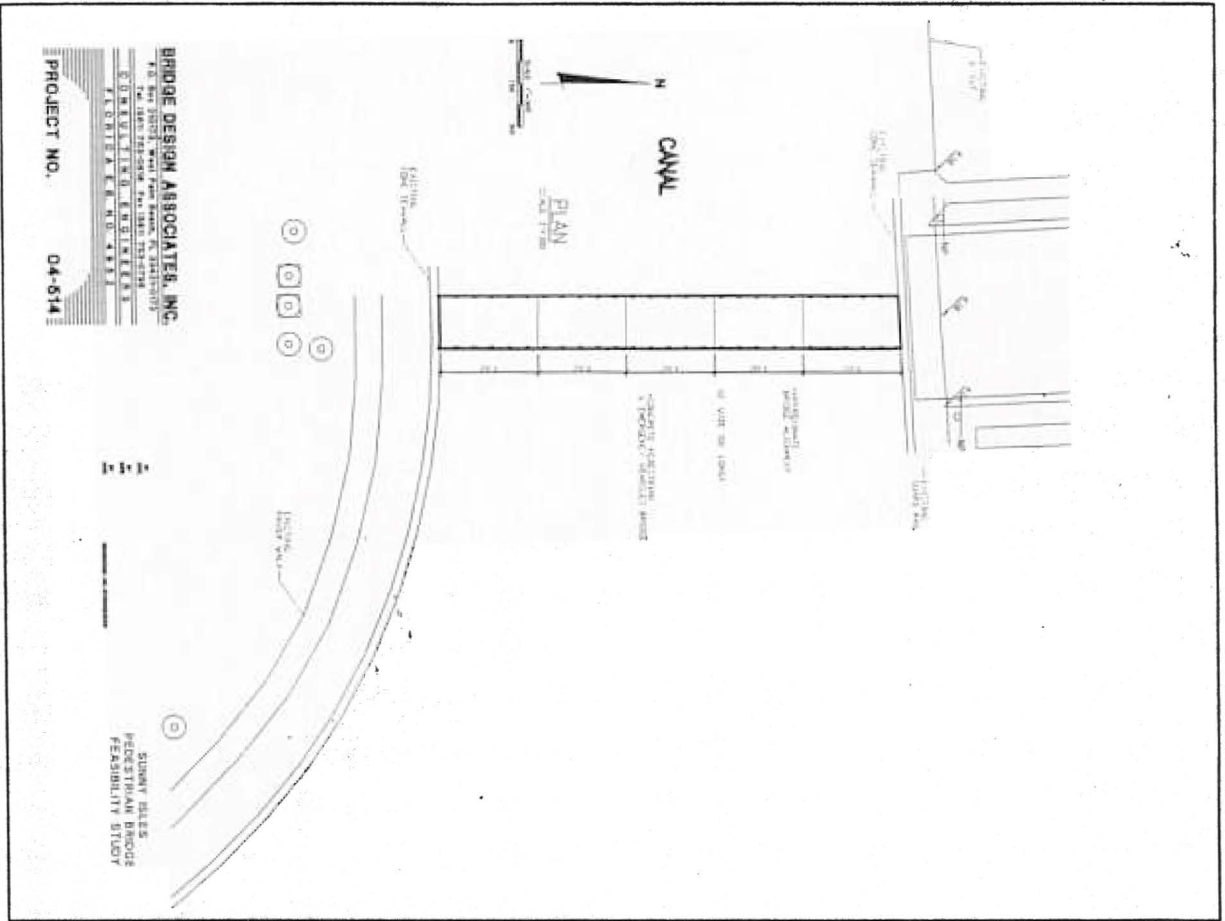
SECTION "A-A"
 SCALE: 1" = 30'

CONCRETE DECKS WITH ALUMINUM HANDRAILS	CONCRETE DECKS WITH ALUMINUM HANDRAILS
100 L.F. ±	100 L.F. ±
5 @ 20 L.F. ±	5 @ 20 L.F. ±
STRAIGHT	STRAIGHT
12 ±	12 ±
PEDESTRIAN & BICYCLE VEHICLES	PEDESTRIAN & BICYCLE VEHICLES

Maps and survey data were used to project possible alignment of the proposed bridge (see Appendix C, Figure 1). Feasibility study for structural analysis was performed by Bridge Design Associates, Inc. to determine the placement and costs of the proposed bridge. It was recommended that the bridge should have a concrete substructure with an aluminum or concrete superstructure, due to the corrosivity of the soil. The use of an aluminum superstructure is for pedestrian access only, while the concrete superstructure is for both pedestrian and emergency access. Four possible design alternatives were proposed (see Appendix C, *Design Alternatives*). Option 1 has pedestrian/emergency vehicle capability with a skewed orientation, a total span of 140 feet, 7 spans at 20 feet, and an estimated cost of \$1,400,000. Option 2 has a pedestrian/emergency vehicle capability at a straight orientation with a total span of 100 ft, 5 spans at 20 ft, and an estimated cost of \$1,330,000. Option 3 has pedestrian access only, with a skewed orientation, a total span of 140 ft, 3 spans at 47 feet, and an estimated cost of \$1,310,000. Option 4 has pedestrian access only, a straight orientation, a total span of 100 feet, 2 spans at 50 feet, and an estimated cost of \$1,230,000.

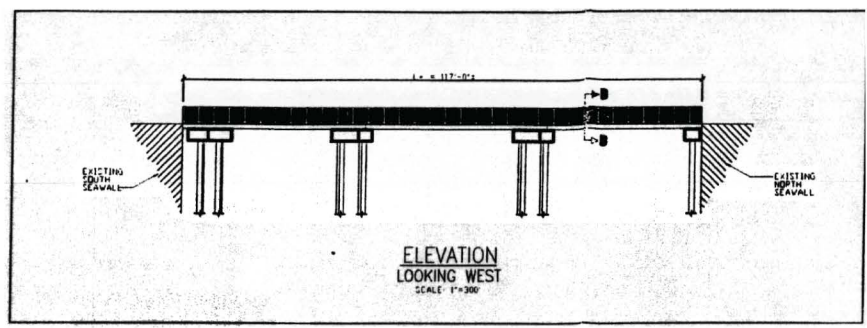
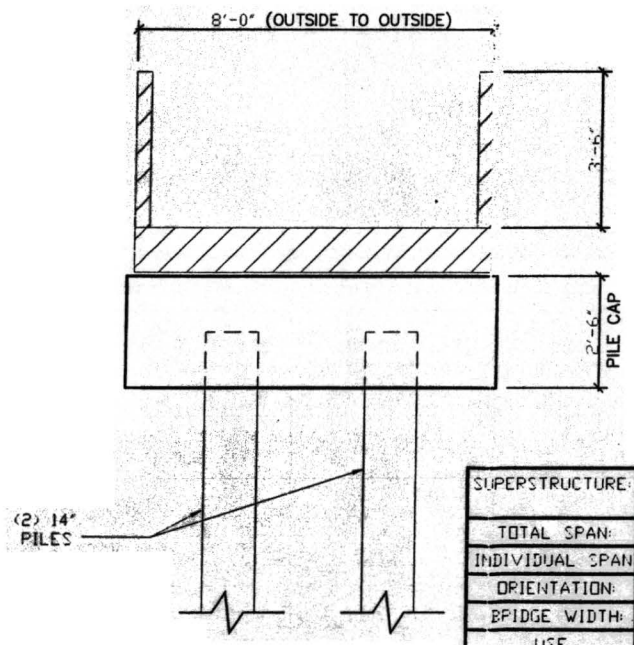
SUPERSTRUCTURE:	ALUMINUM DECK & HANDRAILS
TOTAL SPAN:	140 L.F. ±
INDIVIDUAL SPAN:	3 @ 47 L.F. ±
ORIENTATION:	SKEWED 30° ±
BRIDGE WIDTH:	8' ±
USE:	PEDESTRIAN ONLY
