CITY OF SUNNY ISLES BEACH

Feasibility Study Summary of a Bridge to Link a Pedestrian/Bicycle Greenway

**Extension of North Bay Road from 172nd to 174th Street
City of Sunny Isles Beach**

CGA Project No. 04-4567
September 2004

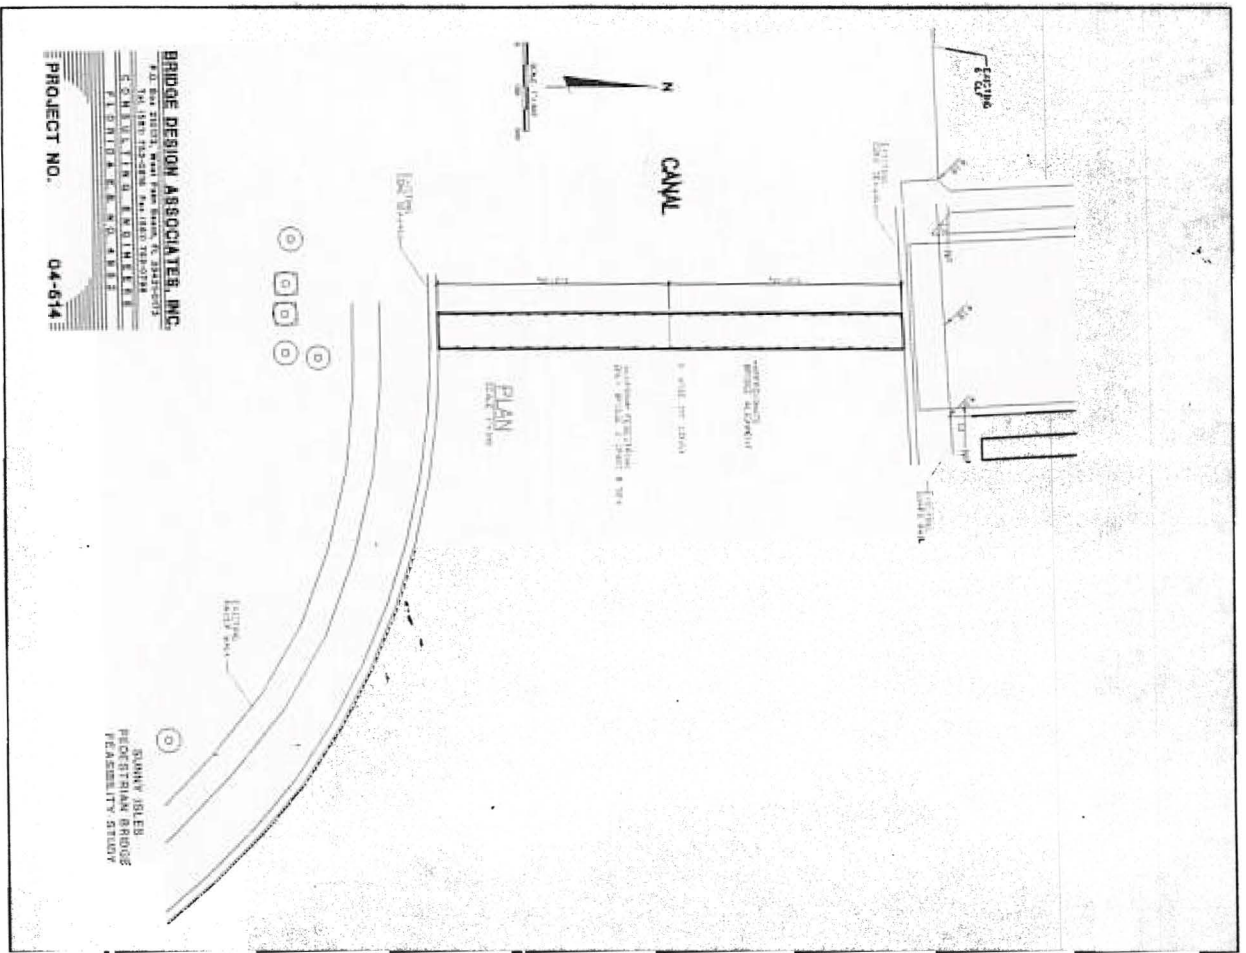
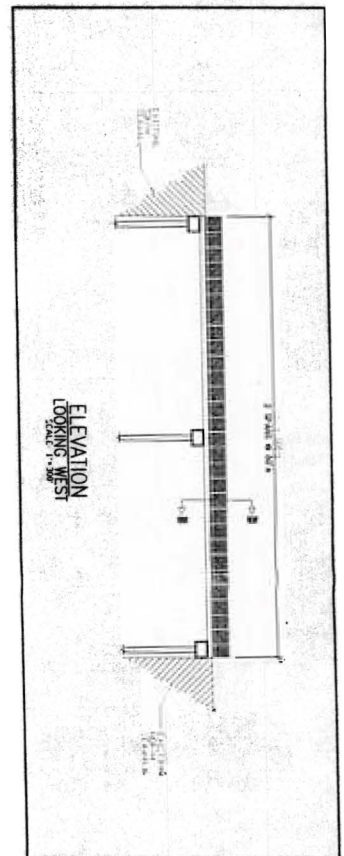
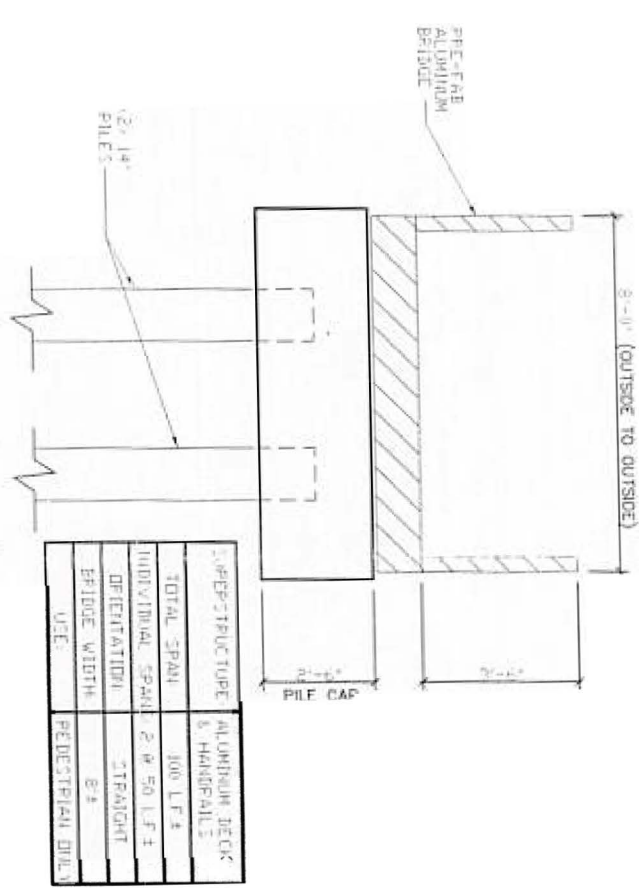
STRUCTURE TYPE	ALUMINUM DECK & HANDRAILS
TOTAL SPAN	100 L.F.A
INDIVIDUAL SPAN	2 @ 50 L.F.A
ORIENTATION	STRAIGHT
BRIDGE WIDTH	8'-0"
USE	PEDESTRIAN ONLY

Maps and survey data were used to project possible alignment of the proposed bridge (see Appendix C, Figure 1). Feasibility study for structural analysis was performed by Bridge Design Associates, Inc. to determine the placement and costs of the proposed bridge. It was recommended that the bridge should have a concrete substructure with an aluminum or concrete superstructure, due to the corrosivity of the soil. The use of an aluminum superstructure is for pedestrian access only, while the concrete superstructure is for both pedestrian and emergency access. Four possible design alternatives were proposed (see Appendix C, *Design Alternatives*). Option 1 has pedestrian/emergency vehicle capability with a skewed orientation, a total span of 140 feet, 7 spans at 20 feet, and an estimated cost of \$1,400,000. Option 2 has a pedestrian/emergency vehicle capability at a straight orientation with a total span of 100 ft, 5 spans at 20 ft, and an estimated cost of \$1,330,000. Option 3 has pedestrian access only, with a skewed orientation, a total span of 140 ft, 3 spans at 47 feet, and an estimated cost of \$1,310,000. Option 4 has pedestrian access only, a straight orientation, a total span of 100 feet, 2 spans at 50 feet, and an estimated cost of \$1,230,000.
